ROCKFALL HAZARD STUDY

East Vail Parcel
Vail, Colorado

**Project No. 17.5029
June 19, 2017**

**Julia M. Frazier, P.G.
Senior Geologist**

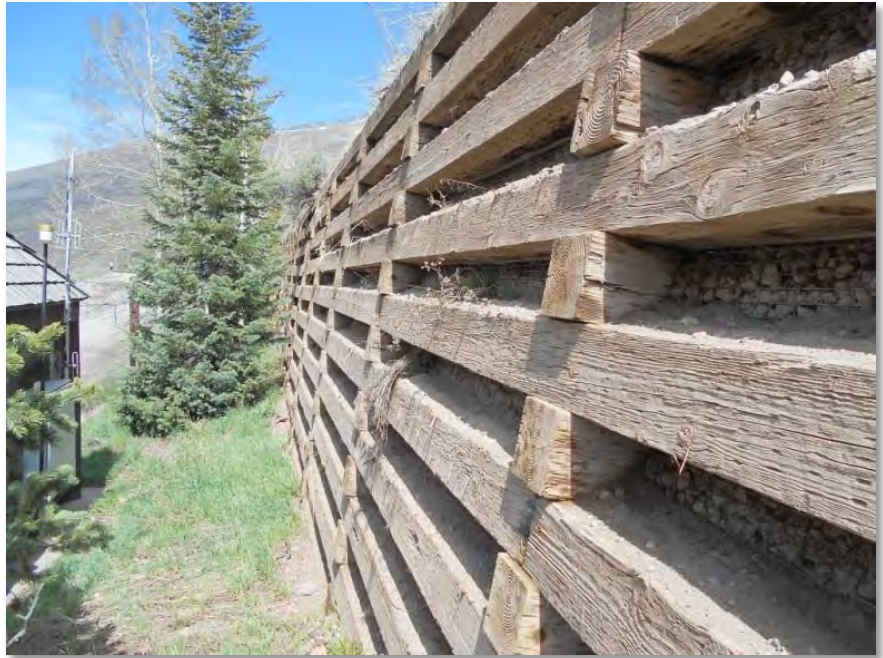
Photograph 2. View of retaining wall located along edge of site that borders Fall Line Drive. Town of Vail shuttle stop is visible in the left side of the photograph.

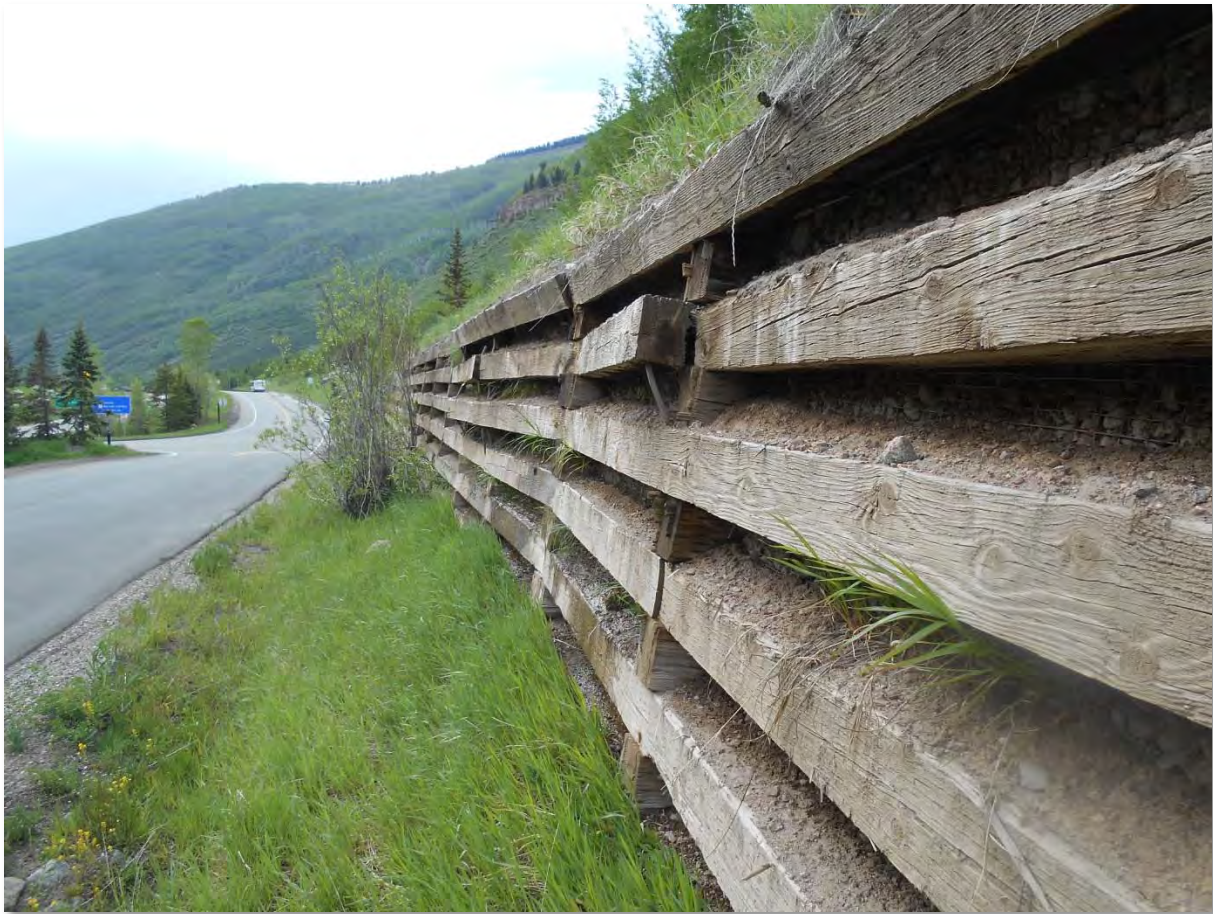
Photograph 3. View of distressed part of the retaining wall along the edge of the site that borders Fall Line Drive. The slope rises steeply upward to the north at the top of the wall. This photograph was taken near the east end of the wall.

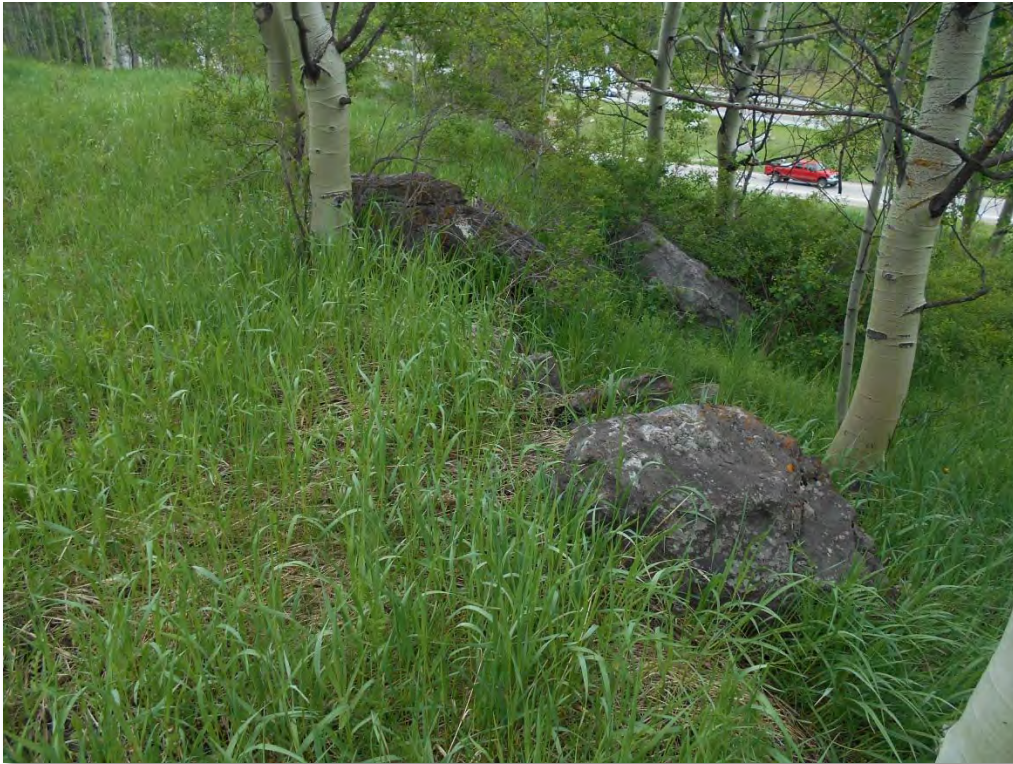
Photograph 5. View of limestone boulders which have come to rest near the base of the slope in the western part of the site. Boulders are about 3 to 4 feet in longest dimension, embedded in the soil, surrounded by mature vegetation, and show lichen on the surface.

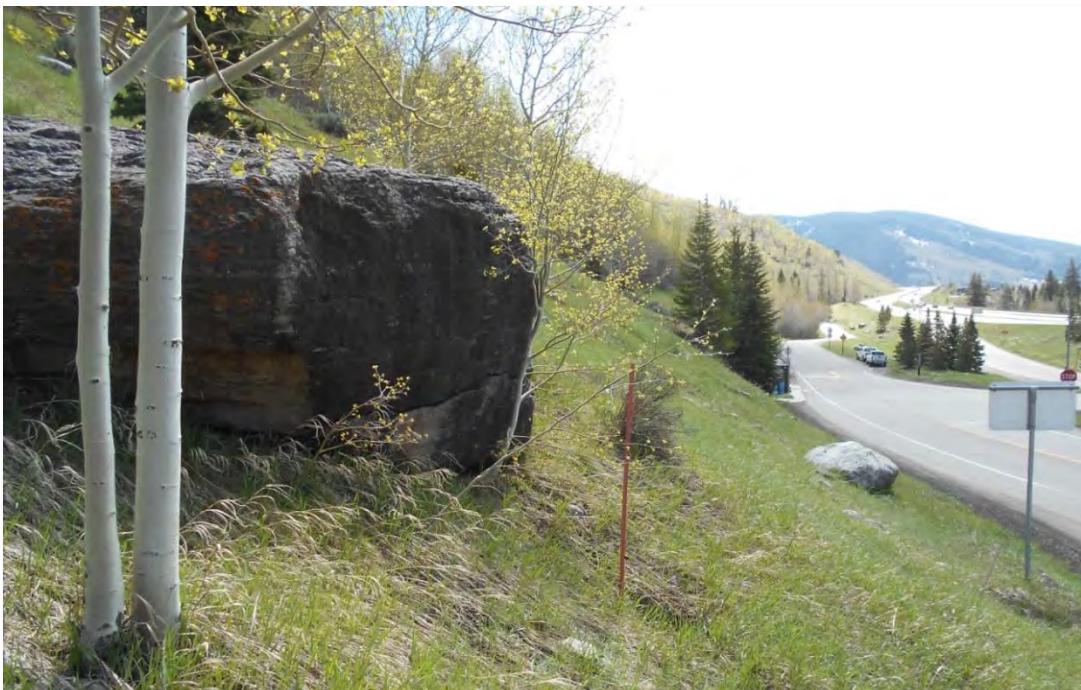
Photograph 6. View of large sized limestone boulder located in the southern area of the site. Boulder measures about 21 feet long by 16 feet wide by 6 feet high. A survey marker has been placed on this boulder (Eagle County Survey Control, 1998).

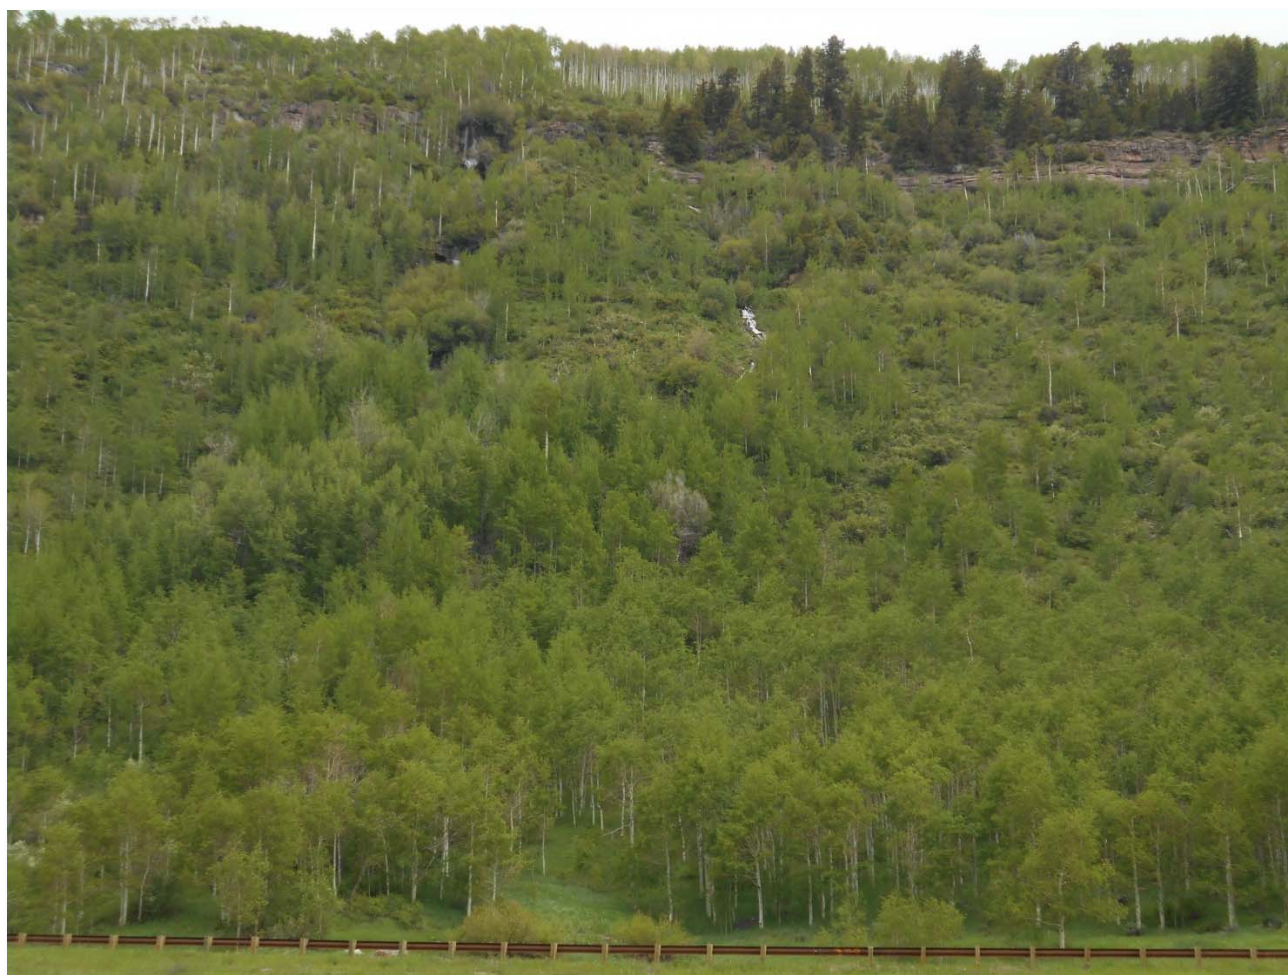
Photograph 7. View of the western part of the site. Note the dense vegetative cover, flowing water, and exposed bedrock outcrops near the top of the slope.

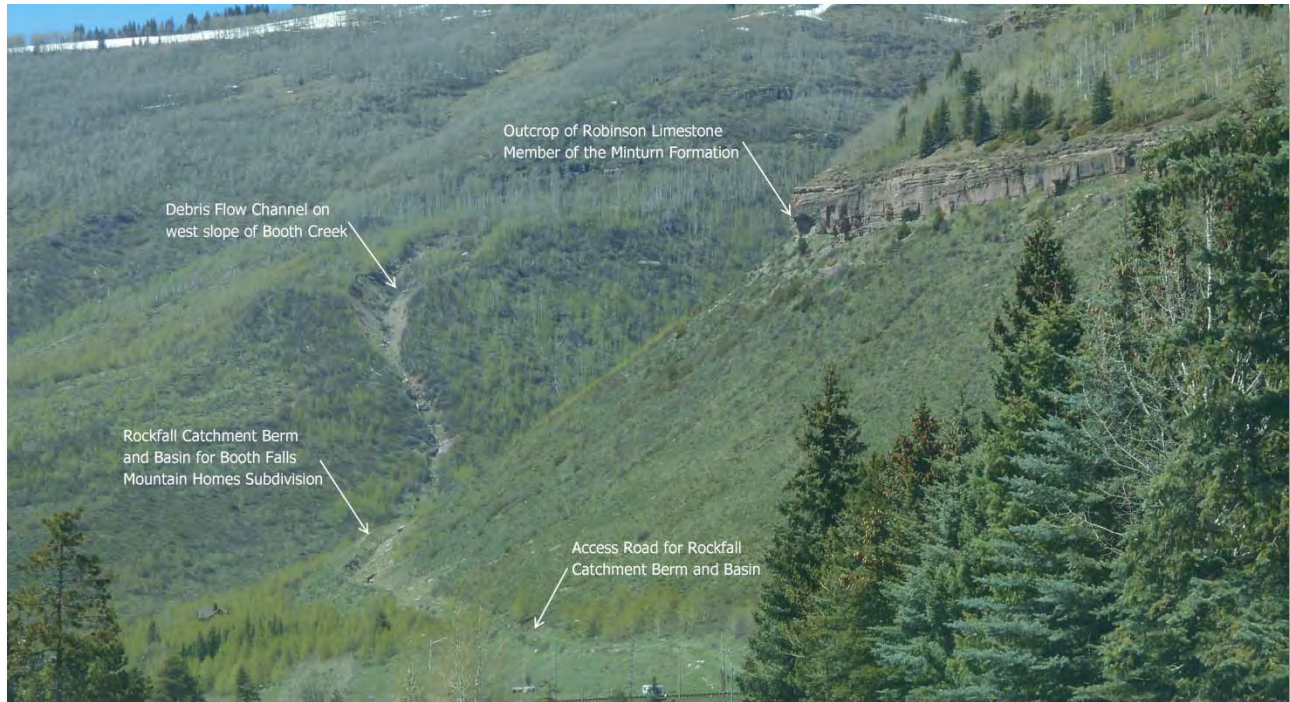
Photograph 12. View looking west toward Booth Creek. The project site is located beyond the trees in the right side of the photograph. Features are labeled.

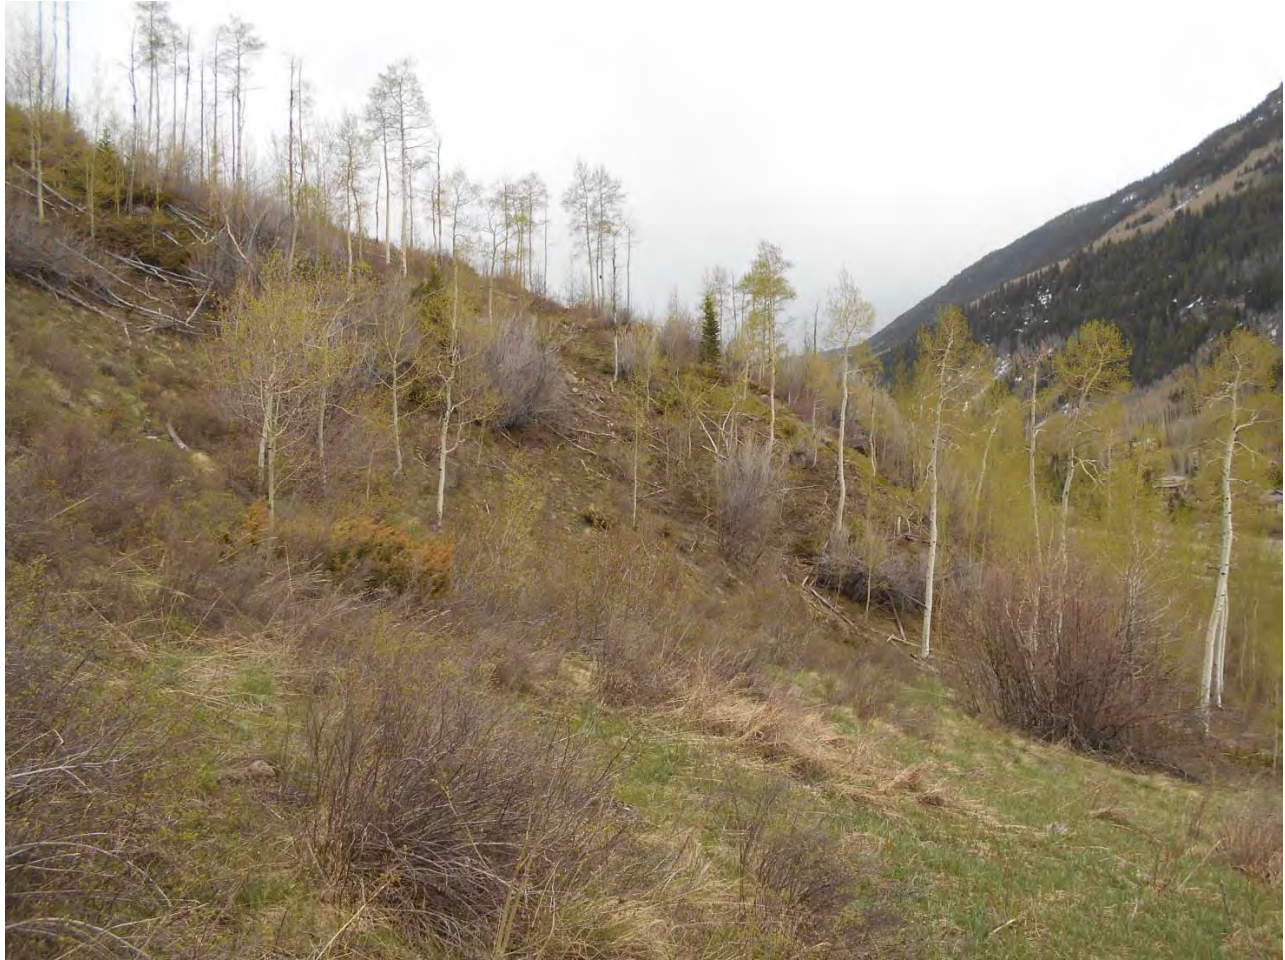
Photograph 13. View looking eastward from the western flank of the landslide toe. The ground surface is relatively steep along the toe and flanks of the slide mass, visible in the photograph.

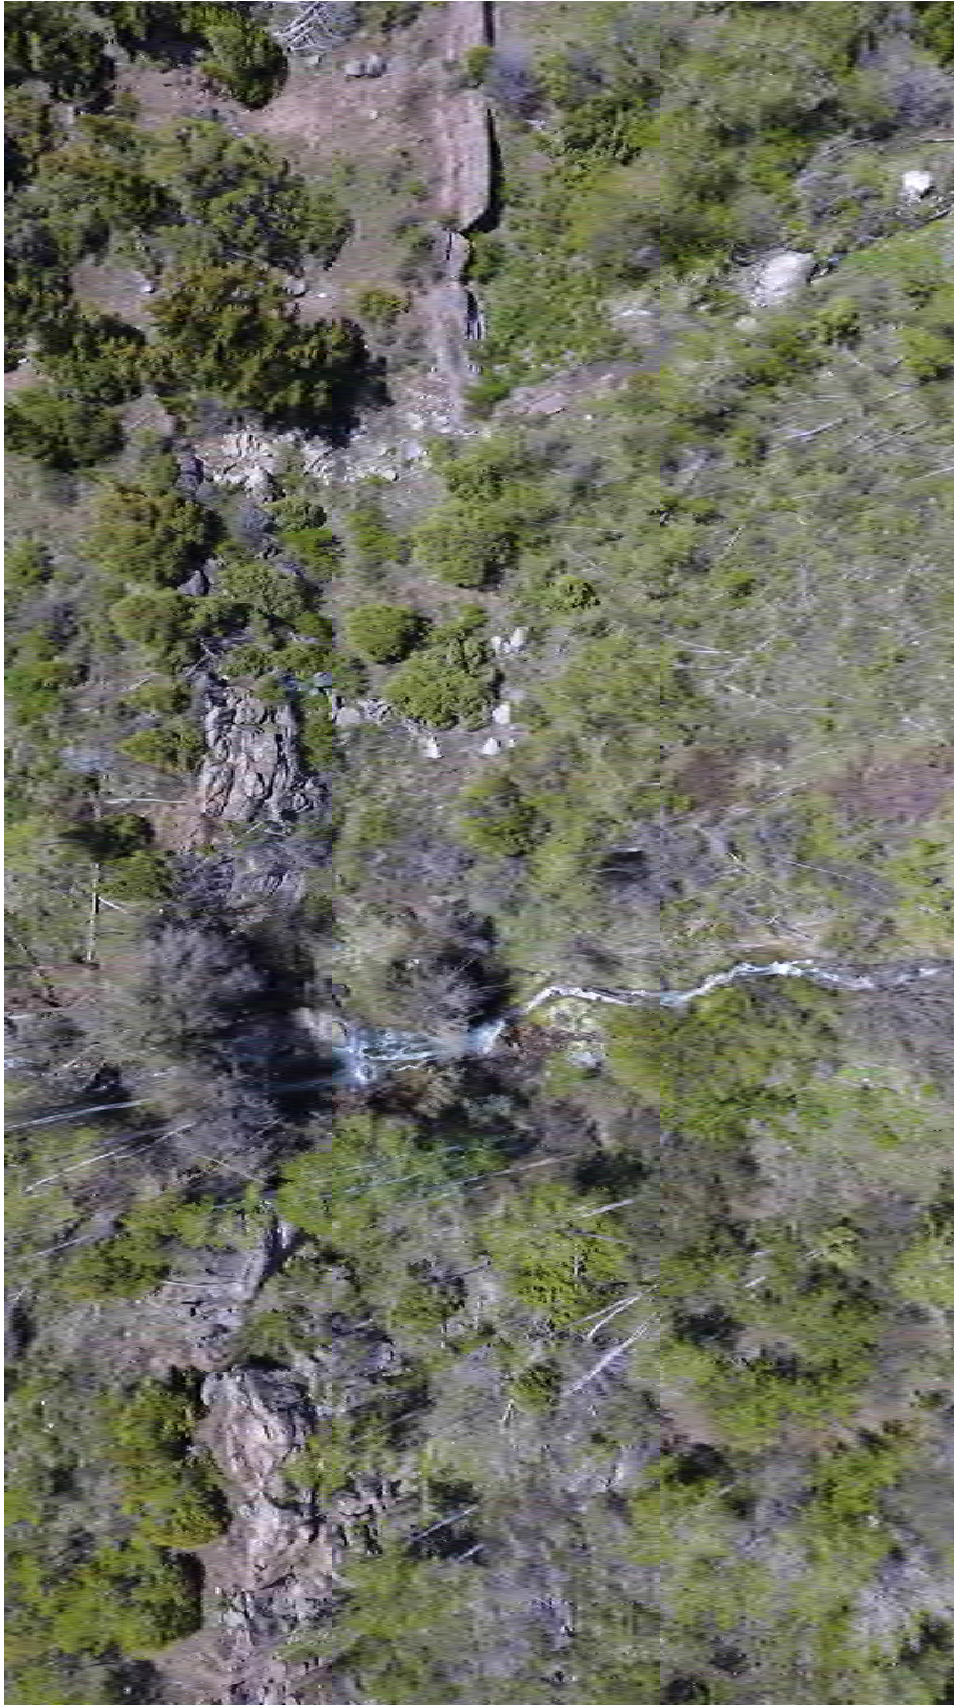
Photograph 18. Aerial view of the rockfall source zone. This photograph shows the steep cliff forming exposures of Robinson Limestone member of the Minturn Formation, dense vegetation in the form of trees and large shrubs, and flowing water in one of the drainages on the west side of the site. The bedrock exposures are fractured, blocky, and ledge-forming.

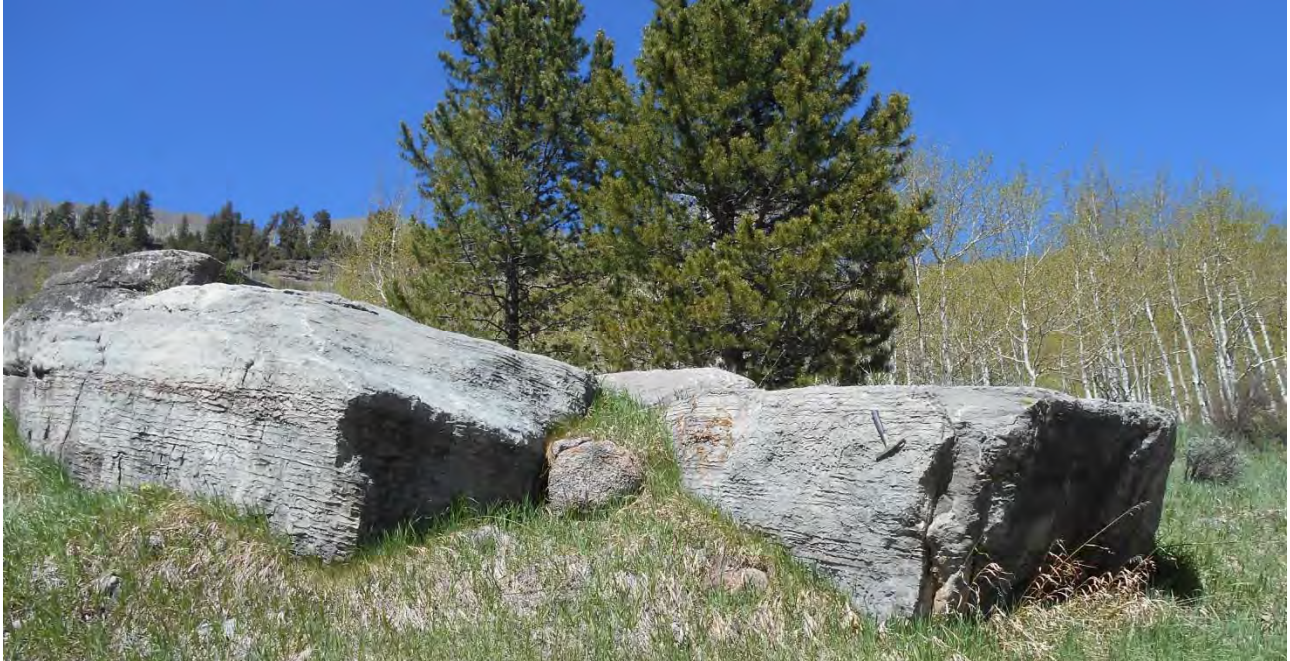
Photograph 22. View of large, angular, slab shaped boulders near the base of the slope within the area most likely to be developed in the future. Boulder sizes were observed to be at least (1) 12 foot by 8 foot by 5 foot, (2) 7 foot by 7 foot by 3 foot, and (3) 21 foot by 12 foot by 9 foot. These boulders are embedded in the soil and have been resting here for some time.

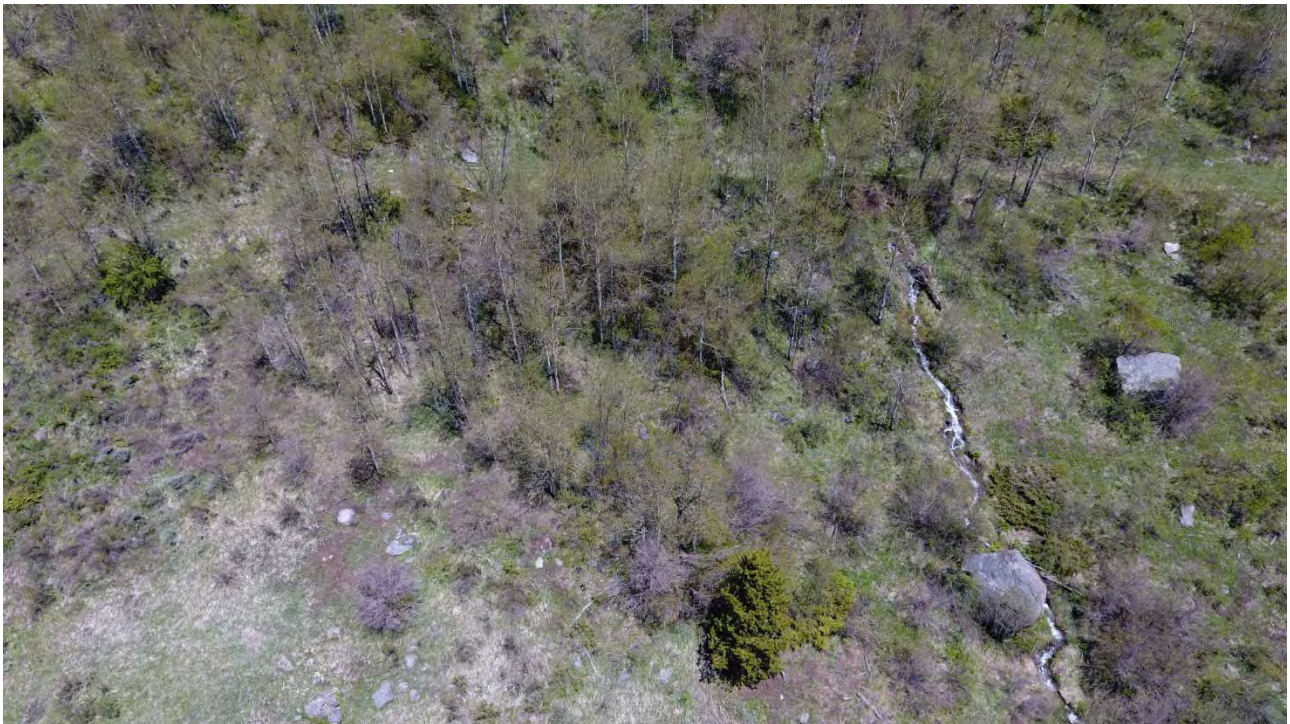
Photograph 23. Aerial view of lower slope in western part of the site. North is toward the top of the photograph. Notice scattered boulders as large as about 7 to 8 feet in longest dimension and slab shaped. Most boulders are 3 feet or less in dimension and are embedded in the soil, representing older, ancient rockfall events.
