PROJECT NO:	17.5029		
PROJECT NAME:	Rockfall Hazard Study, East Vail Parcel		
DRAWN BY:	RAB	CHECKED BY:	JMF
DWG DATE:	06.16.17	REV. DATE:	--

Rockfall Hazard Assessment at Booth Falls Condominiums and  
Proposed Mitigation  
(Colorado Geological Survey)

**ROCKFALL HAZARD ASSESSMENT AT BOOTH FALLS  
CONDOMINIUMS  
AND PROPOSED MITIGATION**

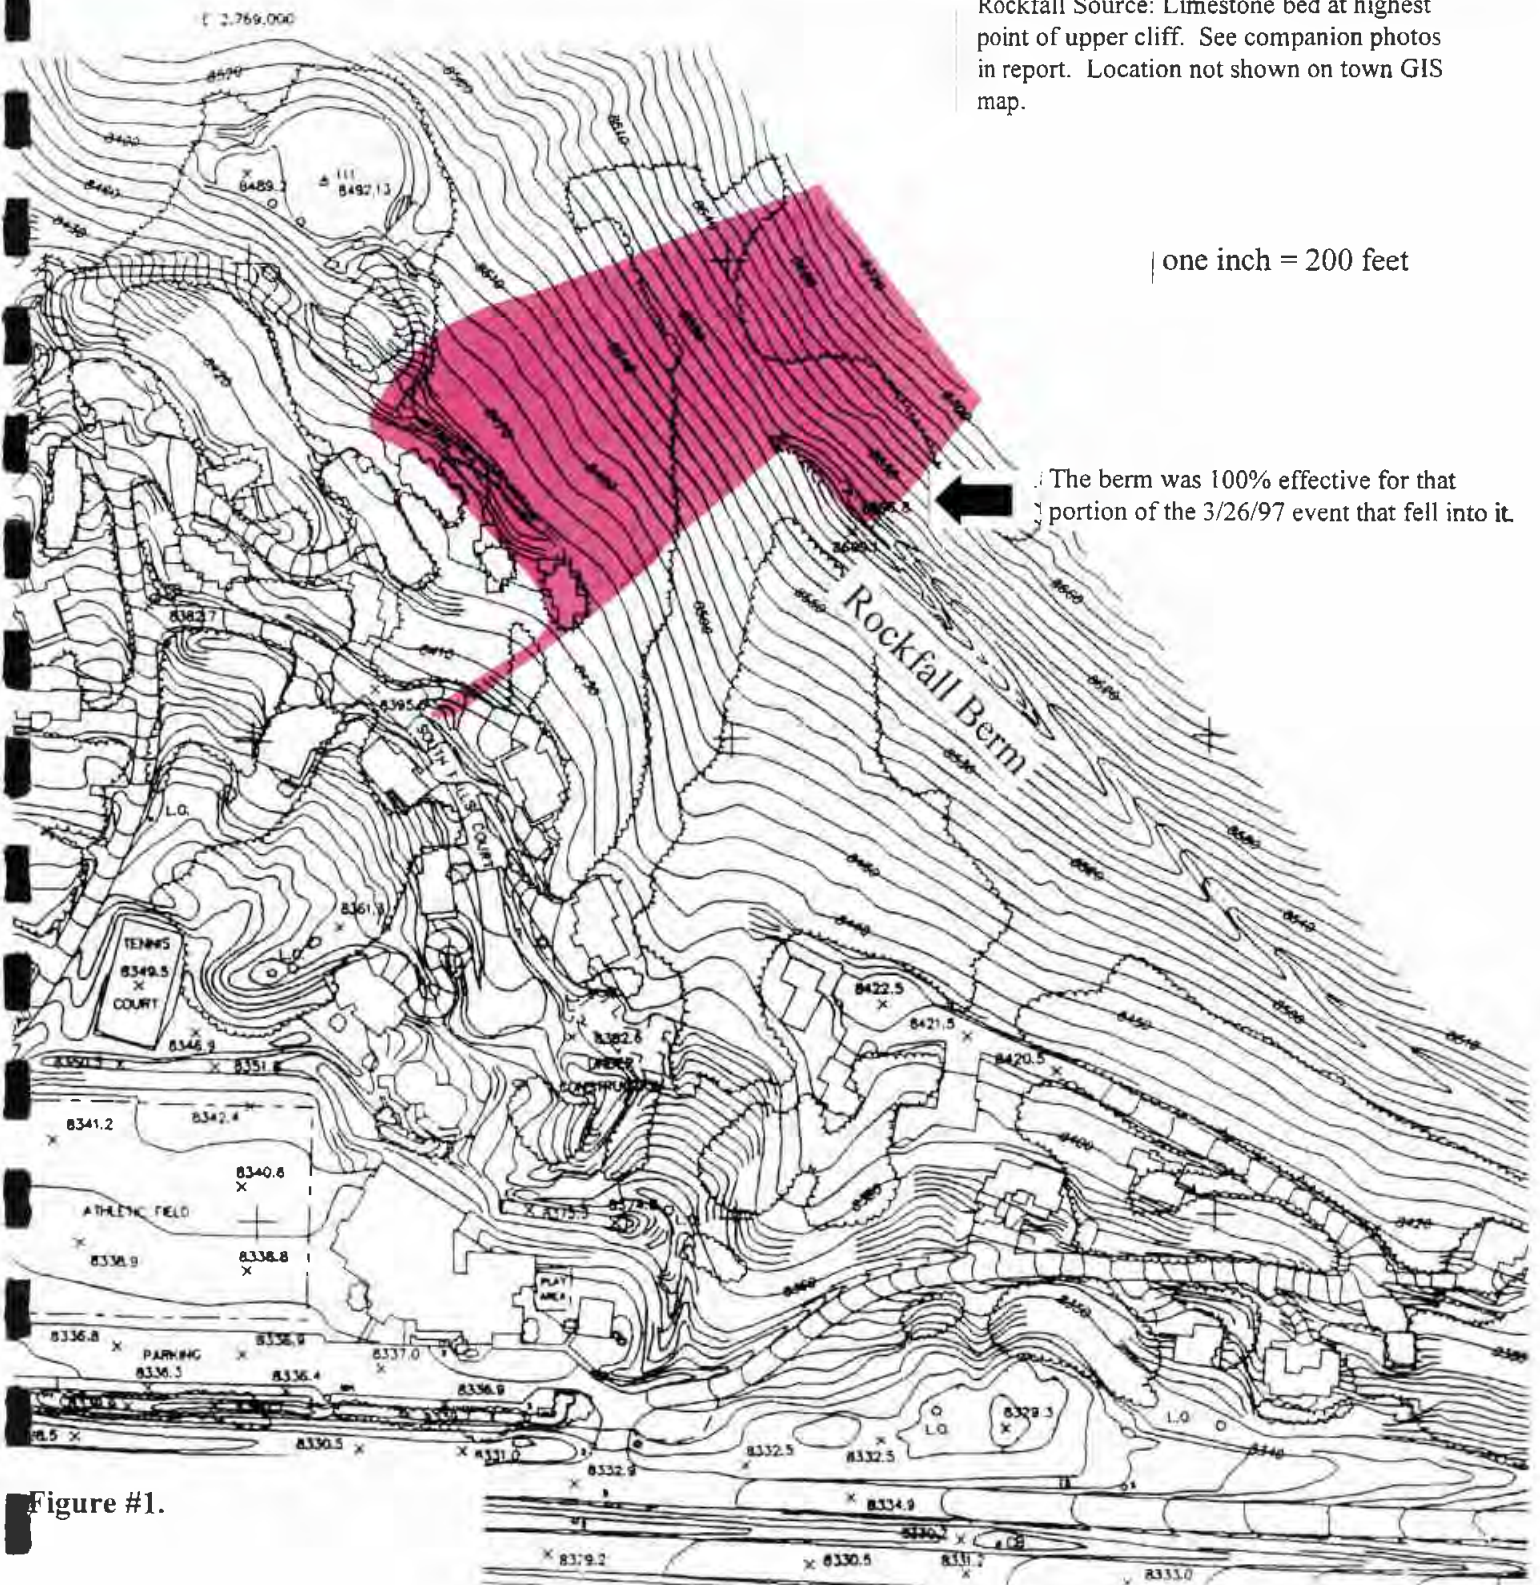
Approximately one third of the swath of rolling rocks were retained by the ditch and berm. See Figure #1. The remaining two-thirds of the event came to rest, scattered around the condominiums. The condo structures received three rock impacts and several near misses. Rock sizes ranged from 2 to 5+ feet in average diameter. Surrounding the condos several items were also damaged or destroyed, (i.e., small haul trailer, trampoline frame, small wooden deck and chairs, wood walkway). Of the three impacts, one was minor and the other two major. The minor impact was from a ~3 foot diameter rock that obviously had slowed almost to a stop upon impacting the westernmost condo structure. The rock came to rest, ominously so, next to a large boulder from an earlier rockfall. A major impact, also about 3-4 feet in diameter at high velocity, had just missed the ditch and berm catchment. The rock impacted and smashed the corner of the easternmost condo, snapped off the side balcony support, and destroyed a trampoline frame along its path before coming to rest in the subdivision below. The third and worst impact was a 5+ foot block that broadsided the easternmost condo. Sufficient rock velocity enabled the boulder to smash through the outside wall, interior walls, and the floor, finally being caught in the crawlspace below. Luckily the resident, whose bedroom this rock smashed through, was not home at the time of the rockfall.

The berm was 100% effective for that  
portion of the 3/26/97 event that fell into it.

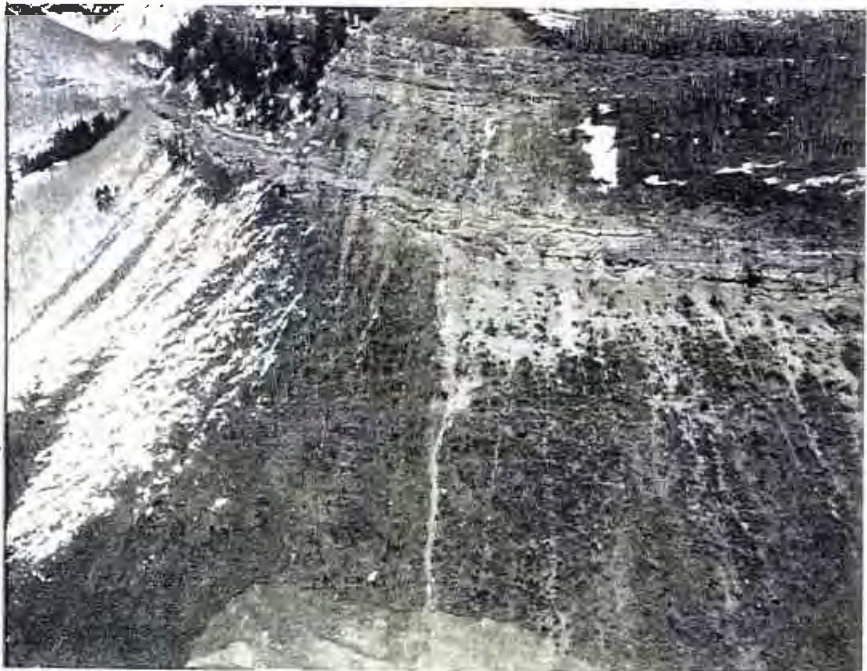
In a ranking of a rockfall hazard the parameters are source area, a steep acceleration zone, proximity of structures to both, and history of rockfall impacts. In two aspects the condominium location is worse than most of the special district to the east because the upper cliff is more fully exposed at this location (it is mostly soil covered to the east) and the slope between and below the cliffs steepen where the slope curves around into Booth Creek Valley. See Photo #1 and Figure #1 map in Appendix A.

The main source area for Booth Falls Condominiums is the upper cliff. The exposed, lower cliff of sandstone reduces in height as it trends to the northwest. Photo #1 and a close-up photo #2 show the extent of the upper cliff where it is not soil covered. They reveal a benchy cliff of beds of limestone, thin shales, and minor sandstone. It is the dense, hard, gray limestone that creates the largest rockfall boulders in the Booth Creek area. The report by B. Stover in Appendix A provides further in-depth

**Photo #1.** Booth Creek rockfall source area. Note enlargement of upper cliff exposure and corresponding rockfall source area, northwest of the ditch and berm terminus.

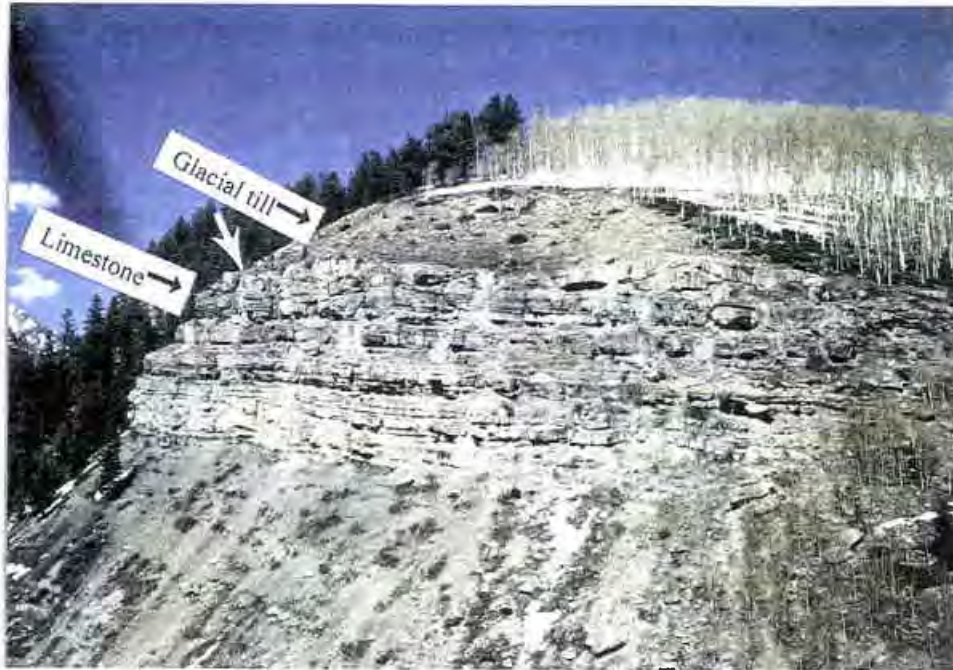
At 11:20 p.m., a ledge of Minturn Formation limestone at the highest exposed outcrop of the upper cliff, just below the exposure of glacial till, failed similarly to that shown in Figure 3 of Appendix A. The ledge dimensions that detached and toppled is roughly 20' x 8' x 8'. As it fell, it impacted and broke additional rock blocks from outcrops below. The rock mass broke apart as it tumbled down the cliff. As it fell down the slope, the rock fragments randomly fanned out such that the path of the rockfall formed a swath more than 500 feet across where they came to rest. See Figure #1 of this report. The location of the rockfall source is shown by arrow in Photo # 1 and #2 and the scar easily seen in Photo #3.

**Photo #2.** Top cliff rockfall source area. White arrow marks location of March 26, 1997 rockfall.

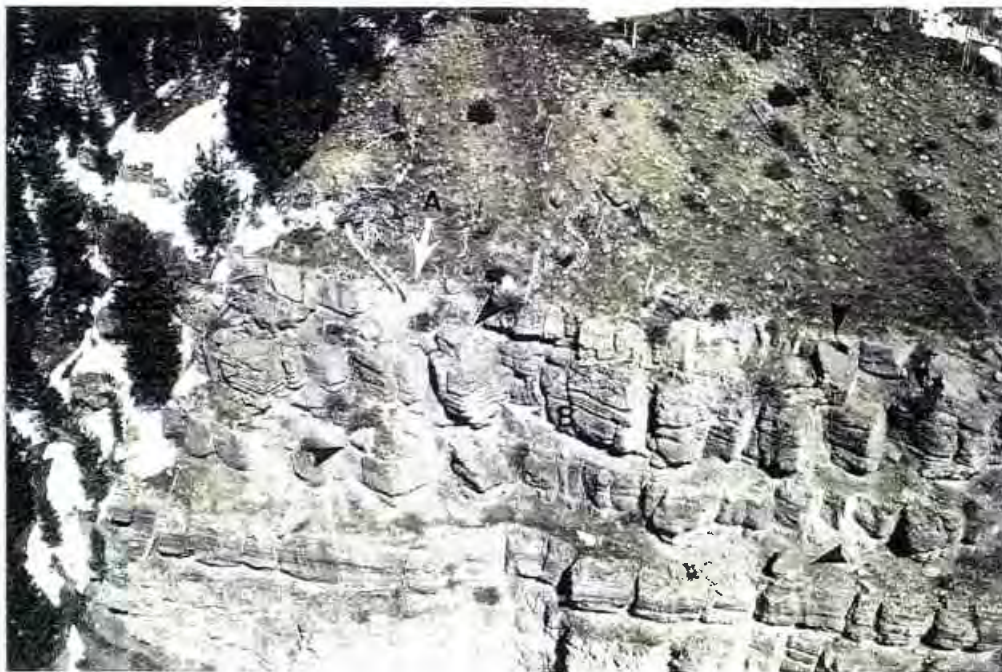
discussion on the source areas. Photos #1 and #2 also show the exposed shale slope, between the cliffs, steepening to the left. The general lack of soil and vegetation suggests that this slope is harder and smoother, compared with the right. A further close-up, Photo #3, reveals limestone blocks, pedestals, and ledges, defined by the crisscrossing joint pattern, being undermined by the quicker-

eroding interbedded shale partings. Also in Photo #3 are several slumped and isolated limestone blocks on the rock slope that have not yet fallen. The history of reported rockfall events at Booth Creek and the physical nature of the slope merits our assessment that, **Booth Falls Condominiums is in a severe rockfall hazardous area.**

**Photo #3.** Close-up aerial view of source area. Note ledgy appearance with joint defined blocks undermined by eroding shale partings. White arrow A marks scar from March 26, 1997 rockfall. White arrow B marks rock pedestal that was hit by rockfall and may be destabilized. Note loose blocks, marked by black arrows.

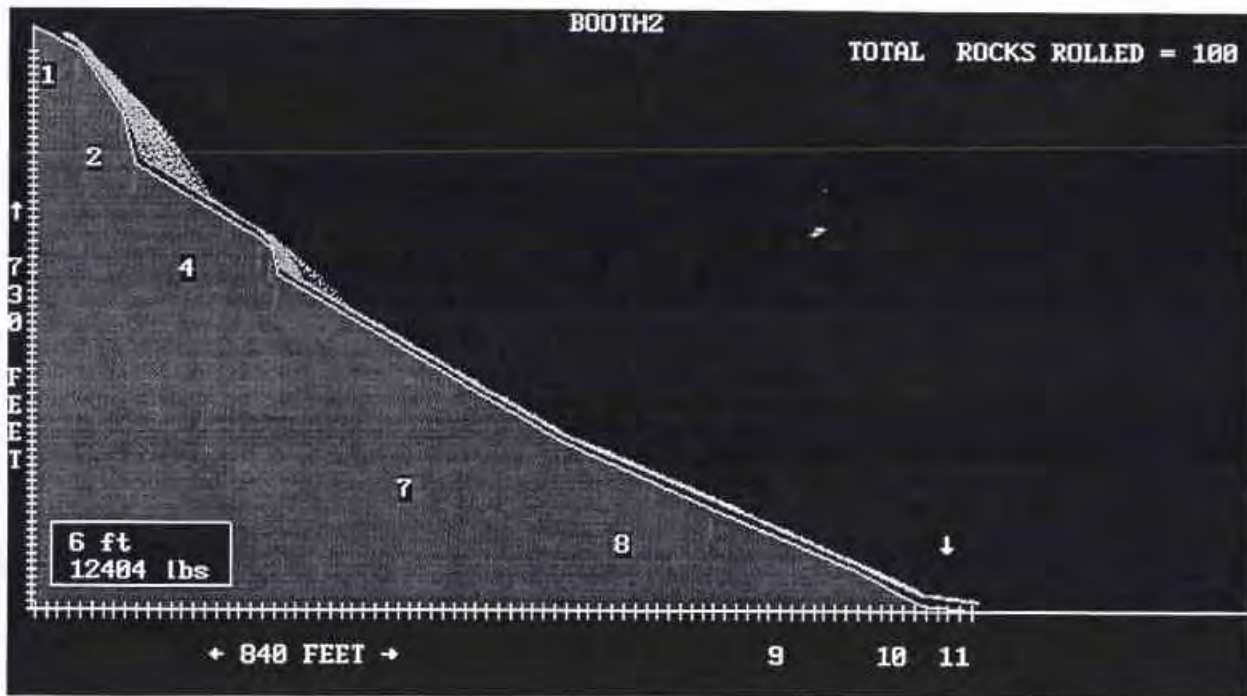
Proper analysis of the hazard for design purposes requires accurate slope geometry and a determination of appropriate rockfall sizes. For the slope geometry we used information gained from our earlier investigation for the special district mitigation, the Town of Vail GIS 1:2400 scale maps, photos, and the USGS 1:24,000 scale map. For the rockfall size using the maximum size boulder that is found on site would be prudent. We used the Colorado Rockfall Simulation Program (CRSP) ver. 3.0a for our analysis. Four to seven foot diameter boulders were modeled, and weight was calculated using the unit weight of limestone. The analysis seemed to bear out observable results of rockfall in the area. Bounce heights were highest on the cliffs and at the transition to the lower, softer slopes the rocks begin just to roll. The critical design factor is the high impact energies developed by these larger rocks. A screen dump is shown on Figure #2 of the CRSP program slope profile. An analysis point was chosen 30 feet upslope from the condominiums where the slope breaks to a grade of 40% to 50%. In modeling rockfall with CRSP we arrived at the following bounce heights, impact kinetic energies (K.E), and velocities at this analysis point.

Figure 2. Screen dump of CRSP program of Booth Creek-west side. Analysis point arrow is 30 feet above condominiums. Horizontal and vertical are not at the same scale.

The following recommendations and design criteria are based on modeled rolling rocks analyzed at 30 feet upslope from the condominiums, so are only valid at that point on the slope. Mitigation design should not only insure that rockfall is contained but also the impact structure remains sound and does not require costly reconstruction afterwards. The CGS recommends that design criteria for mitigation at the condominiums should be capable to withstand and retain a worst case scenario, which is believed to be a boulder in the 6 to 7 foot diameter range. An examination of the source area, the most recent rockfall, and earlier research done by Stover and Cannon for work the CGS did in 1988 seems to confirm this scenario. That translates to a rolling rock with an **impact force of 5,000,000 ft-lbs** at the analysis point. Besides withstanding the impact force the mitigation system would need to prevent any rock that encounters it from climbing and overtopping, or bouncing over. The impact face should be vertical and have an effective height that prevents overtopping. Design height will be specific to siting of the structure. At the analysis point it should be no less than 12. These design parameters do not take into account smaller rock fragments that separate from larger boulders. During inspection of the site following the March 26, 1997 event there was evidence of smaller rocks snapping off the tops of Aspen trees, 25 feet high, near the condos. These rock fragments do not reflect actual bounce heights but display the high rotational velocity of the rock and the centrifugal force acting on fragments as they detach. Options to mitigate these highly random rock fragments are limited to moving the protection system farther up the slope (which will change design criteria) or constructing a low capacity rockfall fence at the top of the berm or wall.

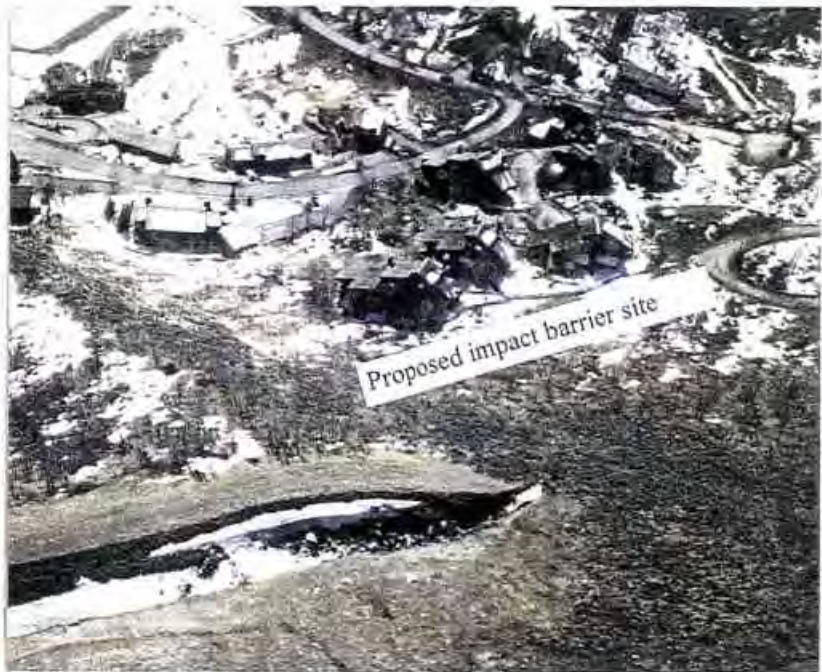
**Photo #4.** Location of proposed impact barrier or berm site. Note accumulation of rocks in existing ditch. The largest are 5 feet in diameter.

Only a stout protection system can be designed at the criteria stated above. Both ditch and berm systems and inertial impact barriers, or a combination of both, can be designed for the site and be cost effective. No rockfall fence on the market can probably withstand the impact forces that are being contemplated. The rockfall protection must be designed to begin at the road and extend to the southeast to a point where sufficient overlap exists with the existing berm above, a length no less than 350 feet. Rocks that skirt the edge of the top berm must be caught by the lower. See Photo #4. At the high impact velocities and

corresponding impact forces both ditch and berm and reinforced impact walls will need to be carefully designed. In a ditch and berm option a careful look will be needed to determine whether the berm of only compacted soil will have the strength to withstand these forces. The earthen berm may need to be reinforced with geotextiles. A rockfall impact barrier or earth wall will need to be reinforced with geotextiles in lifts of 8-12 inches and have a width no less than 10 feet. **We recommend that the Town of Vail retain the CGS for review of the mitigation design and our approval be a condition for design acceptance by the town.**

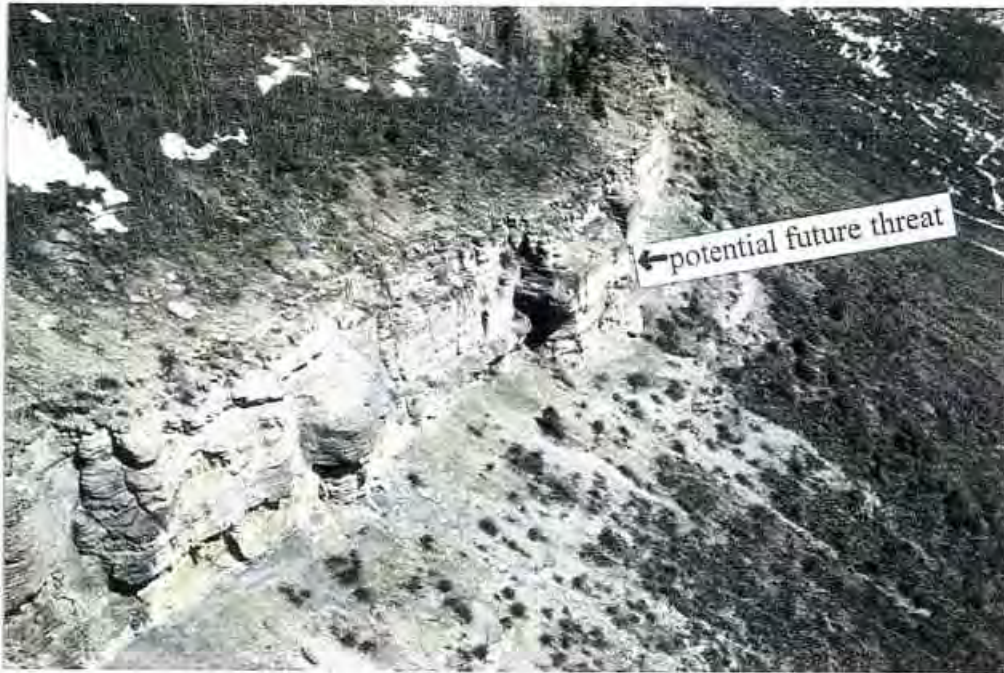
**Photo #5.** Lower sandstone cliff above district ditch and berm. The CGS will visit this feature this spring and install movement gauges for future monitoring.

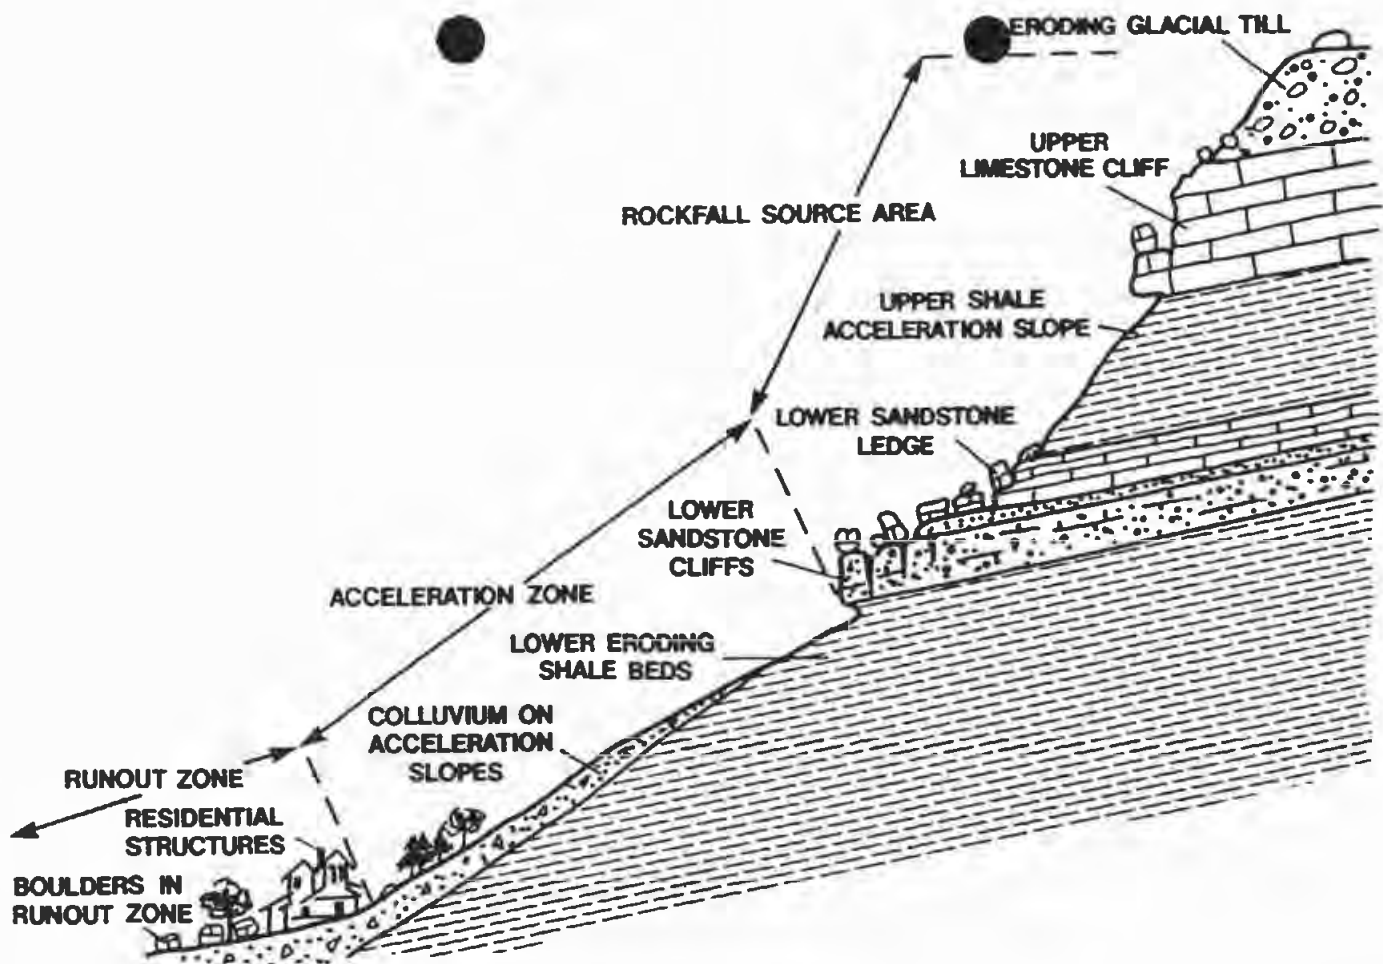
Figure 2. Geologic diagram of compound rock-fall slopes in study area. Drawn to scale with no vertical exaggeration. Note dip of strata toward valley.

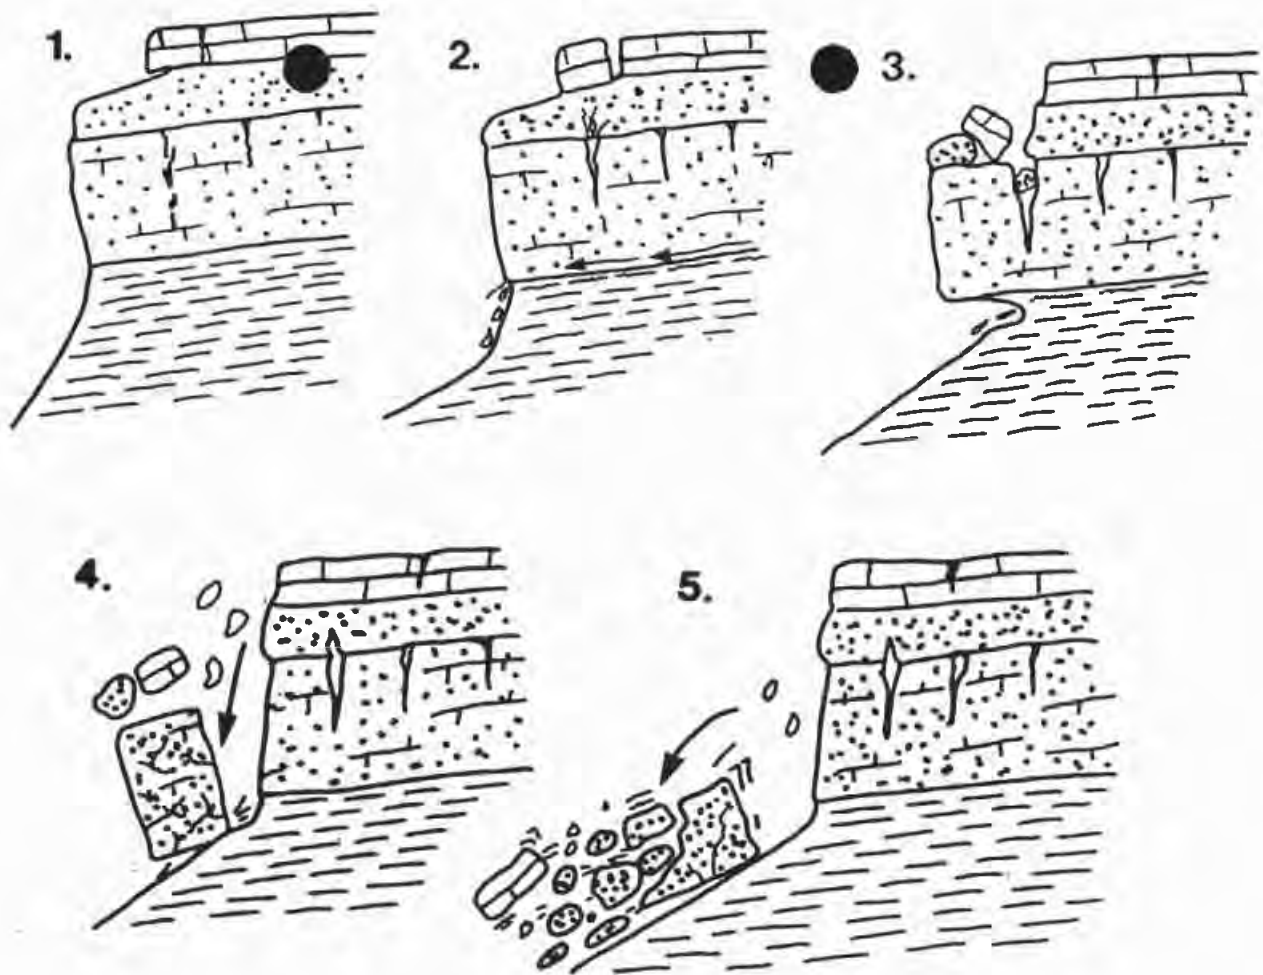
Joint patterns in the cliff forming rocks are caused by stress relief and physical properties of the rock. The joints so formed define planar, vertical cliff faces and act to separate large sections of the cliff into slabs along joints subparallel to the cliff face. Once a slab has detached from the sedimentary bed, it begins to creep outwards owing to gravity and frost wedging in the joints. The joints widen with time, and are often wedged farther apart by tree roots, and smaller rocks that fall into the cracks formed by the joints. (Figure 3)

**Figure 3. Toppling Slab-failure Sequence.** 1. Initial cliff configuration. 2. Differential weathering of soft shale begins to undercut massive cliff forming slabs. Joints open and widen due to slope creep and frost wedging. Springs issue from contact beneath cliff. 3. Undercutting continues. Joints widen and are wedged open by smaller rocks, causing slab to tilt outwards. 4. Slab falls from cliff face onto acceleration slopes, bringing down overlying rocks. 5. Slab topples and shatters, showering runout zone below with boulders, and exposing new cliff face to erosion.

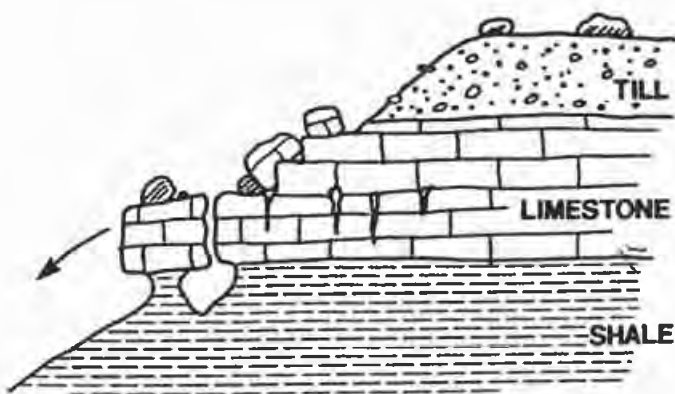
The shale zone upon which the upper limestone cliffs rest is weak and by erosion undercuts the massive limestone ledges, creating pedestal-like blocks which eventually topple off their perches. The limestone is jointed such that blocks approximately 3 m x 1.2 m x 1.2 m are separated from the cliff and tilt outward toward the cliff edge. Thinner beds within the limestone cliff produce more slabby blocks that, if not turned onto their edges by chance during the initial fall, remain flat-side down on the steep slopes.

- E) Upper vertical cliff source area - Jointed slabs and boulders 1,000 vertical ft (305 m) above the runout zone periodically detach from the cliff and free fall and bound downslope and off the lower cliff. Most rocks do not shatter, but remain as intact approximately 8 by 5 ft (2.5 by 1.5 m) limestone boulders which are capable of reaching the farthest limits of the runout zone. (Figure 4)

**Figure 4. Limestone slabs resting on weak shale pedestals, upper cliff source area.**

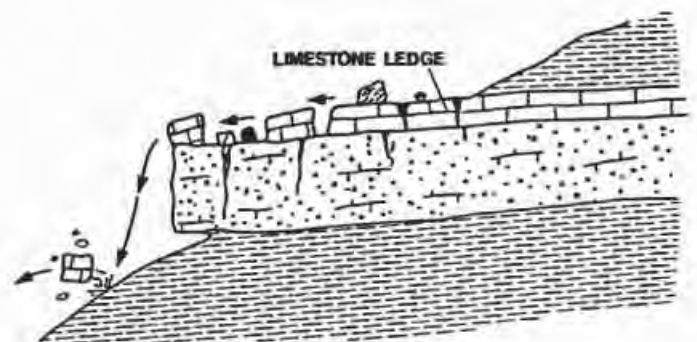
The dip of the rock ledges making up the source area also contributes to rockfall along cliffs in the study area. The strata in the two cliffs dip approximately 15 degrees into the valley, causing any loose stones, cobbles, or boulders on the ledges to inevitably move down to the edge of the 16 m vertical cliff. Limestone blocks separated from their beds by jointing and weathering creep down toward the valley along these dipping bedrock surfaces (Figure 5). Rounded glacial cobbles and gravel

**Figure 5. Slope creep causing limestone blocks to move down bedding planes and off lower cliff edge. Blocks are generally 2 ft x 3 ft. This mechanism is responsible for frequent rock falls in the study area.**
