COLORADO GEOLOGICAL SURVEY

September 19, 2017

Subject: East Vail Rezoning Rock Fall Study Review - Revised
Eagle, CO; CGS Unique No. EA-18-0002

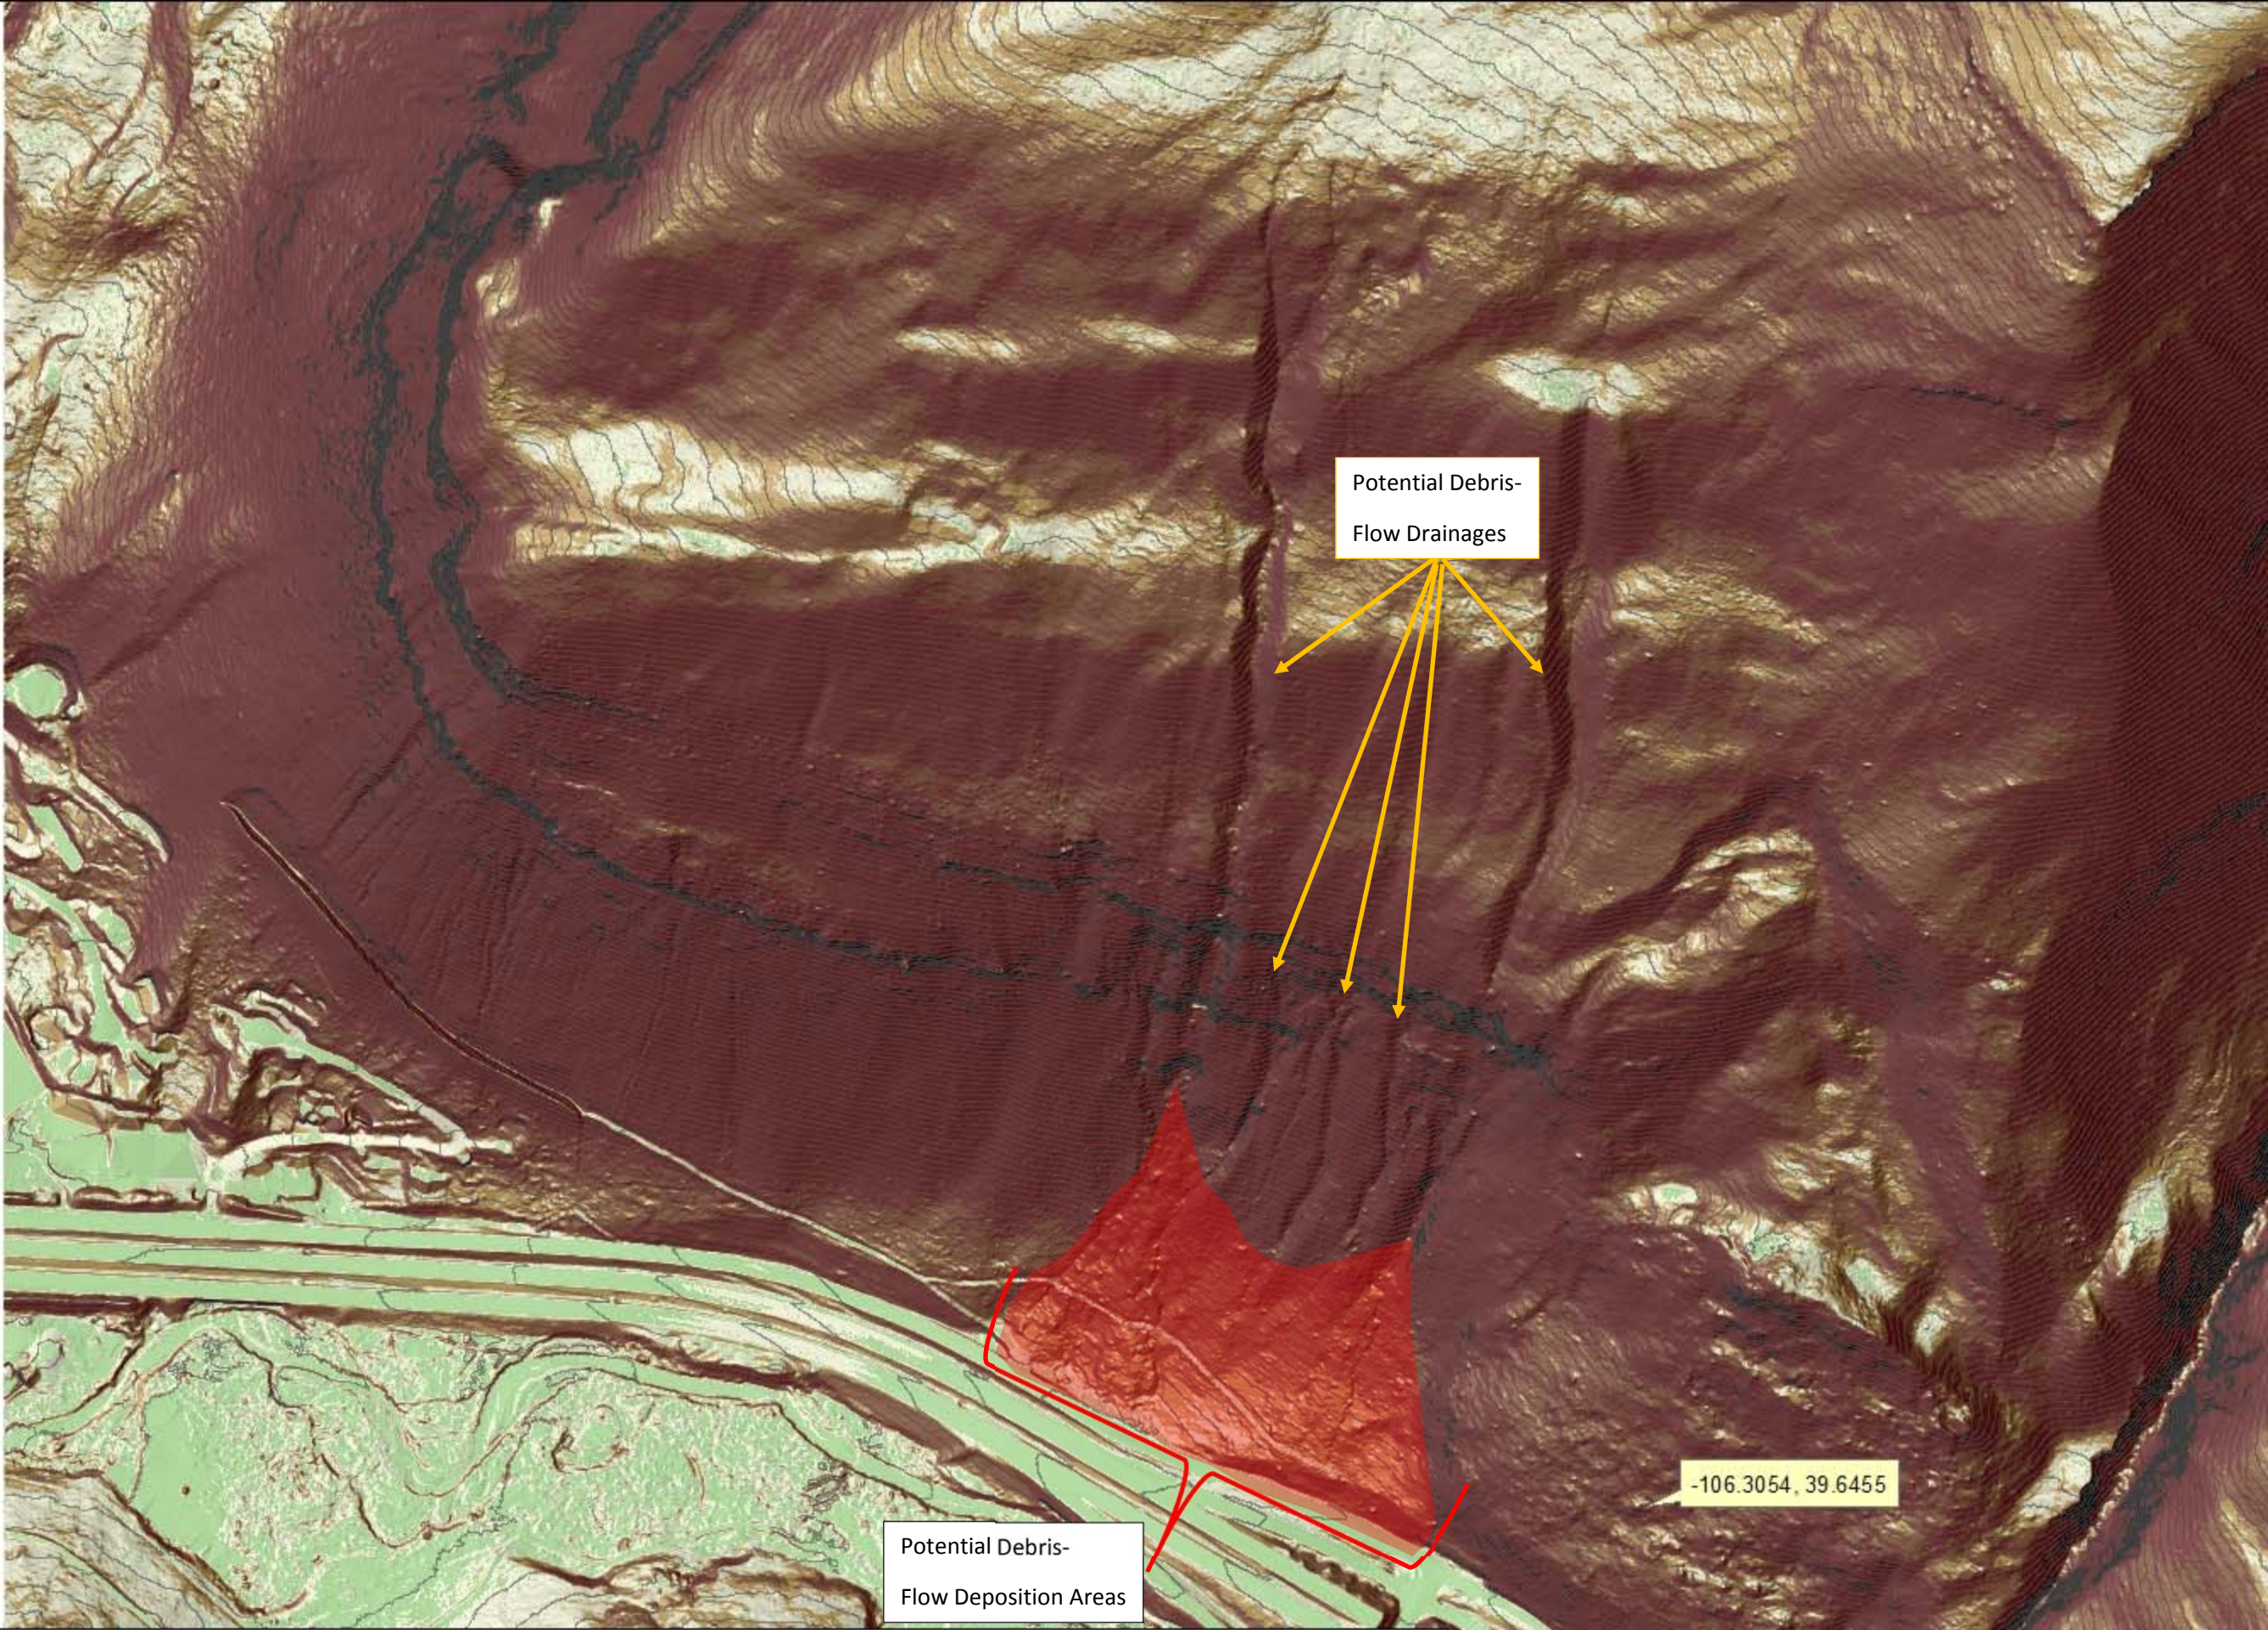
Figure 1

CGS agrees with the “Debris Flow Considerations” discussed on Page 30 of the Cesare report. Based on our desktop review, it is CGS’s opinion that the western portion of the site is exposed to potential debris flows, especially beneath the incised drainages highlighted in attached Figure 1. Depending on local conditions, engineered debris-flow mitigation may be possible at the subject property. However, because debris-flow hazards have not been studied at this site, and because CGS has not seen any specific development plans showing size or placement of buildings, CGS cannot comment on the potential feasibility or effectiveness of debris-flow mitigation at this time. If the Town approves rezoning, CGS recommends that the Town require completion of a debris-flow hazard analysis and design of any necessary mitigation (including preparation of an inspection, maintenance, and repair manual) prior to final Development Plan approval to ensure that the proposed mitigation will provide adequate protection and can be maintained to ensure future performance. CGS requests the opportunity to review and comment on any such hazard analysis and/or mitigation design.

LiDAR-Based Slope Map
Color-Coded to
Highlight Debris Flow Areas

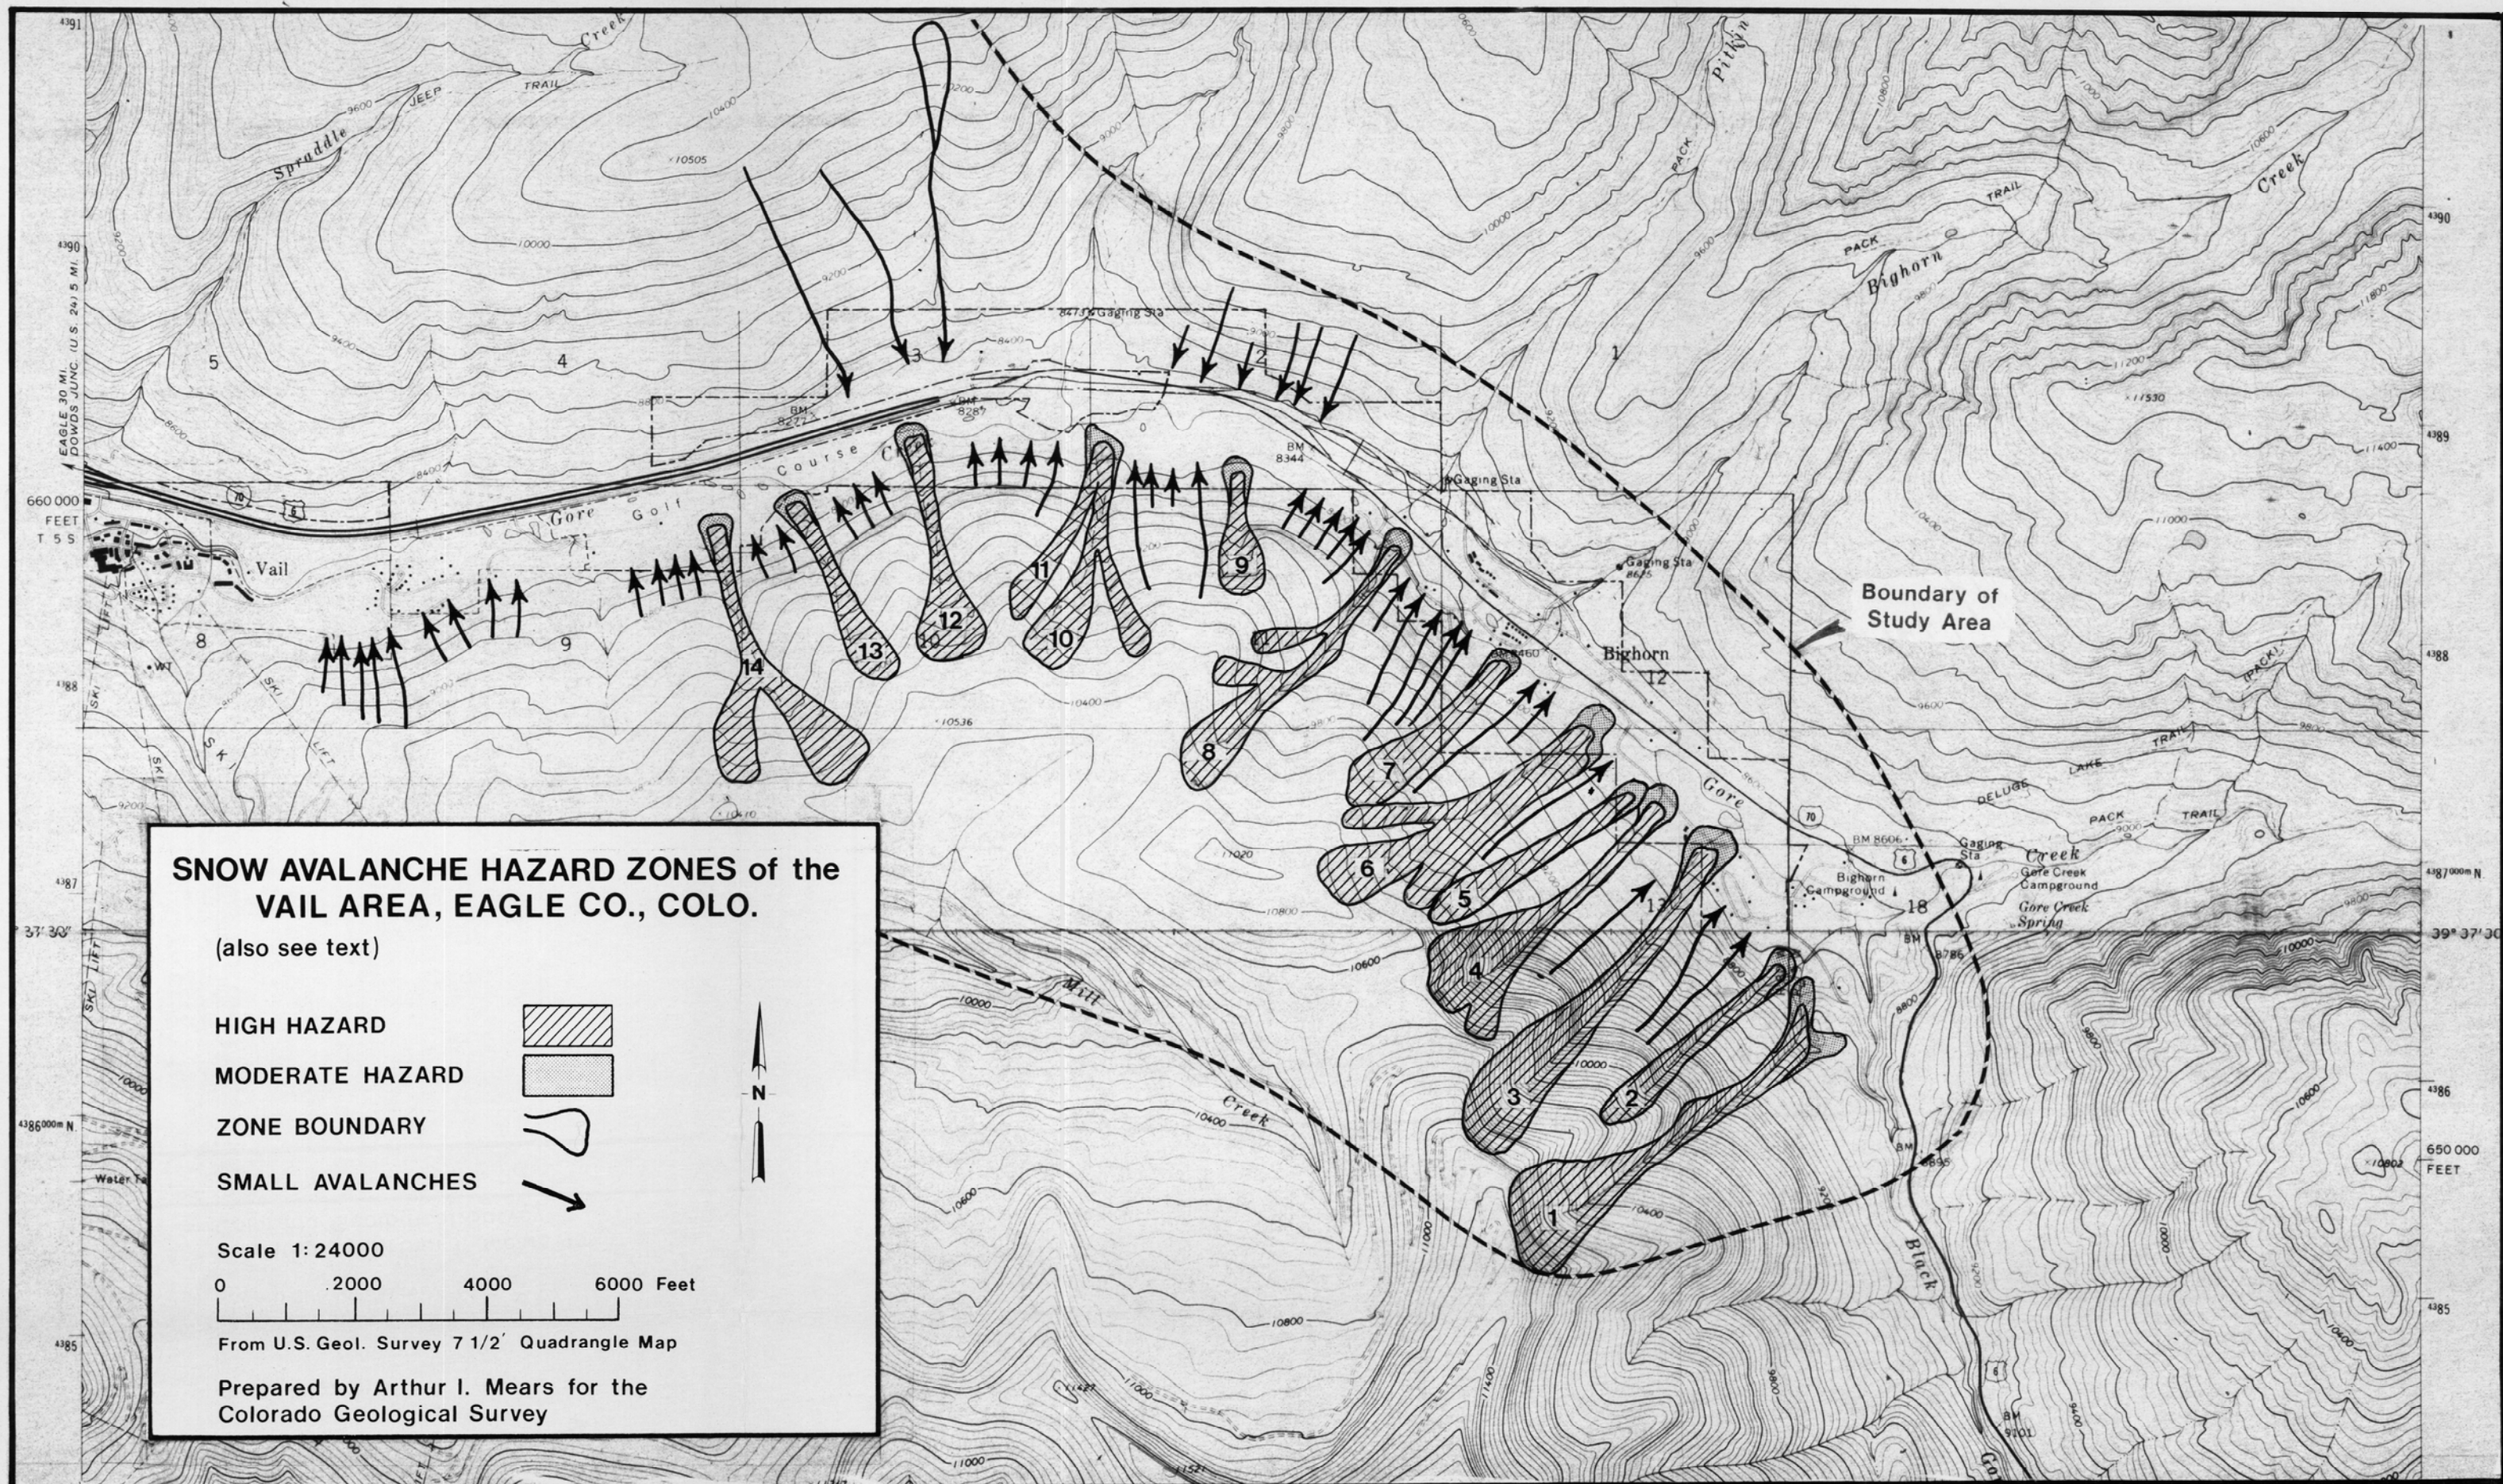
The subject property is included in snow-avalanche hazard maps for the Vail valley that were initially prepared for a CGS Open-File report in 1975, and were subsequently reproduced in CGS Special Publication 7 “Colorado Snow-Avalanche Area Studies and Guidelines for Avalanche-Hazard Planning”. Attached Figure 2 shows the 1975 map for the Vail area, which identifies “small avalanches” along the hillslope to the west of, and possibly including, the western portion of the subject site. As described in the map documentation, small avalanche areas are “not wide enough to be accurately displayed at the mapping scale of 1:24,000, so they are indicated as arrows. Although they appear small at this scale, they can also be very destructive.” Because it is not possible to rule out snow avalanche hazards to the subject property at this map scale, and because it does not appear that avalanche hazards have been specifically evaluated for the subject site, CGS recommends that the Town require completion of an avalanche hazard analysis and design of any necessary mitigation prior to final Development Plan approval to ensure that the proposed mitigation will provide adequate protection and can be maintained to ensure future performance. CGS recommends that any such hazard analysis and/or mitigation design be reviewed by the Colorado Avalanche Information Center.
