Subject: Geologic Hazards Analysis Report  
East Vail Workforce Housing  
Vail, Colorado  
Project No. 18.5080

Geologic Hazard Analysis  
East Vail Parcel  
Vail, Colorado  
Skyline Project No: 18105

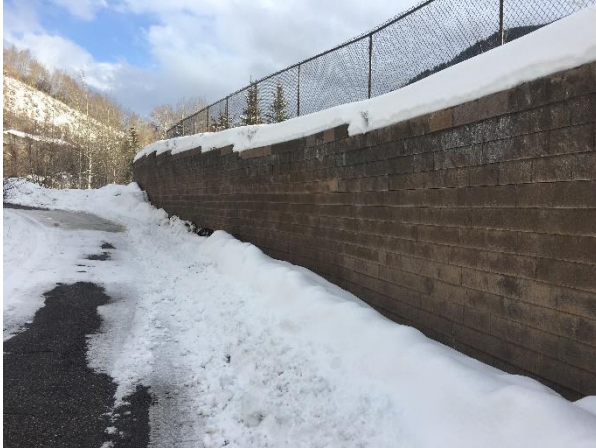
**Photograph 1.** Existing rockfall impact barrier wall located about 50 feet upslope from existing Booth Falls residences. This system is about 10 feet high, with an additional low capacity, chain link fence at the top. (photo courtesy of Nathan Thompson, GSI)

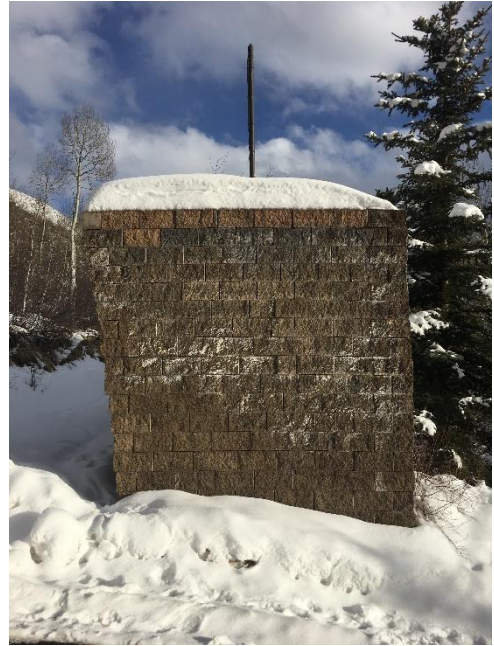
**Photograph 2.** Sideview of the existing rockfall impact barrier wall located upslope from Booth Falls. (Photo courtesy of Nathan Thompson, GSI)

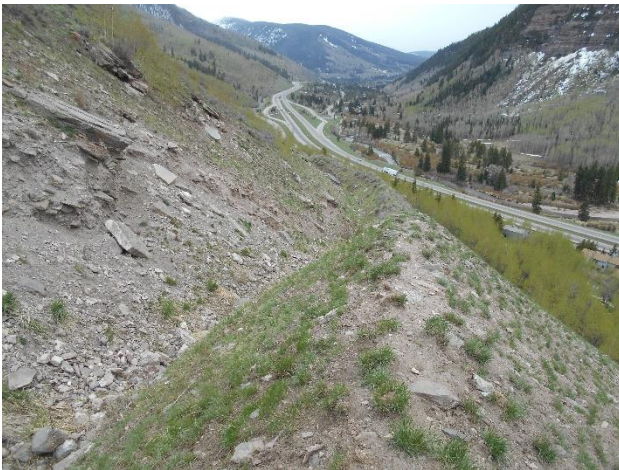
**Photograph 3.** Existing rockfall berm upslope from Booth Falls. Photograph was taken while standing on the crest of the berm, looking east. Interstate 70 is visible in the background.

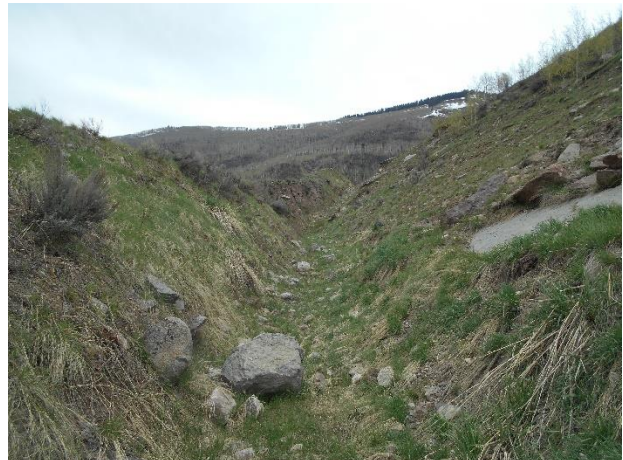
**Photograph 4.** Existing rockfall berm and catchment system upslope from Booth Falls, looking west. Photograph was taken while standing in the catchment area near the east end.

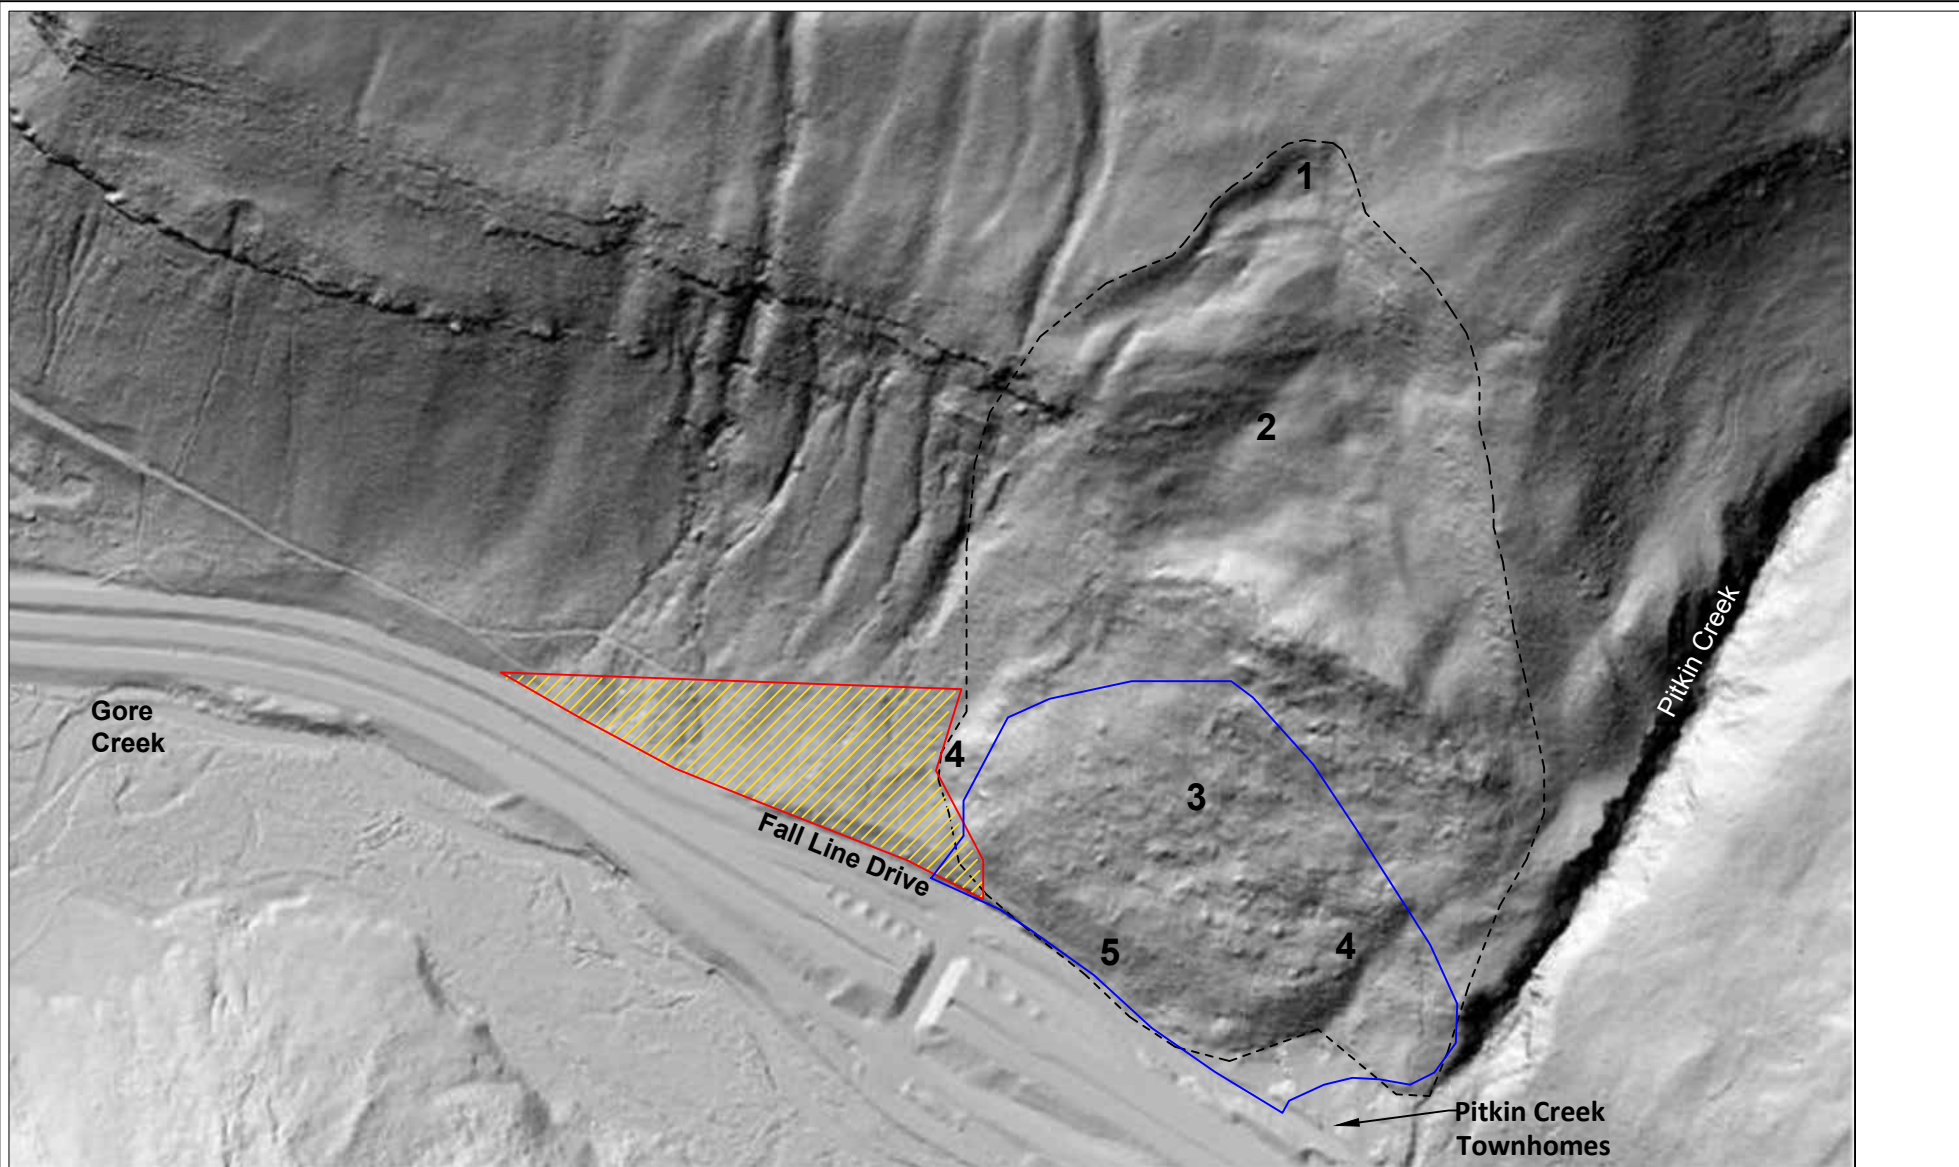
FIGURE 7  
Landslide Map

An existing landslide occupies the eastern approximate 18 acres of the EVP, the area to remain undeveloped (NAP). The landslide is visible in the LiDAR collected for the area, shown on Figure 5. Figure 6 shows a slope map derived from the LiDAR, with marked landslide extents. Geomorphic features of landslide movement have been obscured by heavy vegetative cover and smoothed by natural processes over time. The LiDAR imagery assisted in delineating the extents of the landslide (Figure 7), which extend further upslope than previously identified in published geologic maps (*Kellogg and others, 2003*). The landslide extents delineated in this report are approximate.

Historical landslides are complex, and characteristics vary even within a single landslide mass, including type of slope failure (may be a combination of various mobilization mechanisms), timing of slope failure events, causative factors, direction of sliding, and others. The mechanism of sliding for this landslide may be a combination of block sliding and deep rotational processes. The detachment location for the landslide is located further upslope and beyond the boundaries of the EVP. The steep toe of the landslide is abruptly cut off by Fall Line Drive (Figure 7). The western flank of the landslide in the area of the toe is also steep and forms a recognizable break in slope on the topography map. Based on LiDAR imagery, the approximate extent of the landslide is about 1,750 feet wide by about 2,500 feet long from head scarp to Fall Line Drive.

Skyline recommends implementing a slope monitoring program during construction or grading activities near the landslide. If development within the extents of the landslide is planned, additional geological and geotechnical analysis should be performed to further characterize the landslide and the potential impact the proposed development would have on slope stability.

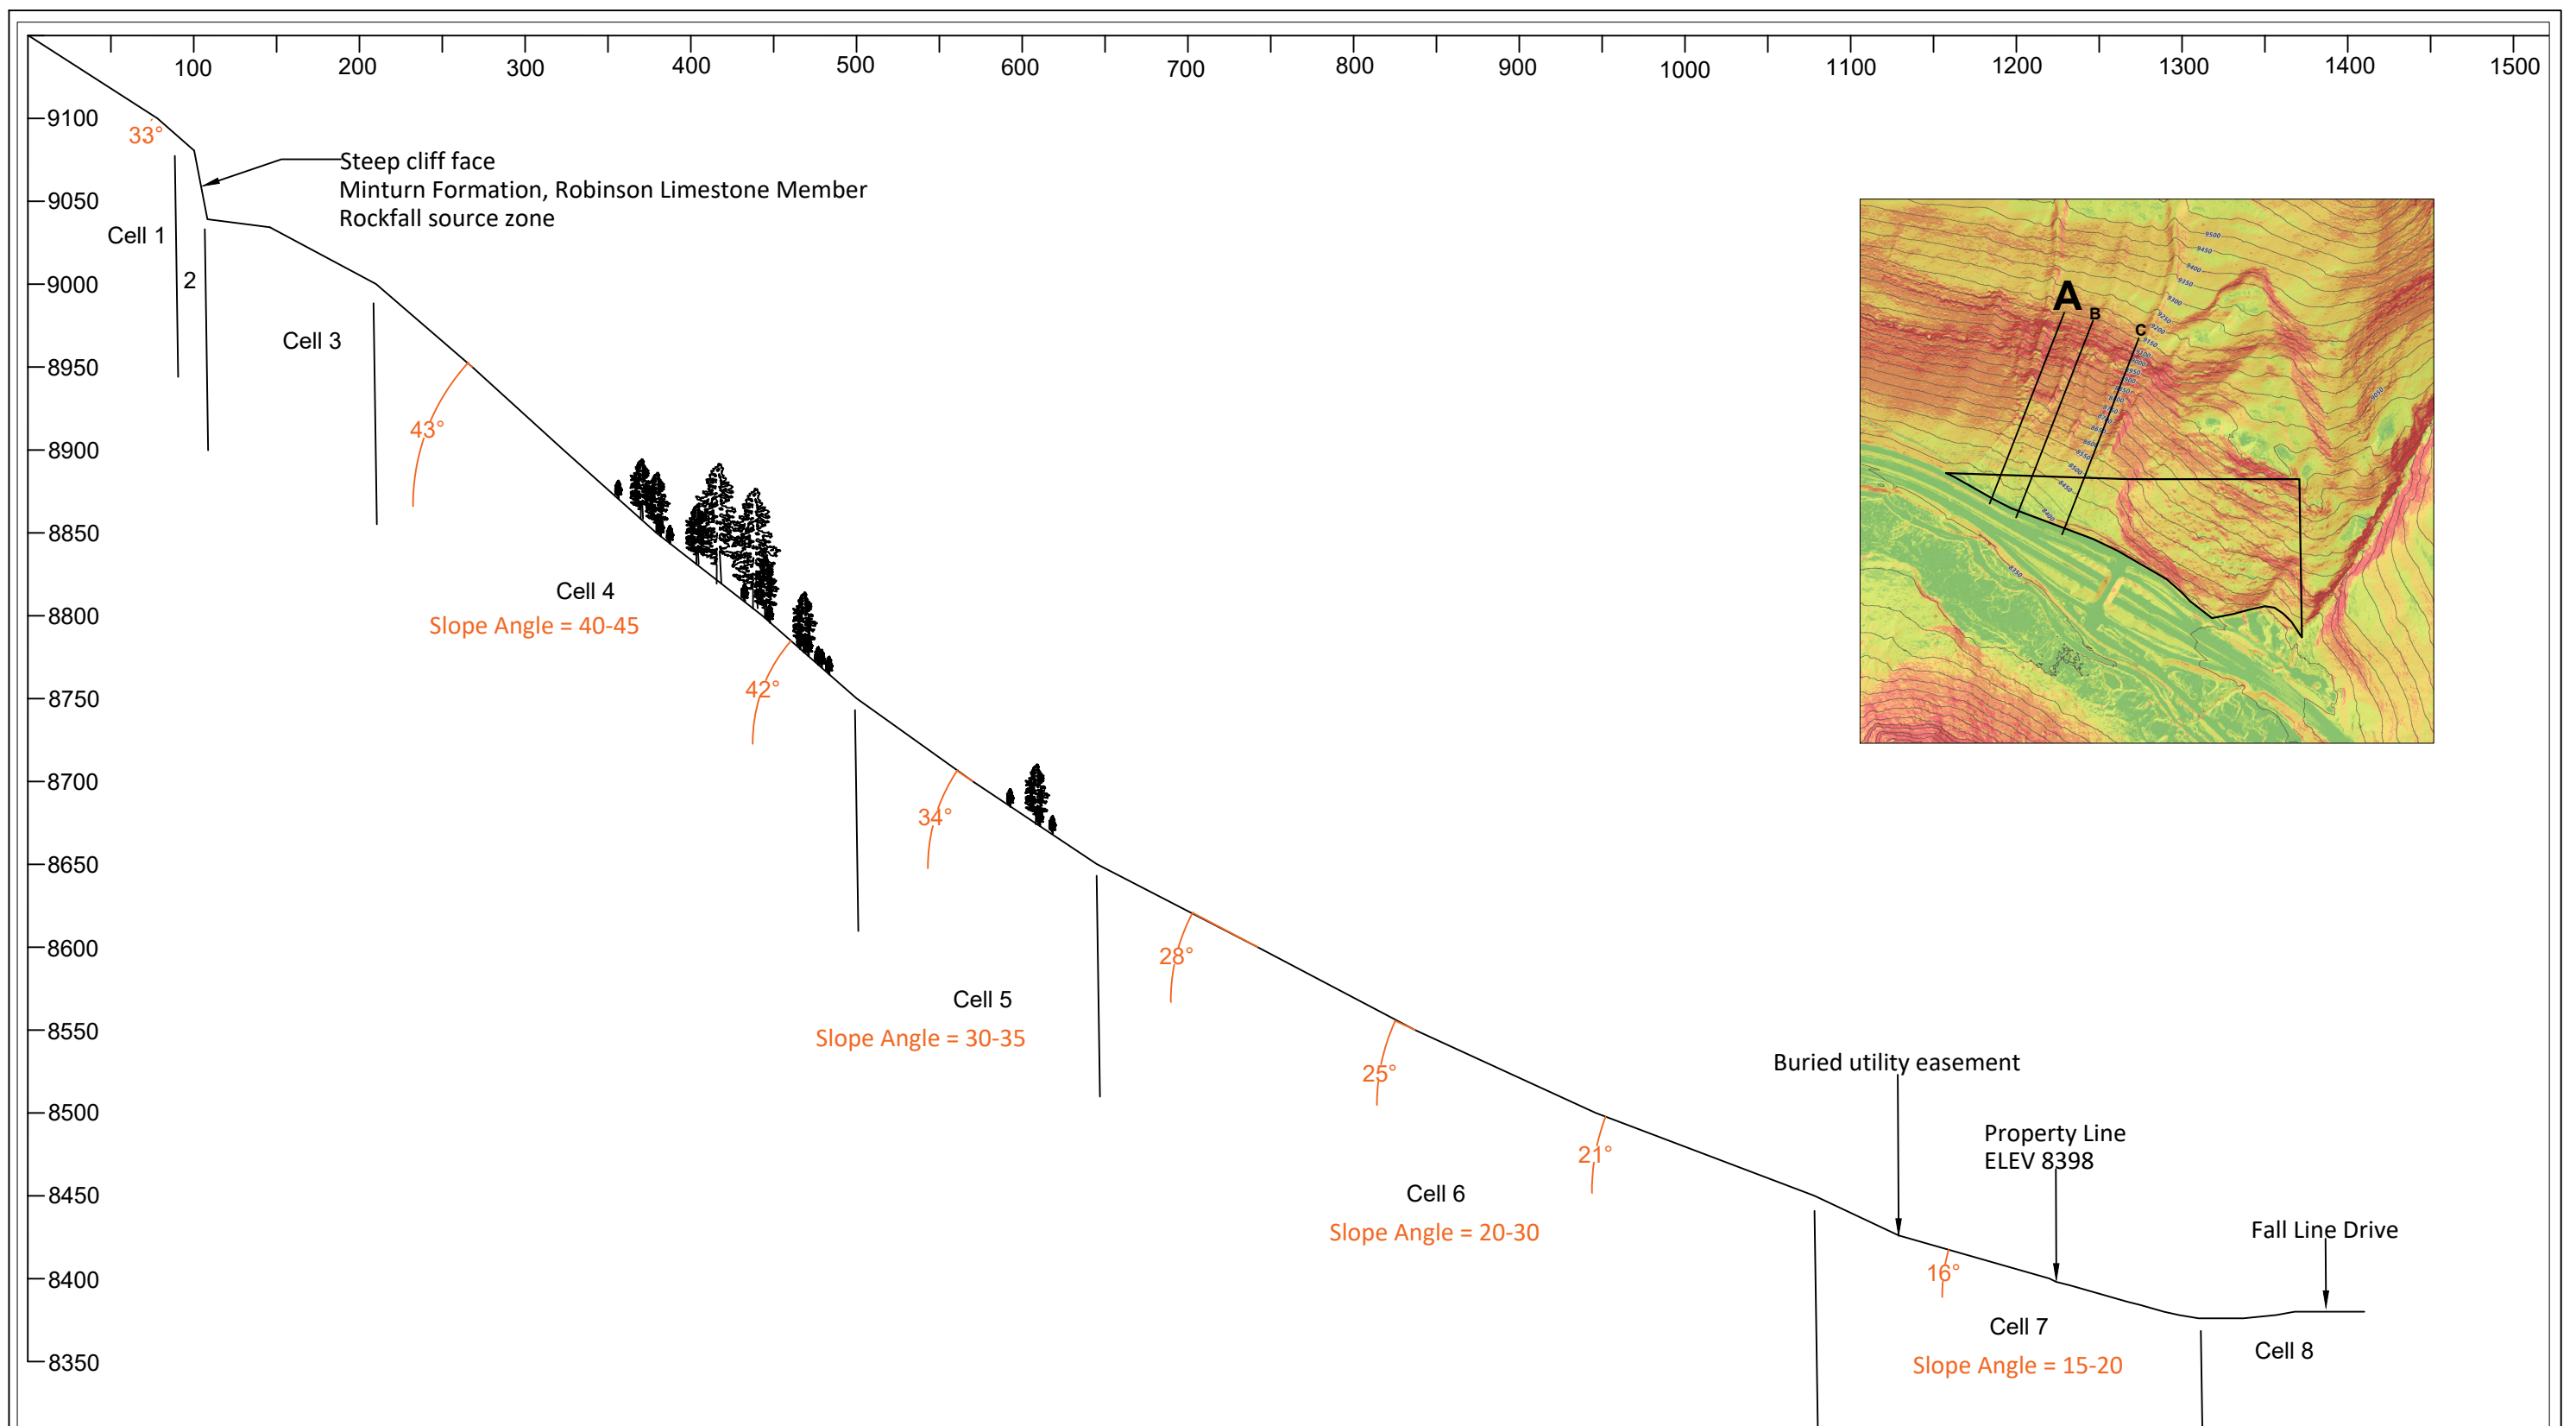
FIGURE 8  
 Study Section A

Study Section A is located on the west side of the EVP (Figure 6). Study Section A spans a length of about 1,600 feet along the slope and an elevation range from 8380 to 9150 (Figure 8). The slope is vegetated with aspen trees, shrubs, and grass, and covered in colluvium and limestone boulders that have broken

from the steep cliff rockfall source zone at about elevation 8040 to 9080. Skyline understands that the intended barrier system at this location is a reinforced, rigid wall with catchment area. The distance along the slope from the rockfall source zone to the property boundary is about 1,300 feet. Table 3 lists slope profile parameters used for Study Section A.

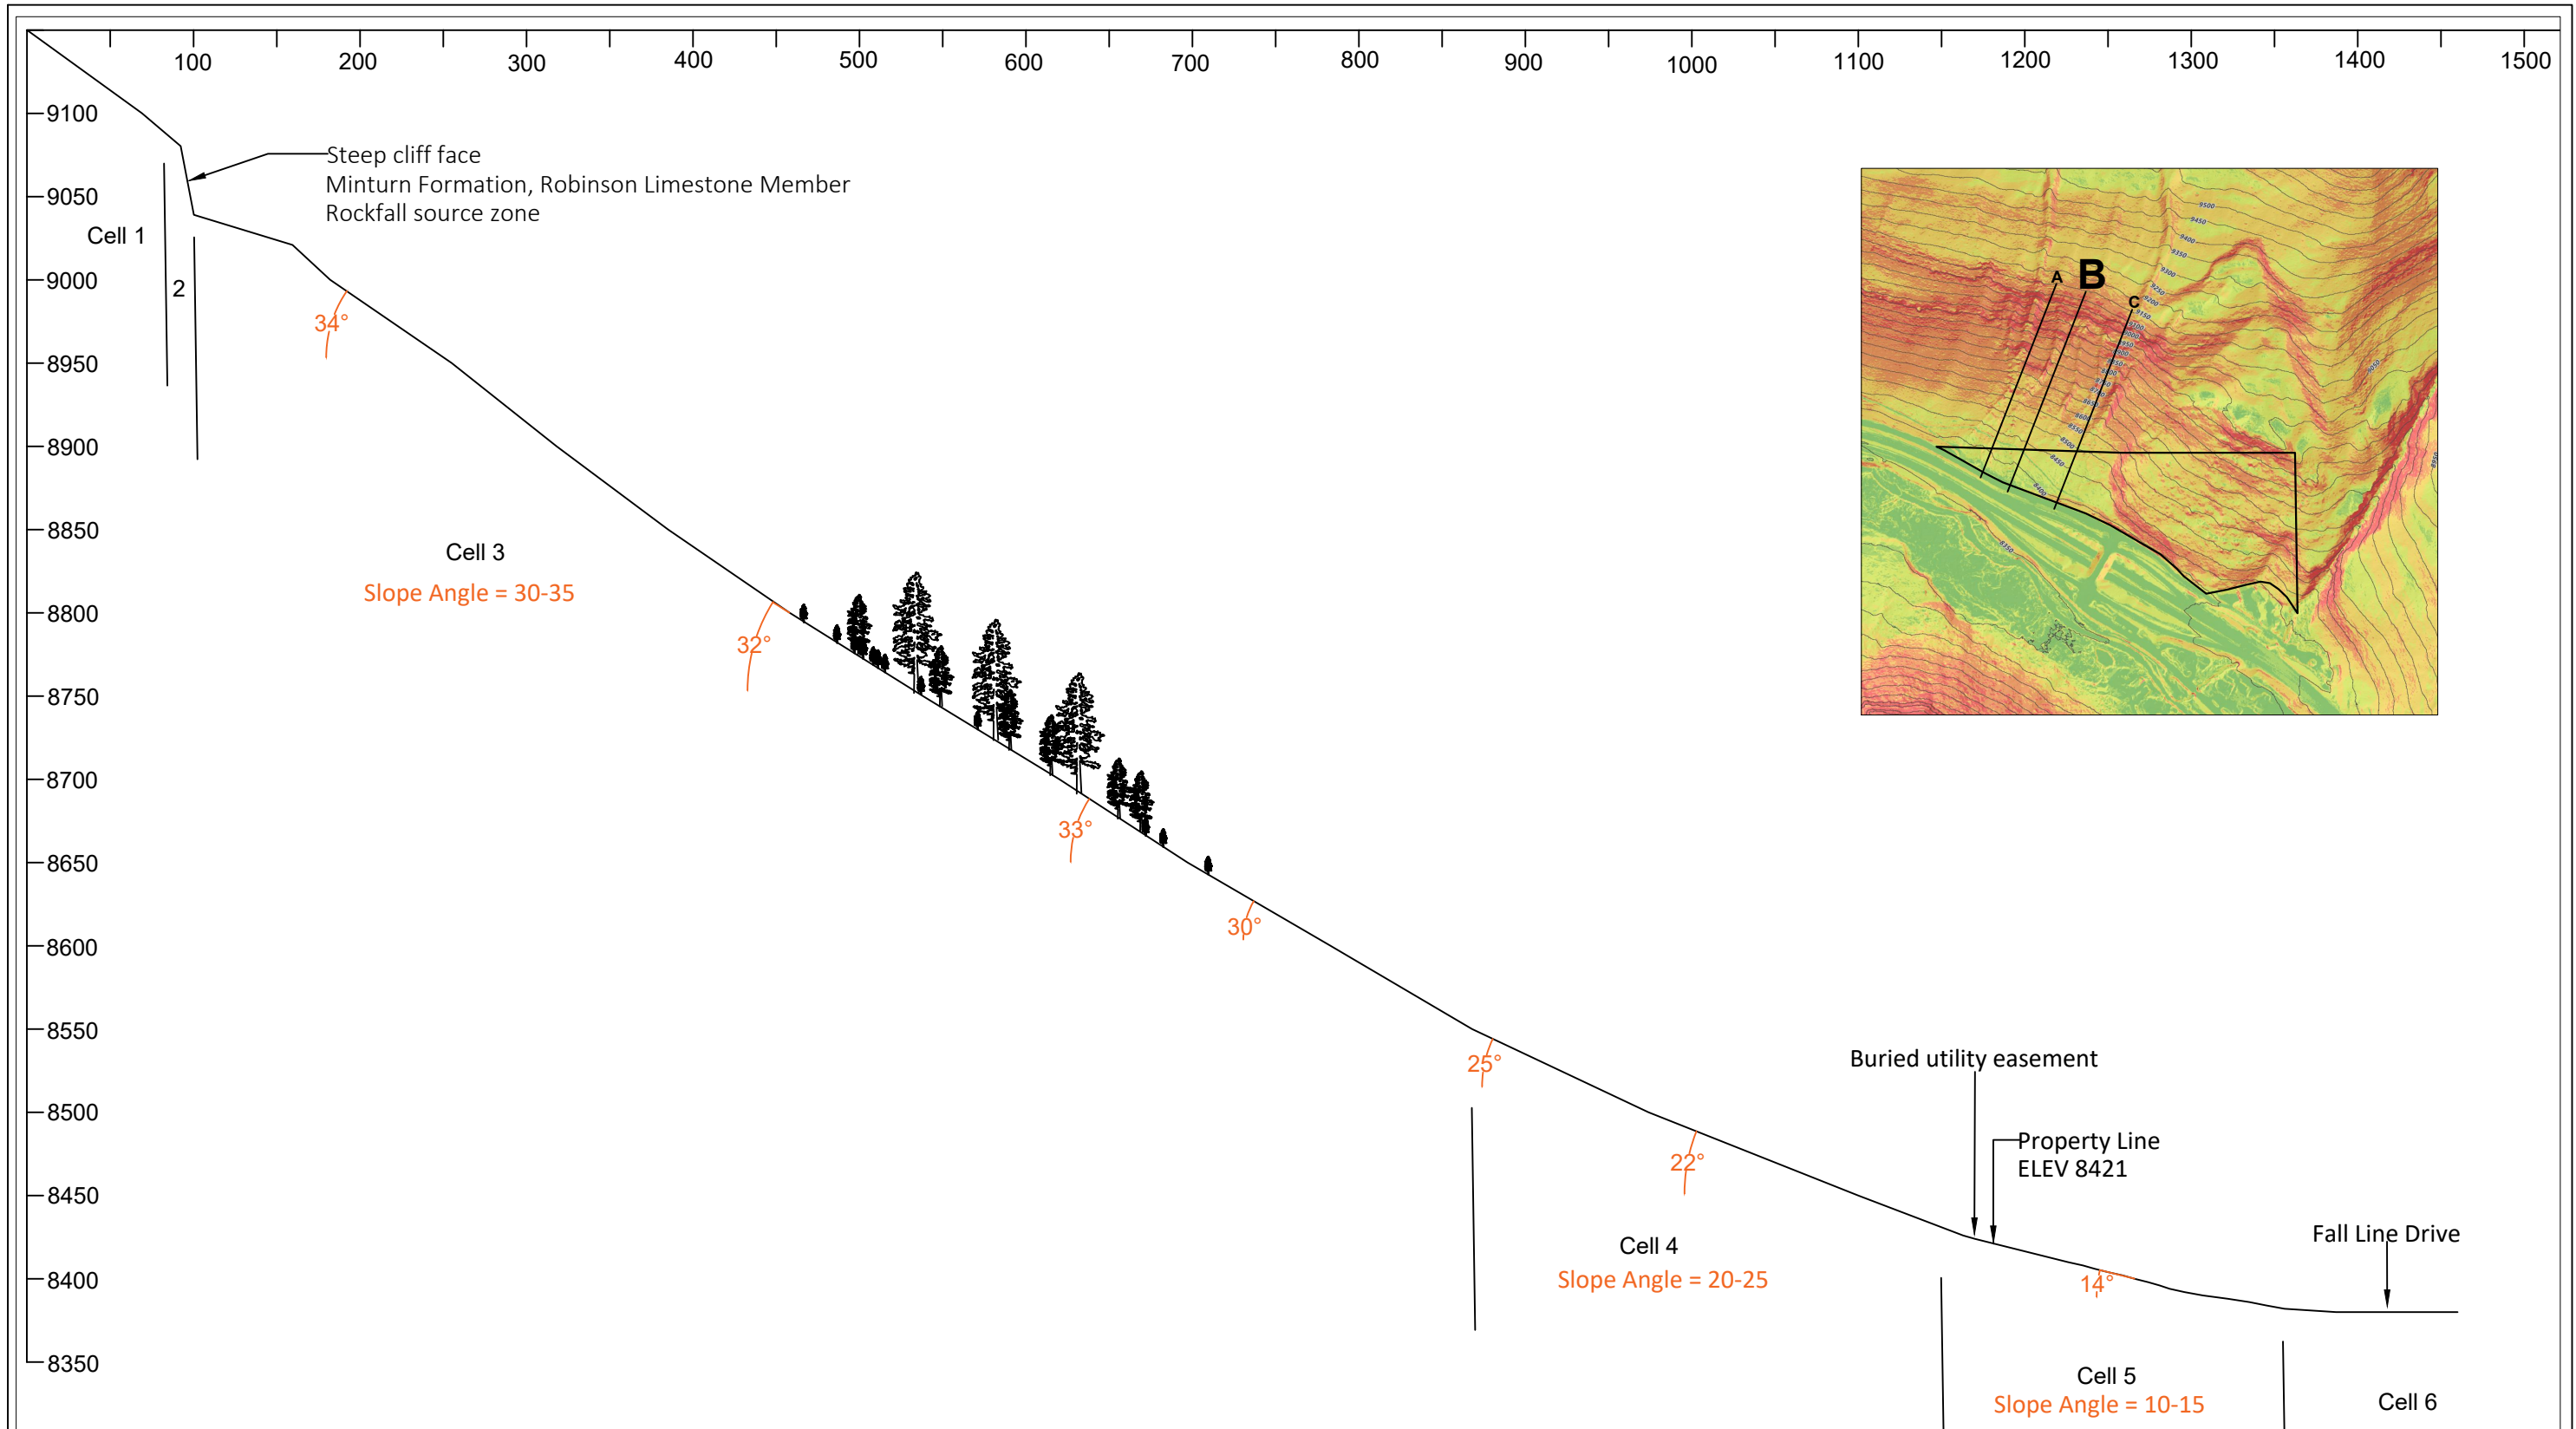
FIGURE 9  
Study Section B

Study section B is located near the middle of the proposed development (Figure 6). Study Section B spans a length of about 1,650 feet along the slope and an elevation range from 8380 to 9150 (Figure 9). The slope is vegetated with aspen trees, shrubs, and grass, and covered in colluvium and limestone boulders that have broken from the steep cliff rockfall source zone at about elevation 8040 to 9080. Skyline understands that the intended type of barrier system at this location is an earthen berm with catchment area located upslope from the proposed buildings. The distance along the slope from the rockfall source zone to the property boundary is about 1,260 feet. Table 4 lists slope profile parameters used for Study Section B.

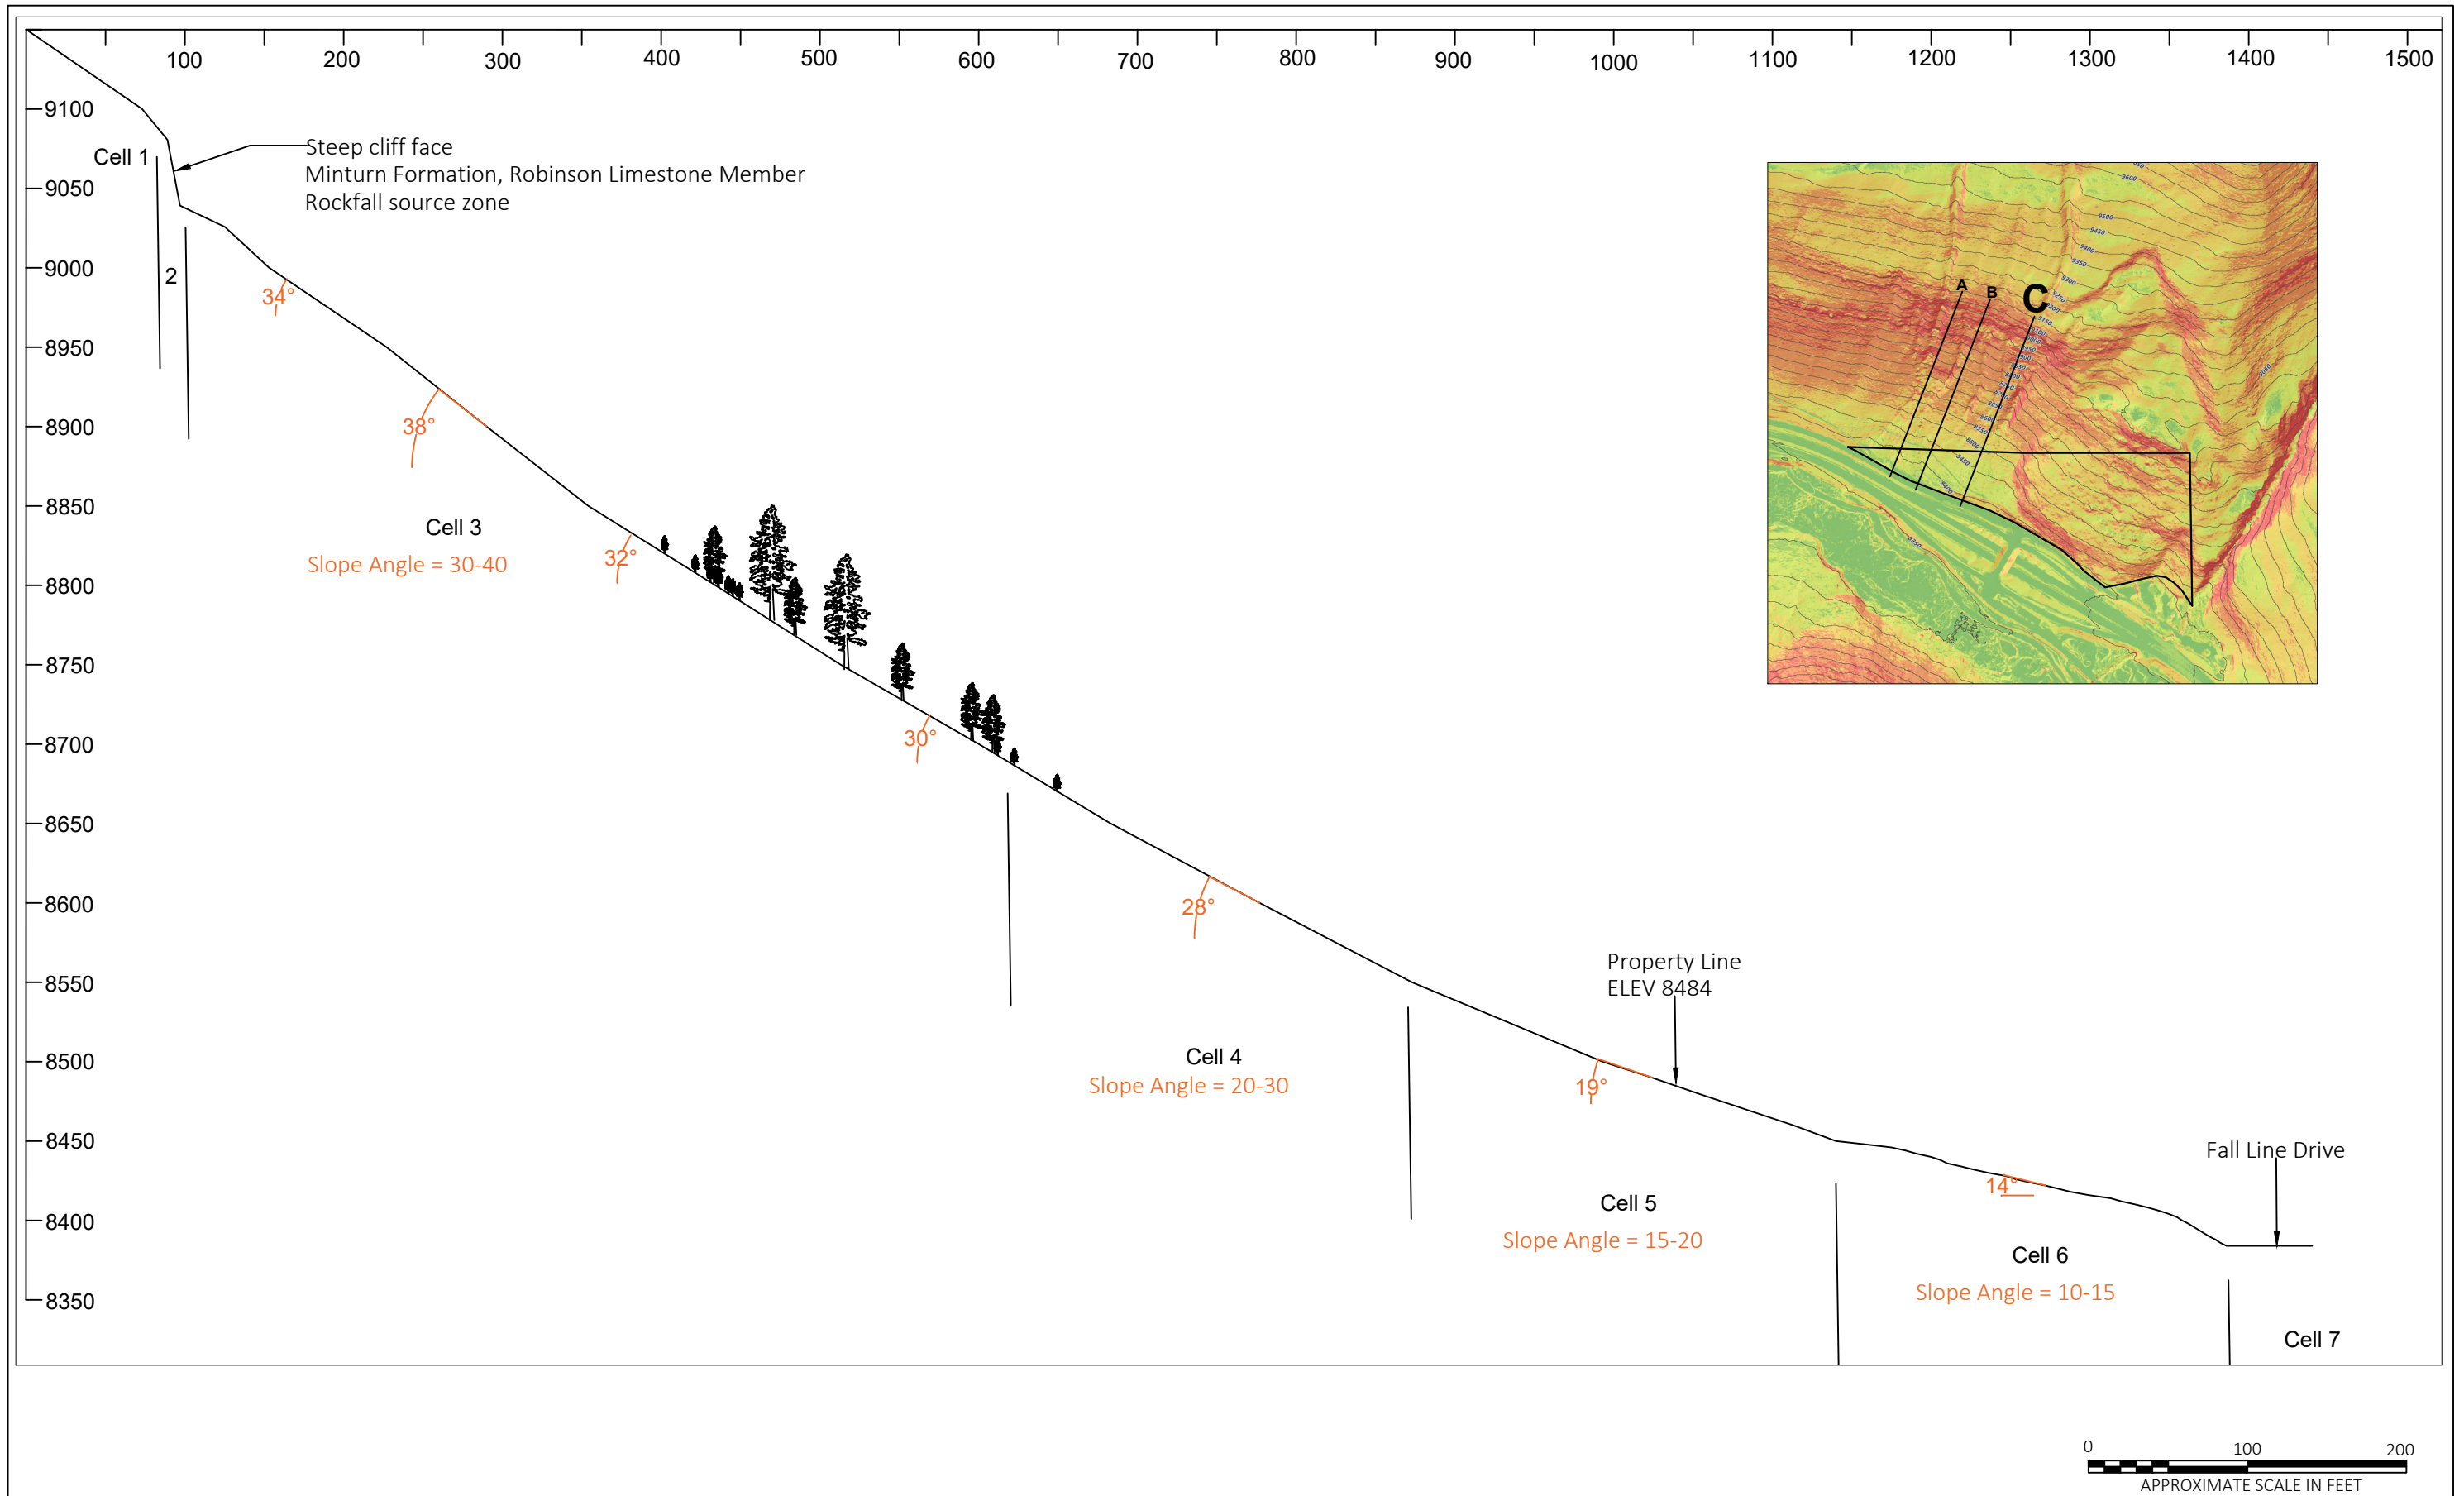
FIGURE 10  
 Study Section C

Study section C is located near the east side of the proposed development (Figure 6). Study Section C spans a length of about 1,630 feet along the slope and an elevation range from 8384 to 9150 (Figure 10). The slope is vegetated with aspen trees, shrubs, and grass, and covered in colluvium and limestone boulders that have broken from the steep cliff rockfall source zone at about elevation 8040 to 9080. Skyline understands that the intended type of barrier system at this location is an earthen berm with catchment area located upslope from the proposed buildings. The distance along the slope from the rockfall source zone to the property boundary is about 1,100 feet. Table 5 lists slope profile parameters used for Study Section C.
