**GEOLOGIC HAZARDS REVIEW  
PROPOSED TOWN OF VAIL  
PUBLIC WORKS FACILITY DEVELOPMENT  
1309 ELKHORN DRIVE, VAIL  
EAGLE COUNTY, COLORADO**

**PROJECT NO. 18-7-606**

**NOVEMBER 6, 2018**

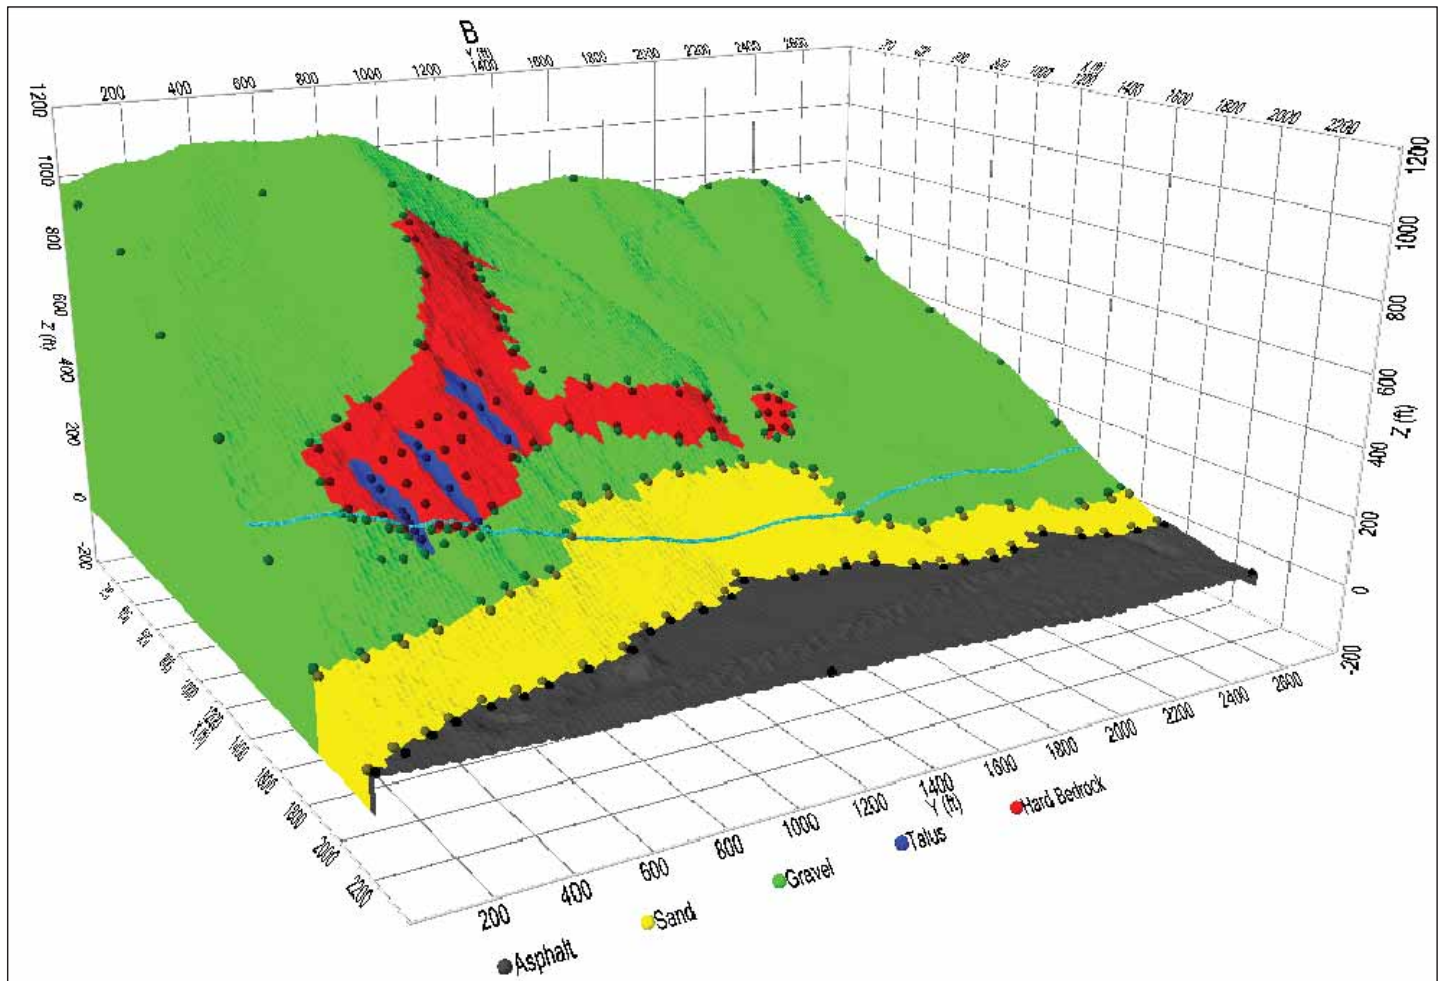
A map showing potential rockfall hazard areas is presented in Figure 2. The potential hazard consists of a rockfall source zone, a rockfall runout zone, and an area of potential rockfall paths between the source zone and the runout zone. The project site is located in the potential runout zone as shown on Figure 1.

The majority of rocks presently posing a hazard to the proposed development are located at the rock outcrop located approximately 560 feet up the slope and along the ridge to the northwest of the proposed development area about 400 to 1000 feet up the slope. The source zones are primarily intact sandstone, conglomerate, and limestone that exhibit varying degrees of weathering and fractures.

The rockfall runout zone evaluated for this study is defined as the area of ground at the ditch/berm and two-track road and south into the area of the proposed development. This area has been impacted by falling rock in the past as can be observed by the boulders adjacent to the ditch/berm. In our opinion, the existing ditch/berm feature should not be considered effective rockfall mitigation for the proposed development.

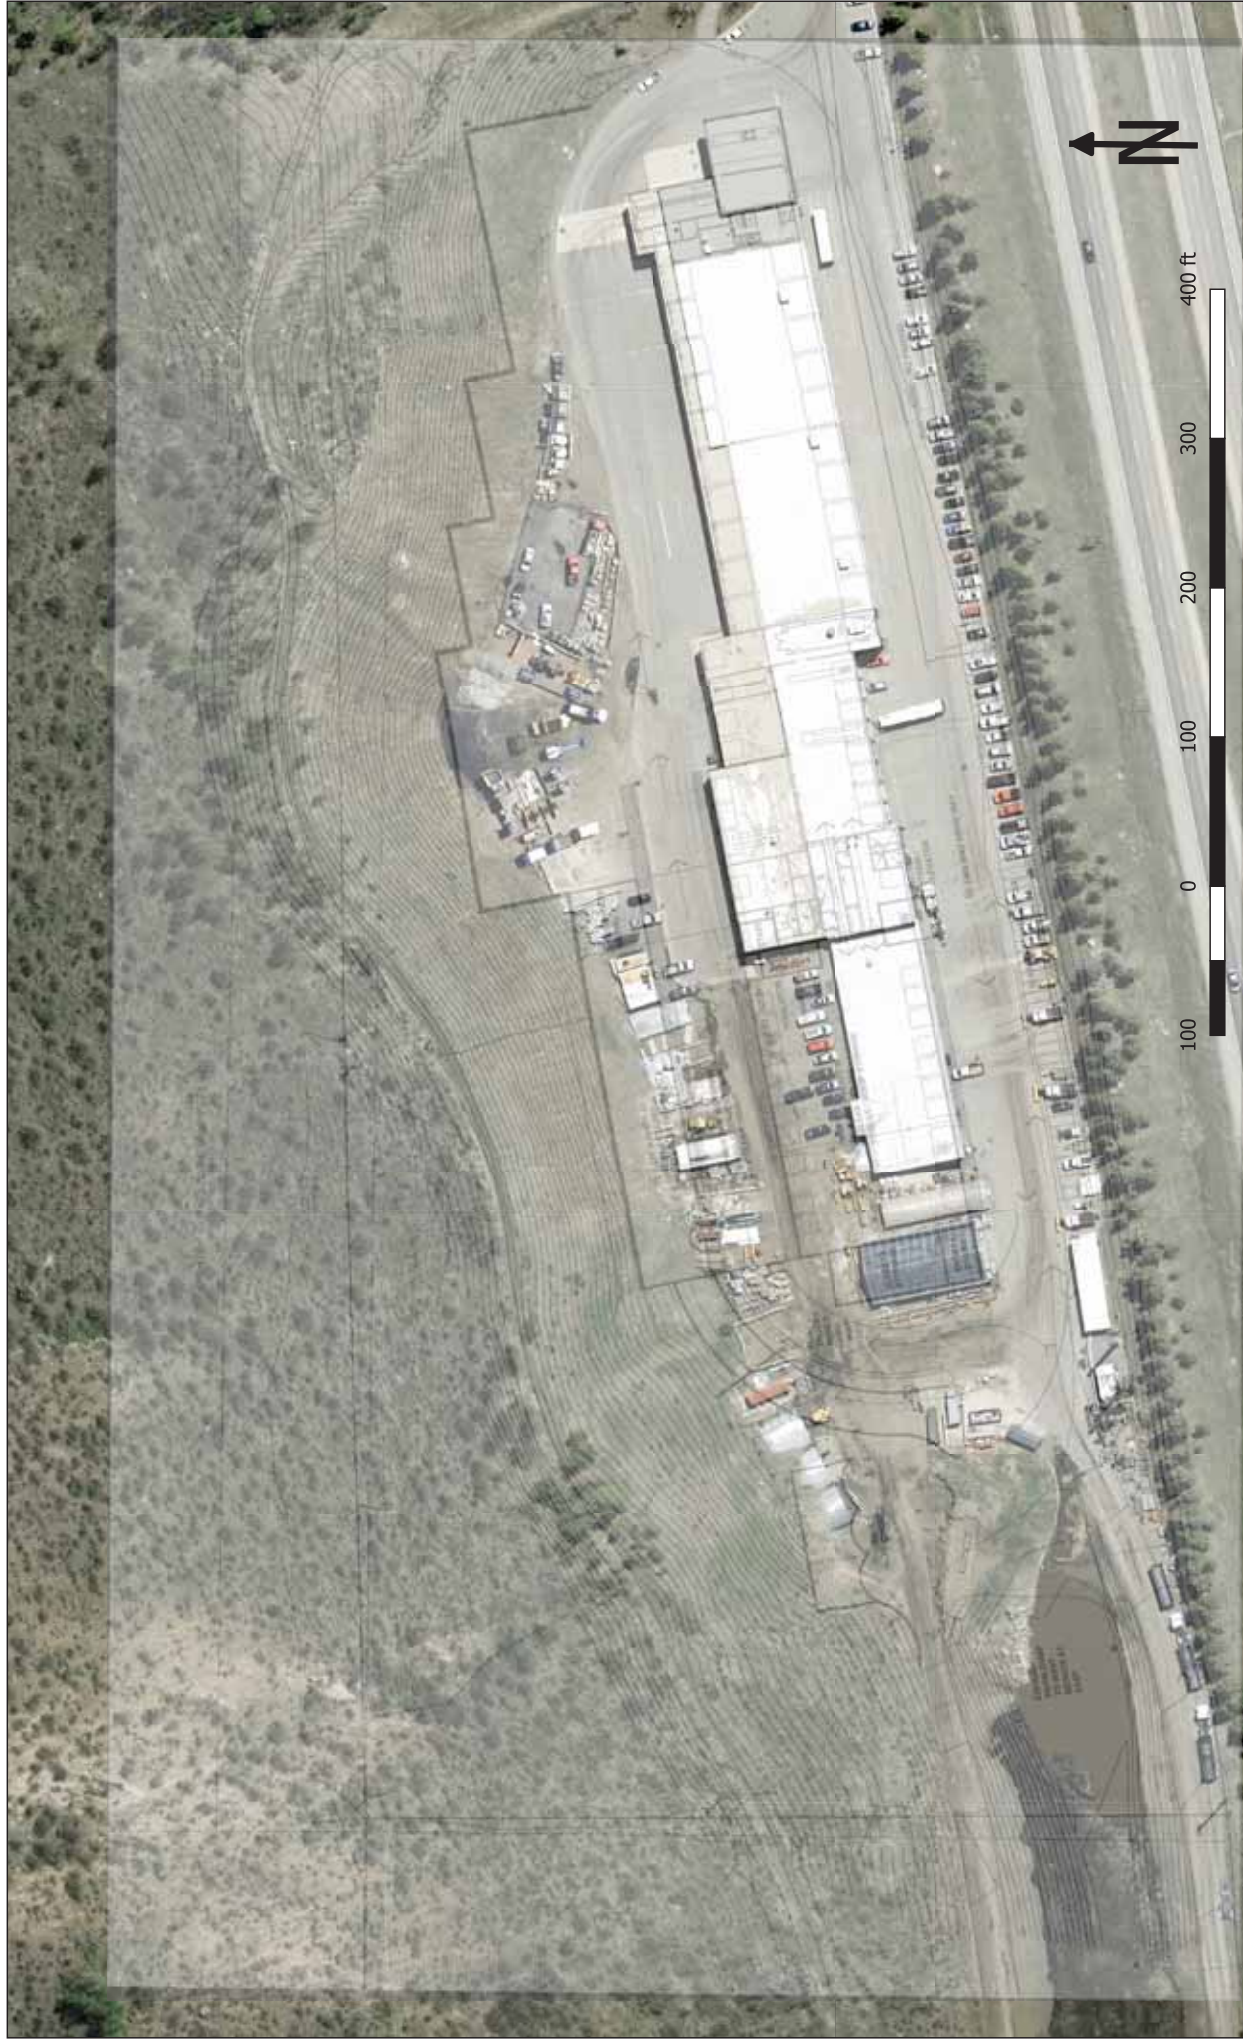
The results are presented in Table 1. We analyzed the results of our rockfall model at one point, the crest of the ditch/berm and along the lower edge of the two-track trail above the proposed development area, see Figure 4. We also calculated the rockfall dynamic probability distribution at this location. The engineering results of the modeling are given in the following table for a 2% exceedance probability. The bounce height is to the centroid of the rock block. The rockfall dynamic probability distribution may be used to assess the feasibility of rockfall mitigation.

Point Evaluated	Velocity ft/s (m/s)	Bounce Hight ft (m)	Kinetic Energy ft-lb (kJ)
Point 1	22 (6.7)	2.5 (0.8)	350,000 (470)

Based on the CRSP analysis and our observations at the site, rockfall mitigation is recommended. In our opinion, a flexible rockfall barrier (Option 1) or MSE wall/soil berm (Option 2) with a catchment area uphill of it located in the area of the existing ditch/berm and two-track trail will be an effective mitigation. A flexible rockfall barrier will have the lower amount of visual impact and will require a limited amount of space to construct. The modeled energies and bounce heights for a 2% exceedance probability from the source zone are around 350,000 foot-pounds (470 kJ) and 2.5 feet (0.76 m), respectively. The modeled energies and bounce heights associated with rockfalls from these zones are presented above in Table 1. Based on these modeled energies and bounce heights, the barrier would need to be around 7 feet (2.11m) tall with a strength of 420,000 ft-lb (570 kilojoules). We recommend that a 3 meter (9.9 foot) tall Geobrugg GBE-1000A-R system (or equivalent) or suitable MSE wall or soil berm with catchment area designed by a qualified civil engineer be installed along the existing two-track road, for mitigation of the potential rockfall at the site. A soil berm with catchment area may also reduce the risk of damage due to debris flow at the subject site. If a flexible barrier option is chosen, the existing berm should be extended by approximately 200 feet to the west to intercept possible debris flow paths and the outlet improved so as to not direct flow toward the existing public works office building or existing employee housing building. This berm should be designed by a qualified Civil Engineer to account for design debris flow volumes and velocities.
