**GEOLOGIC HAZARDS REVIEW
PROPOSED TOWN OF VAIL
PUBLIC WORKS FACILITY DEVELOPMENT
1309 ELKHORN DRIVE, VAIL
EAGLE COUNTY, COLORADO**

PROJECT NO. 18-7-606

NOVEMBER 6, 2018

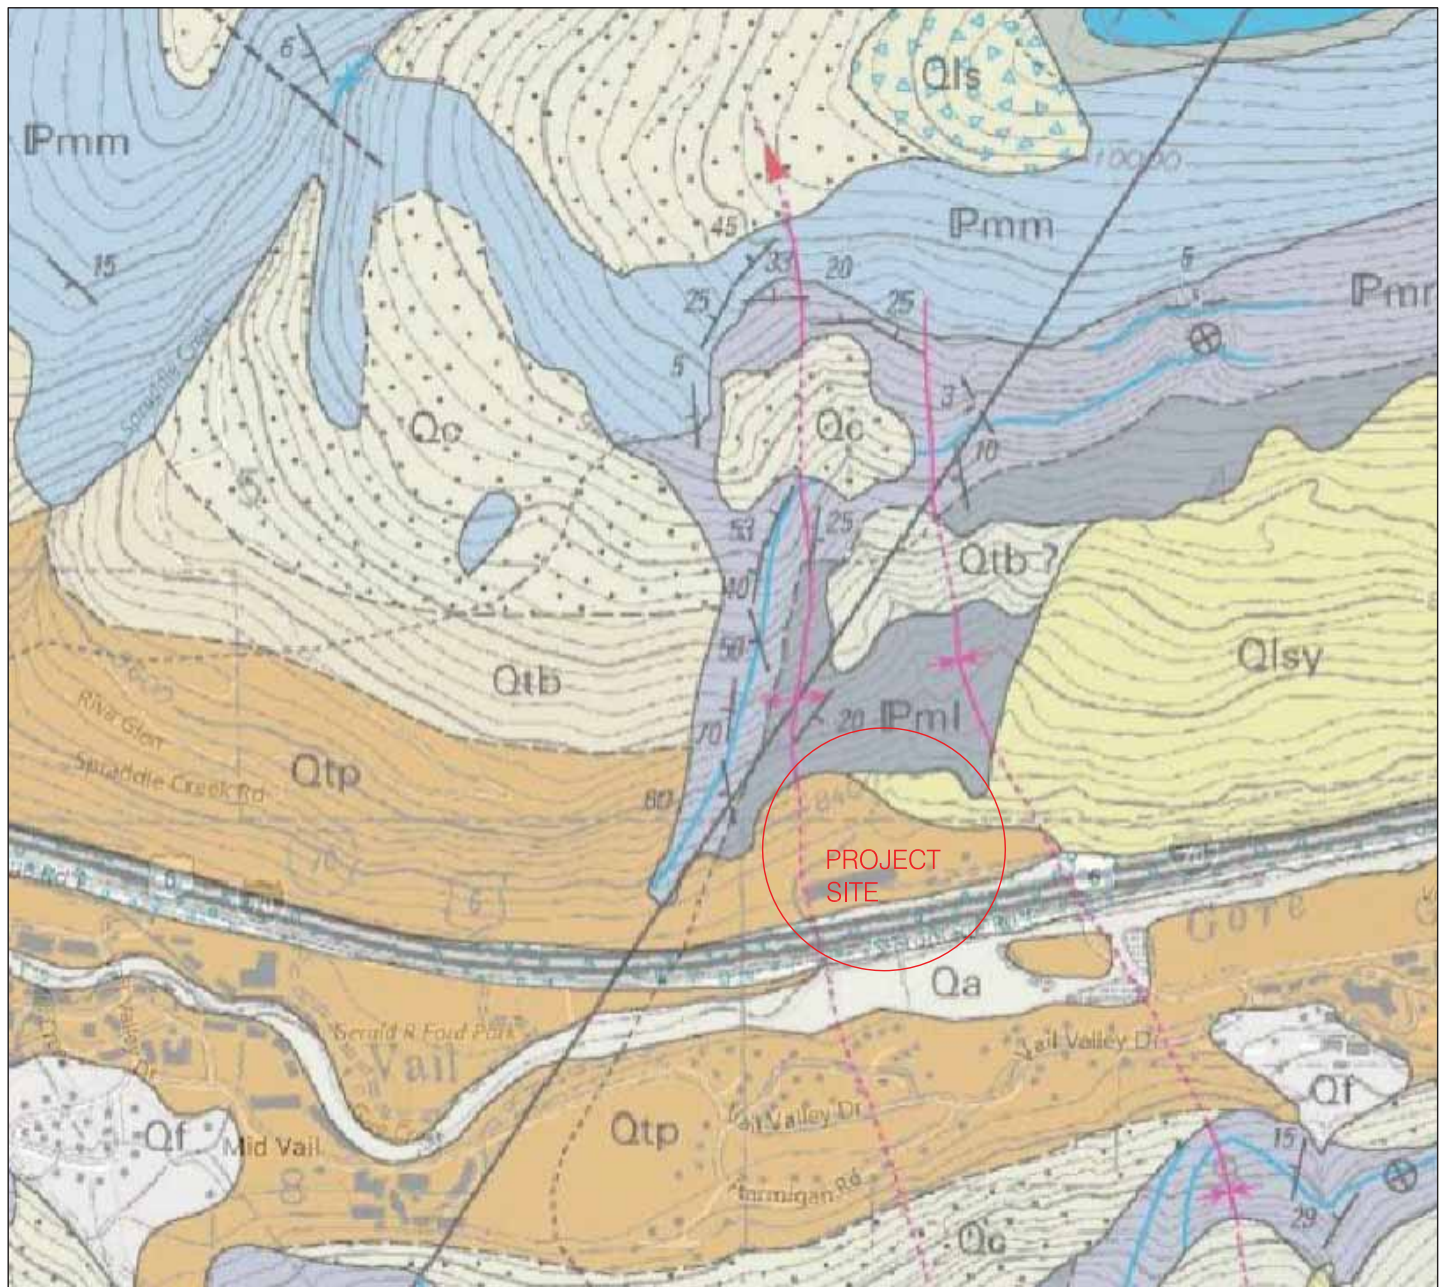
The main geologic features in the project area are shown on Figure 3. This map is based on regional mapping by Kellogg and Others (2003) published by the United States Geological Survey.

The project site lies along the axis of the Laramide-age north-south trending Spraddle Creek Fold. Formation rock in the area consists of the Pennsylvanian-age Minturn Formation middle member (Pmm), the Robinson Limestone Member (Pmr), and the lower member (Pml). The lower member consists of arkosic conglomerate, sandstone, siltstone, and shale that is pinkish-gray to grayish-brown. The Robinson Limestone Member is a fossiliferous medium to thick bedded marine limestone interbedded with light tan arkosic pebbly sandstones, siltstones, and shales. The middle member consists of arkosic conglomerate, sandstone, siltstone, and shale that is pinkish-gray to grayish-brown. The bedding dip of the formation rock in the vicinity of the

Surficial deposits in the area include upper Pleistocene-age Pinedale glacial till (Qtp), middle Pleistocene-age Bull Lake glacial till (Qtb), and recent landslide deposits (Qlsy). The Pinedale glacial till consists of sub-angular to sub-rounded gneiss cobbles and boulders in a light tan sandy matrix that is unsorted and unstratified. The Bull Lake glacial till consists of material similar to that of the Pinedale till but also contains sandstone, conglomerate, or limestone cobbles and boulders derived from the Minturn Formation. The recent landslide deposits consist of debris deposited by recent landslides that is unstratified and unsorted. The landslide to the northeast of the project site is active and is a deep rotational slide with shallow soil slumping near the surface (Kellogg and Others, 2003).
