ROCKFALL HAZARD STUDY

East Vail Parcel
Vail, Colorado

**Project No. 17.5029
June 19, 2017**

**ROCKFALL HAZARD STUDY
East Vail Parcel
Vail, Colorado**

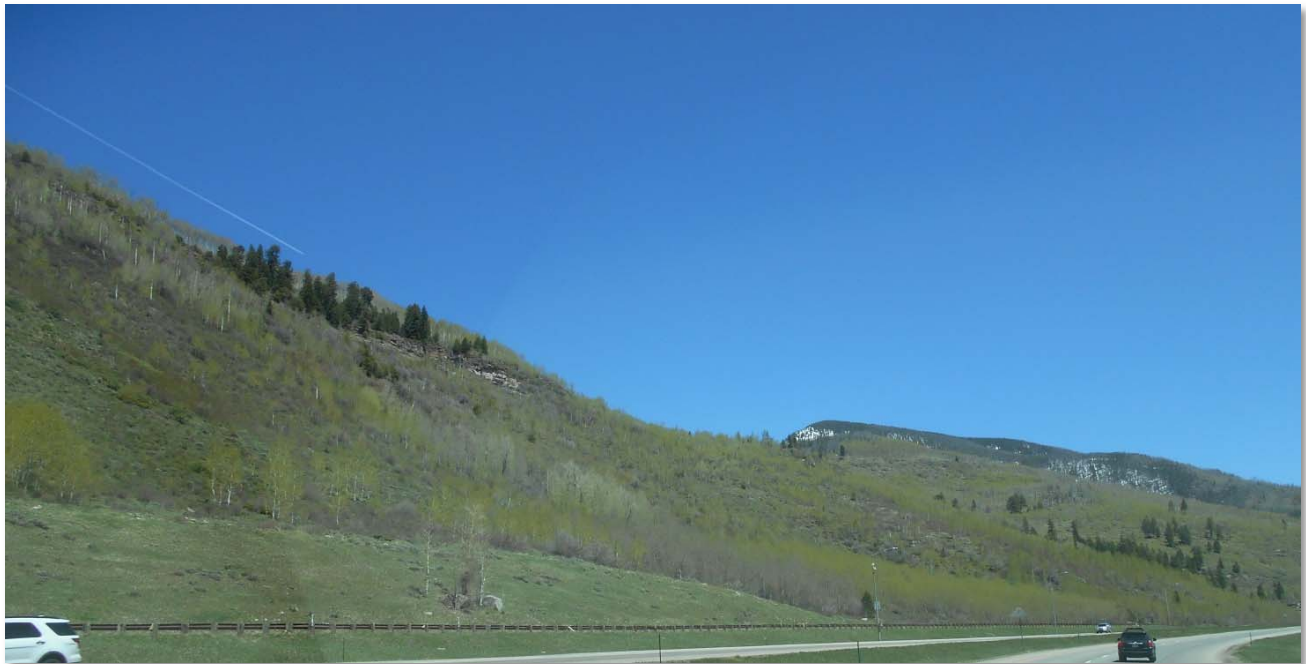
Photograph 1. View of the project site. Photograph taken from the eastbound lane of I-70 looking east across the site. The photograph shows the relatively steep slope of the site and the rock outcrops present upslope from the site.

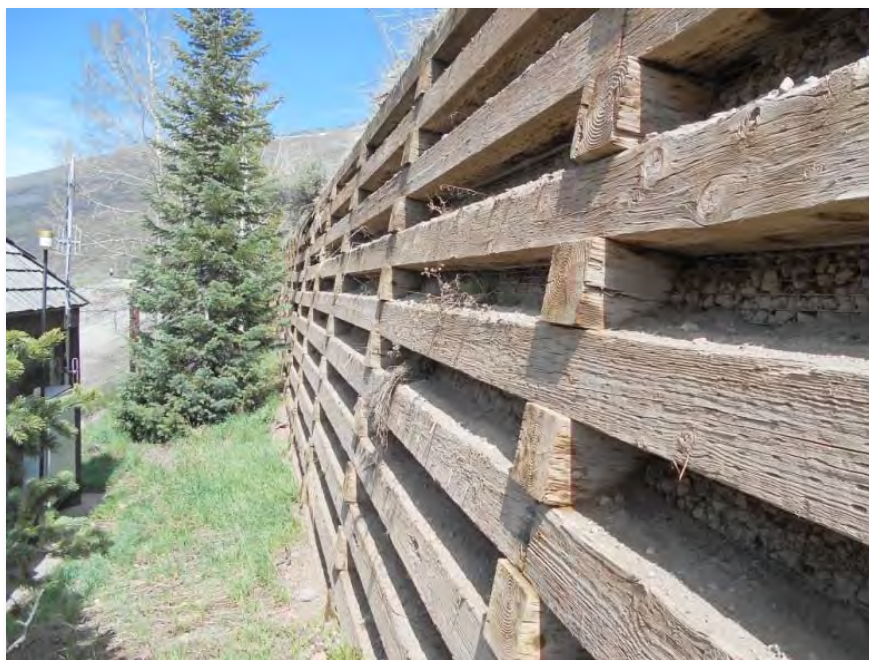
Photograph 2. View of retaining wall located along edge of site that borders Fall Line Drive. Town of Vail shuttle stop is visible in the left side of the photograph.

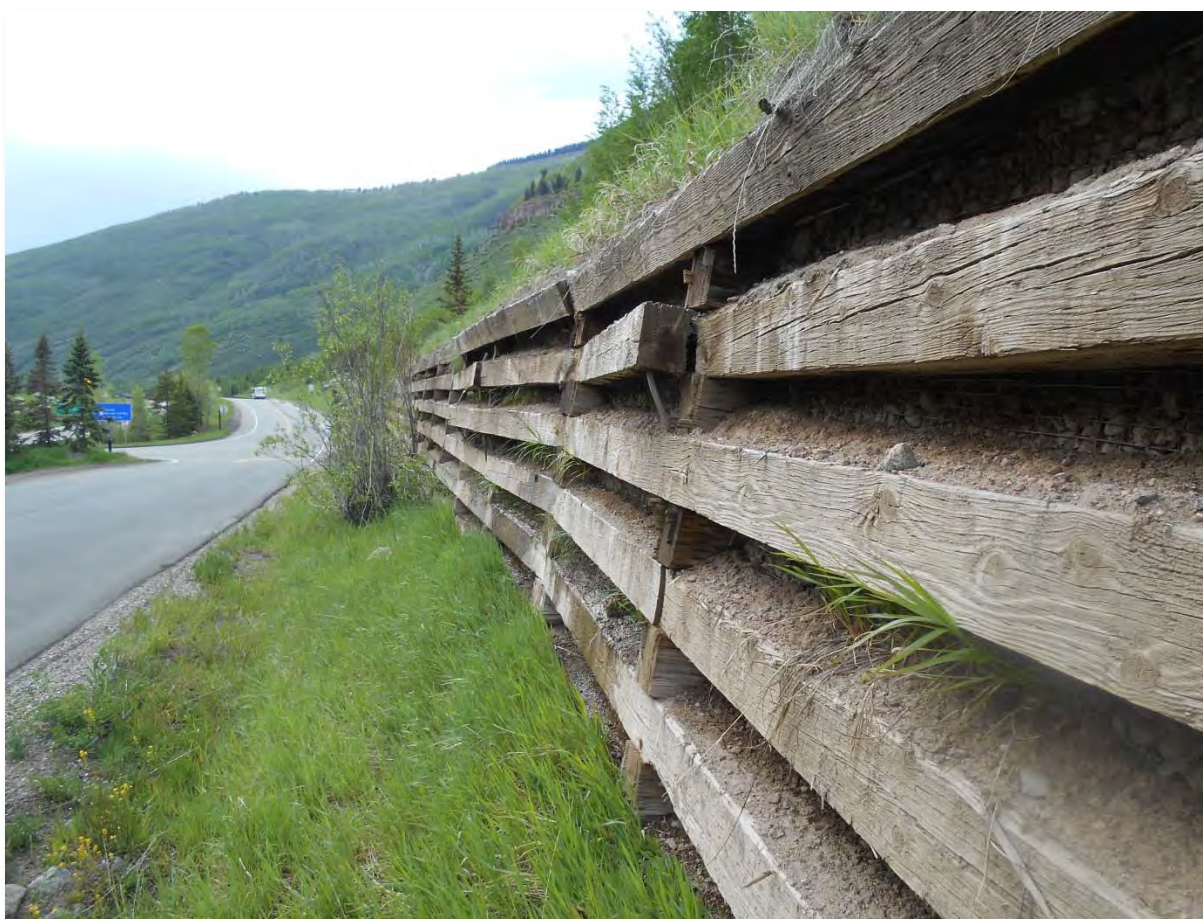
Photograph 3. View of distressed part of the retaining wall along the edge of the site that borders Fall Line Drive. The slope rises steeply upward to the north at the top of the wall. This photograph was taken near the east end of the wall.

Cesare did not observe evidence of recent landslide movement at the project site. The retaining wall for the Town of Vail shuttle stop which is located at the toe of the landslide, appears to be performing adequately. The landslide area displays benched and hummocky topography with over-steepened toe and flank areas, however, fresh landslide features, such as tension cracks, scarps, slumps, and other features, were not observed. Figure 7 shows the bare earth land surface and provides a convincing depiction of the landslide extents. Cesare is not aware of landslide movement causing distress to the townhomes in the Pitkin Creek subdivision notched into the toe near the southeast corner of the site.

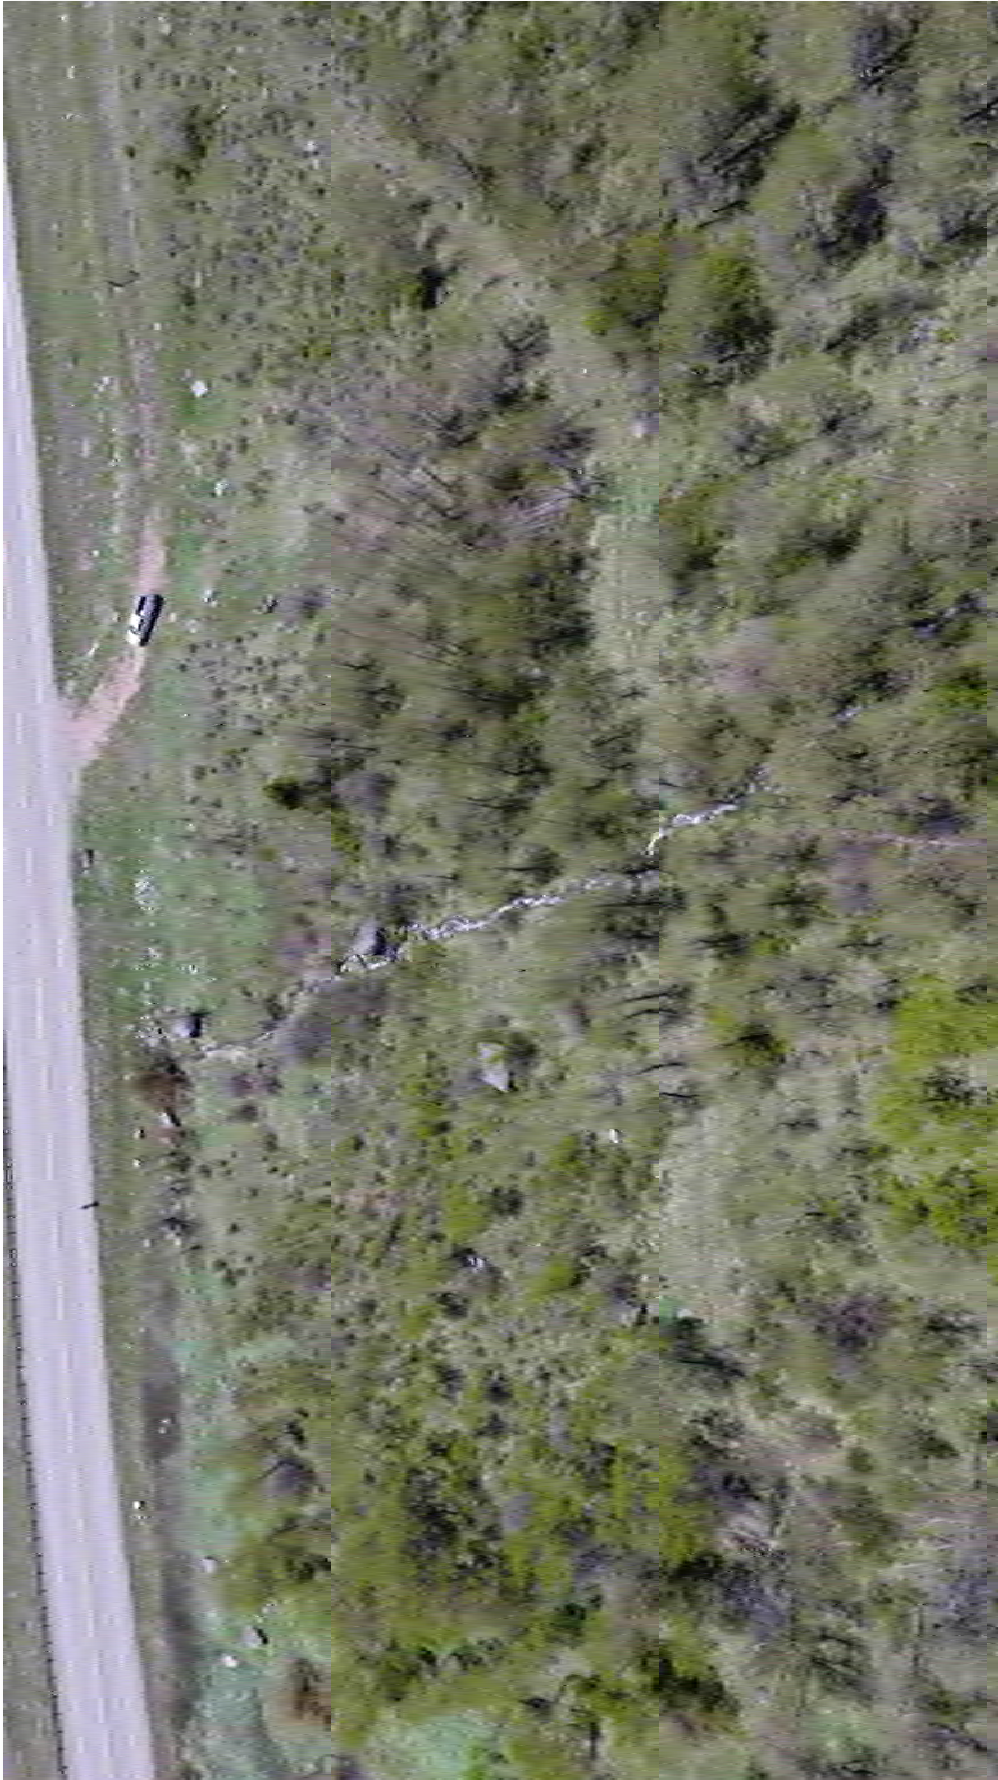
Photograph 4. Aerial view of the west side of the site. The single track road that traverses the site is visible, along with one of the drainages onsite (with flowing water). The white Cesare truck is parked at the beginning of the access road for the rockfall berm, constructed on the neighboring property to the west (Booth Creek). Large, gray limestone boulders which have come to rest on the lower slope are visible in the photograph.

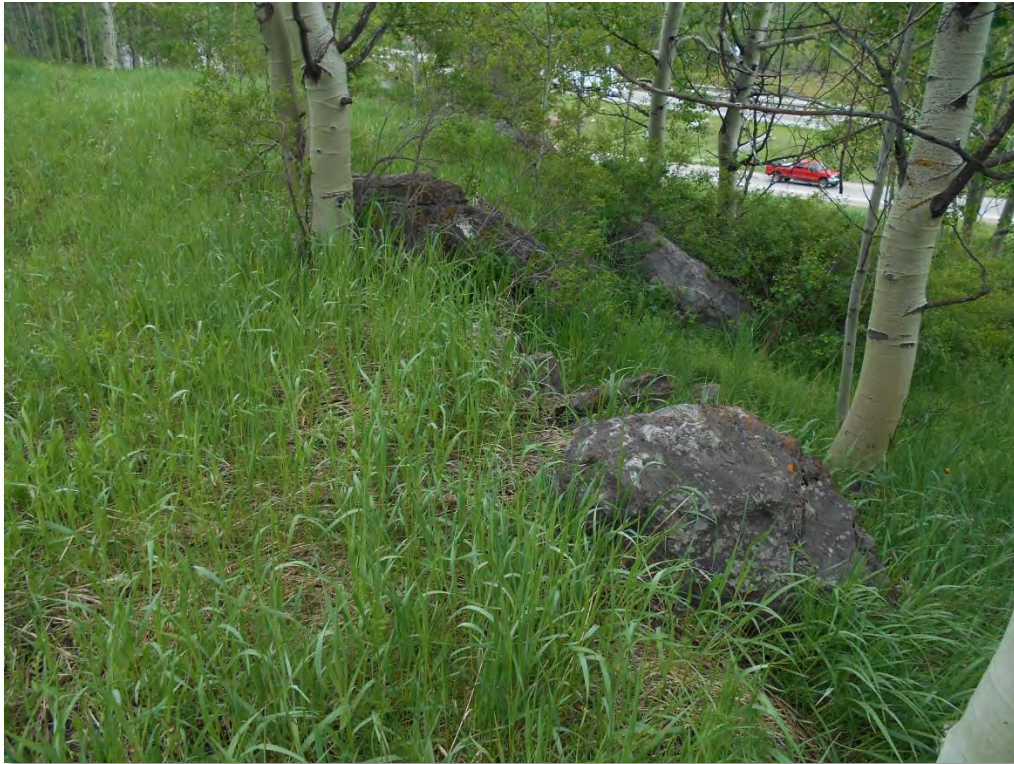
Photograph 5. View of limestone boulders which have come to rest near the base of the slope in the western part of the site. Boulders are about 3 to 4 feet in longest dimension, embedded in the soil, surrounded by mature vegetation, and show lichen on the surface.

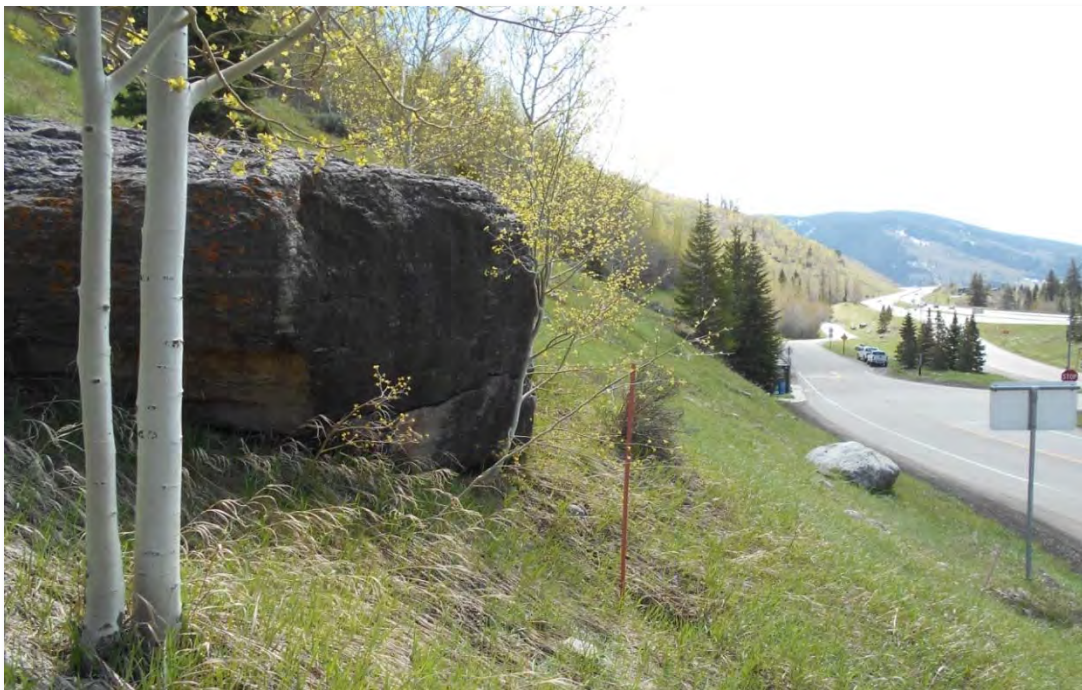
Photograph 6. View of large sized limestone boulder located in the southern area of the site. Boulder measures about 21 feet long by 16 feet wide by 6 feet high. A survey marker has been placed on this boulder (Eagle County Survey Control, 1998).

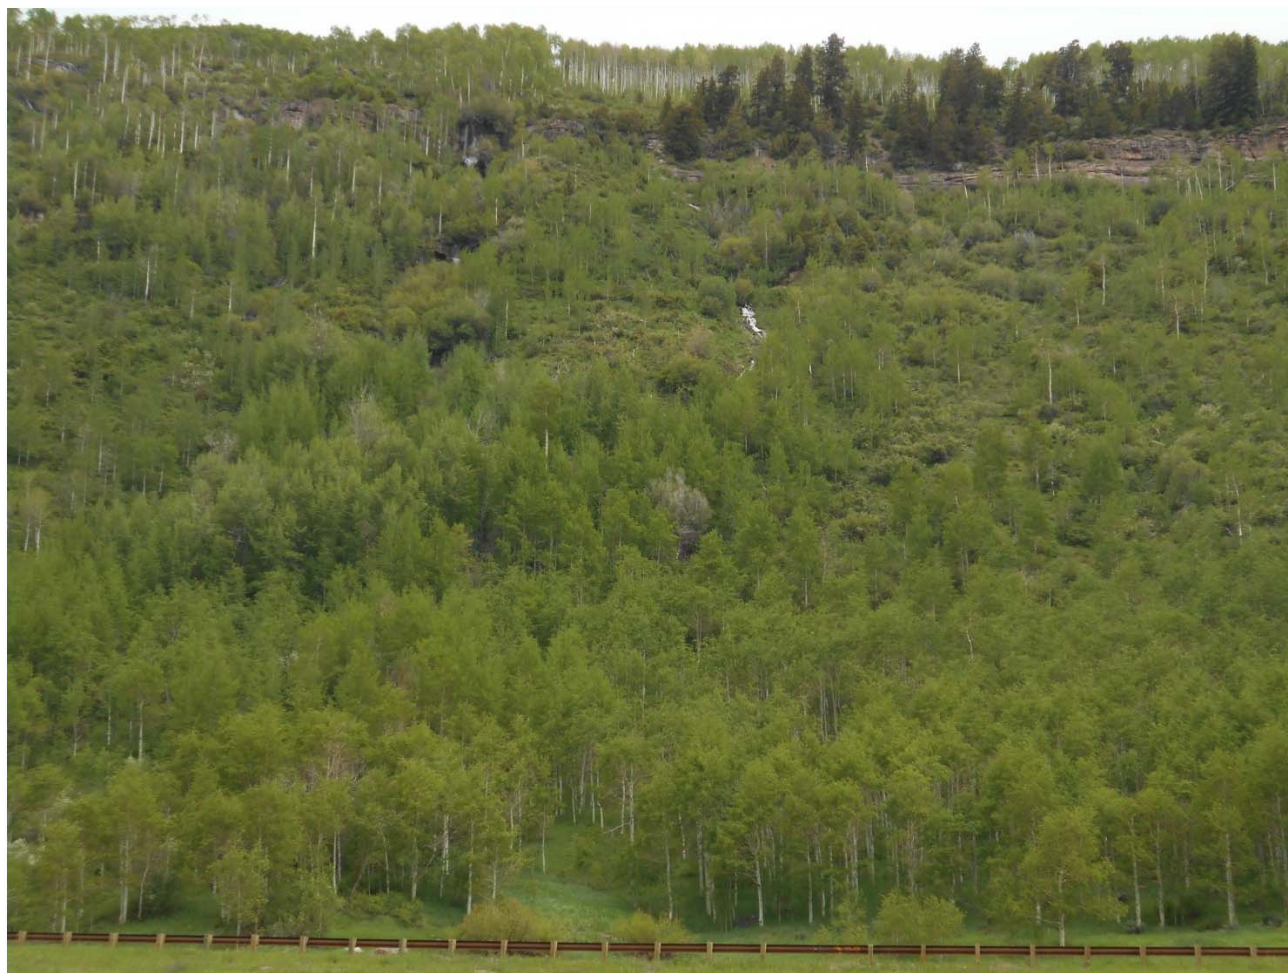
Photograph 7. View of the western part of the site. Note the dense vegetative cover, flowing water, and exposed bedrock outcrops near the top of the slope.

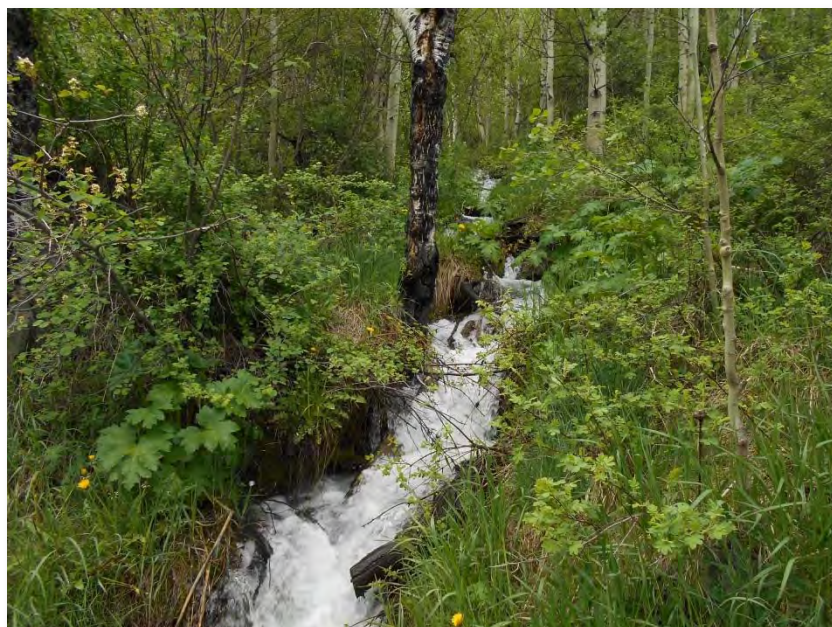
Photograph 8. View of flowing water in the western part of the site.

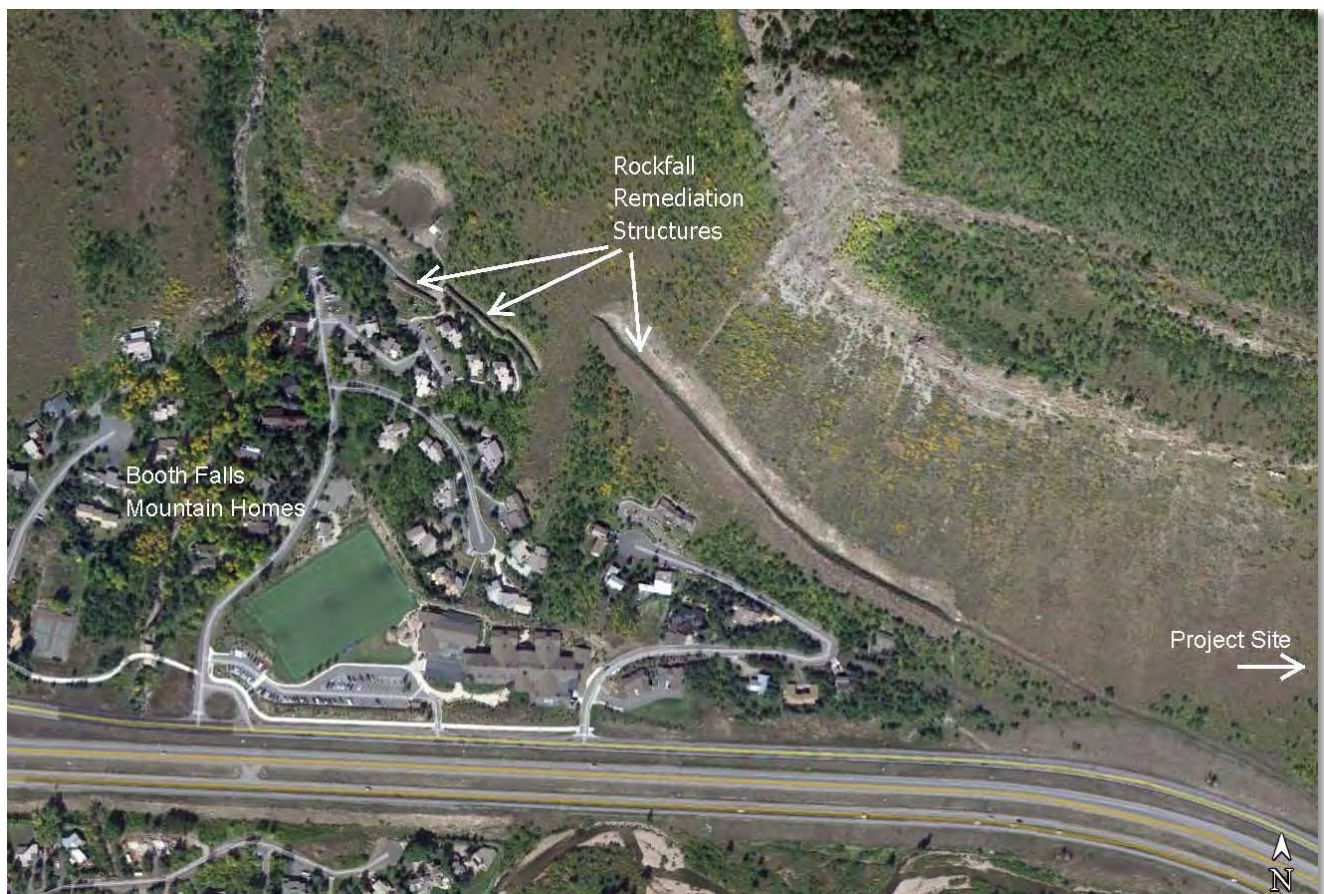
Photograph 9. Google Earth image of Booth Falls Mountain Homes to the west of the project site. Examples of existing rockfall remediation structures are labeled.

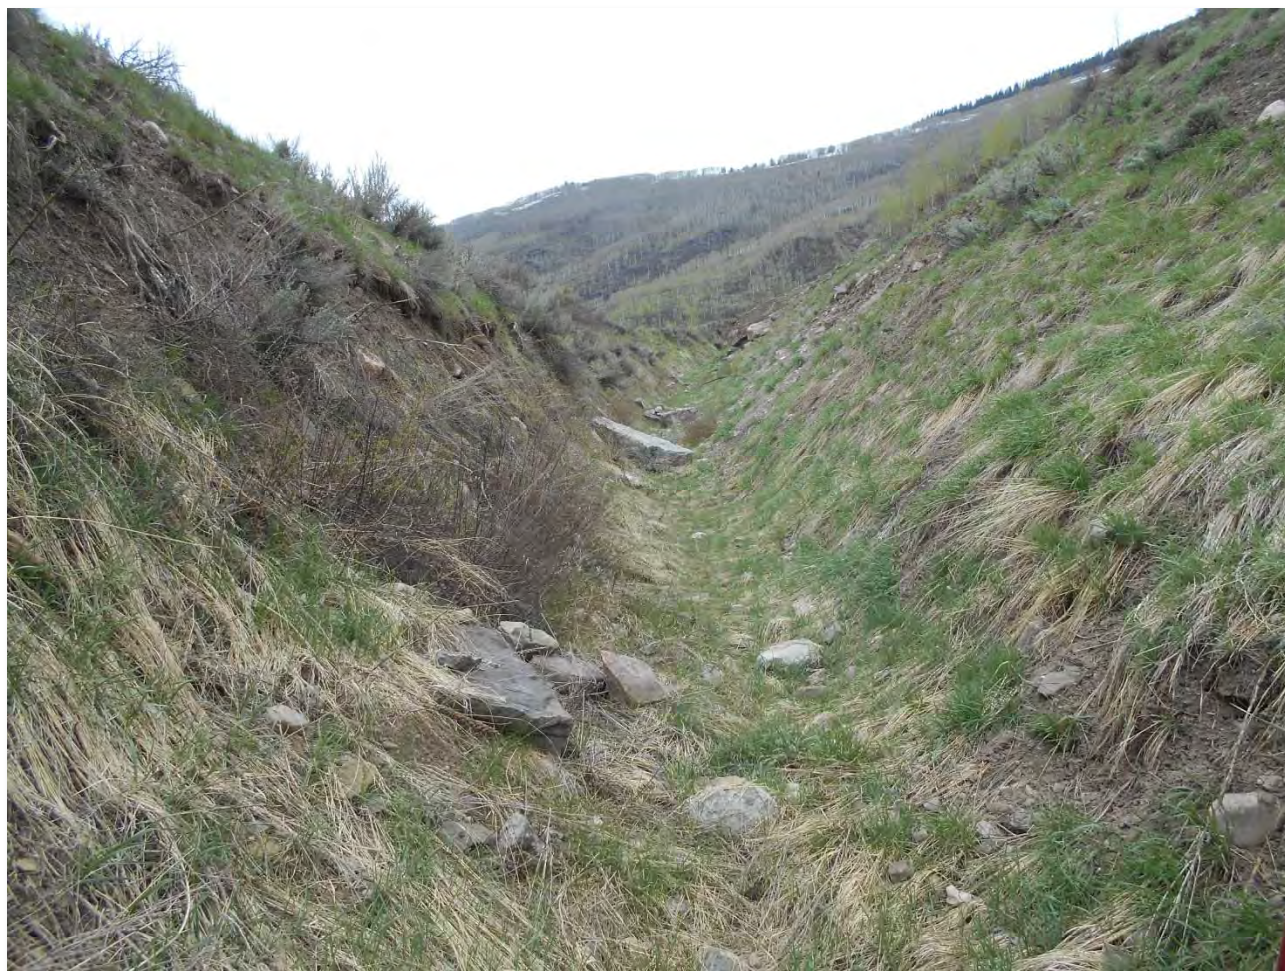
Photograph 10. View of rockfall catchment berm and basin, upslope from Booth Falls Mountain Homes. View looking west toward Booth Creek. The berm is between 10 and 15 feet high, and the ditch is about 20 feet from crest of berm to backslope.

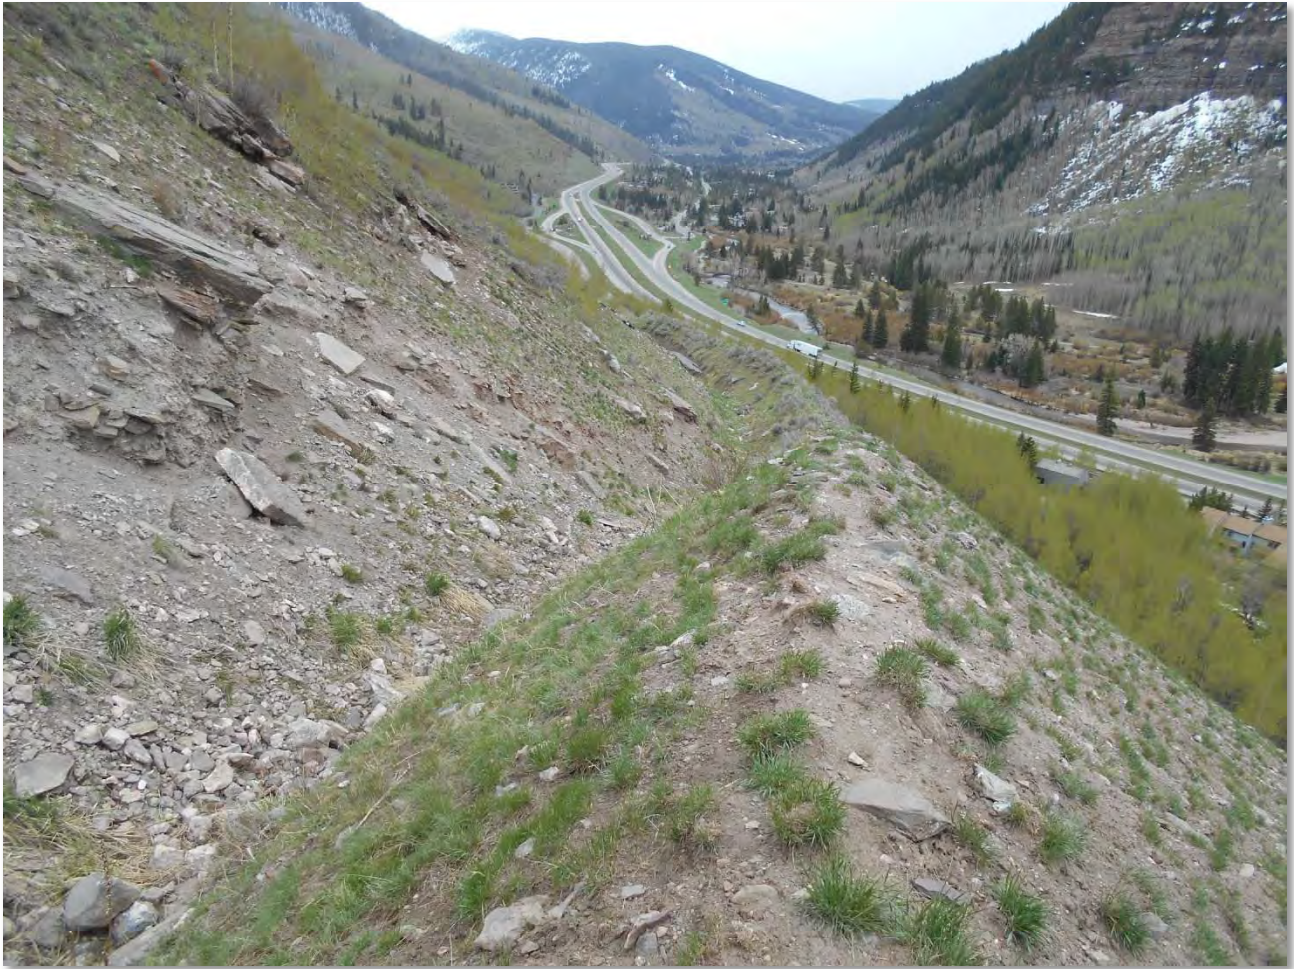
Photograph 11. View of rockfall catchment berm and basin upslope from Booth Falls Subdivision. View looking east toward the project site.

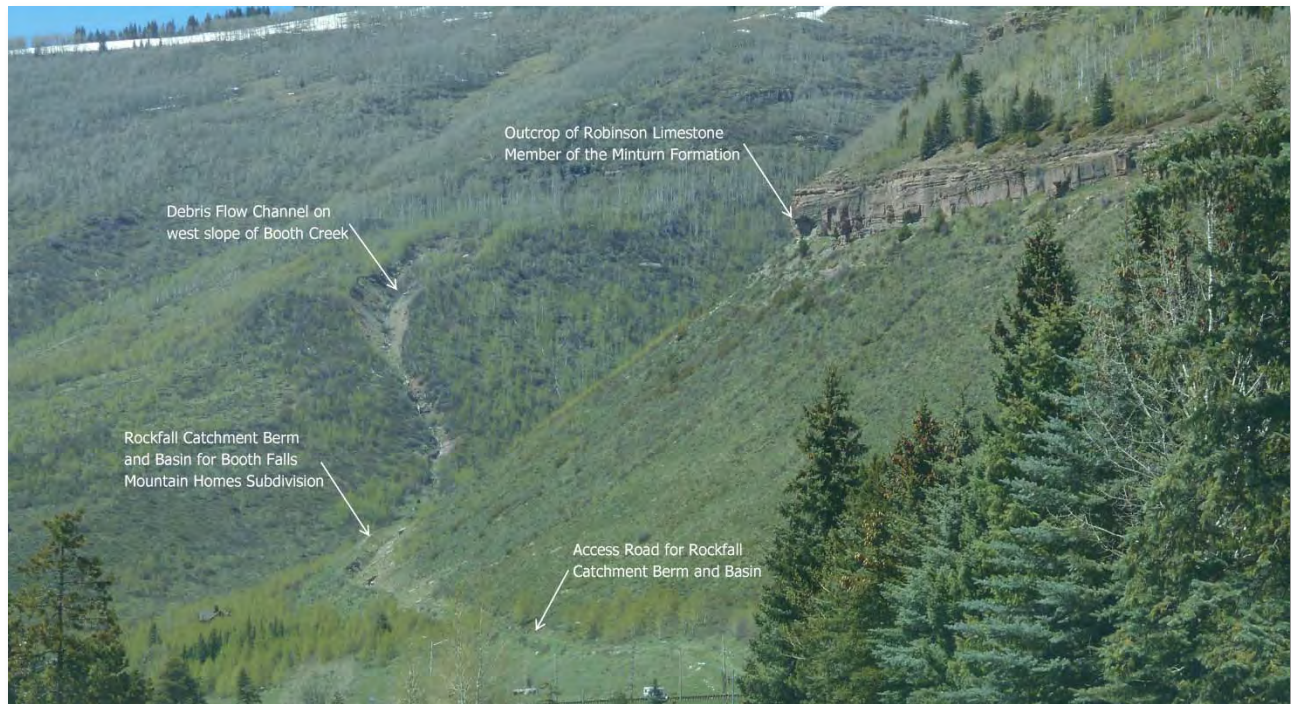
Photograph 12. View looking west toward Booth Creek. The project site is located beyond the trees in the right side of the photograph. Features are labeled.

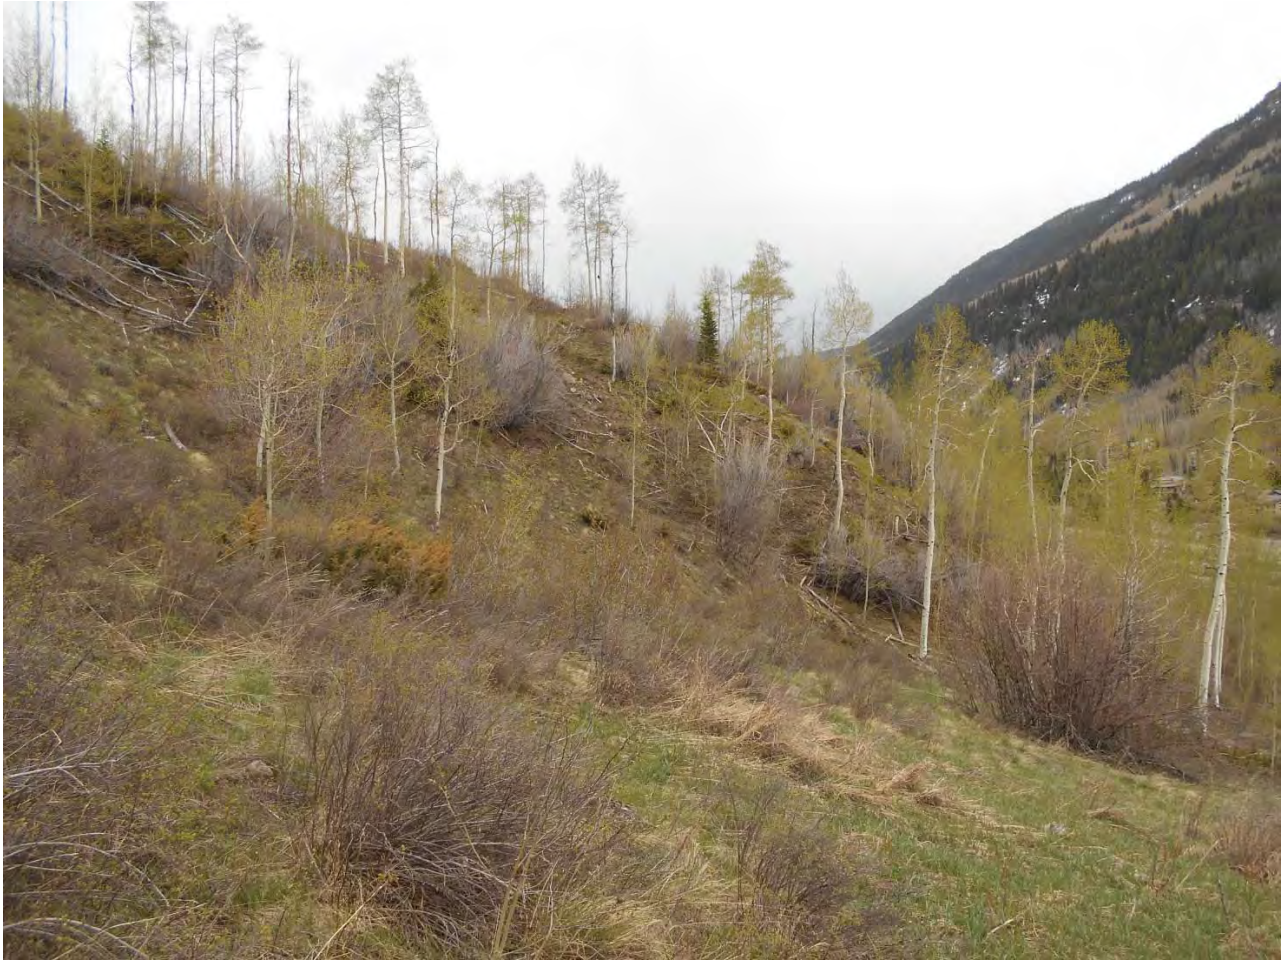
Photograph 13. View looking eastward from the western flank of the landslide toe. The ground surface is relatively steep along the toe and flanks of the slide mass, visible in the photograph.

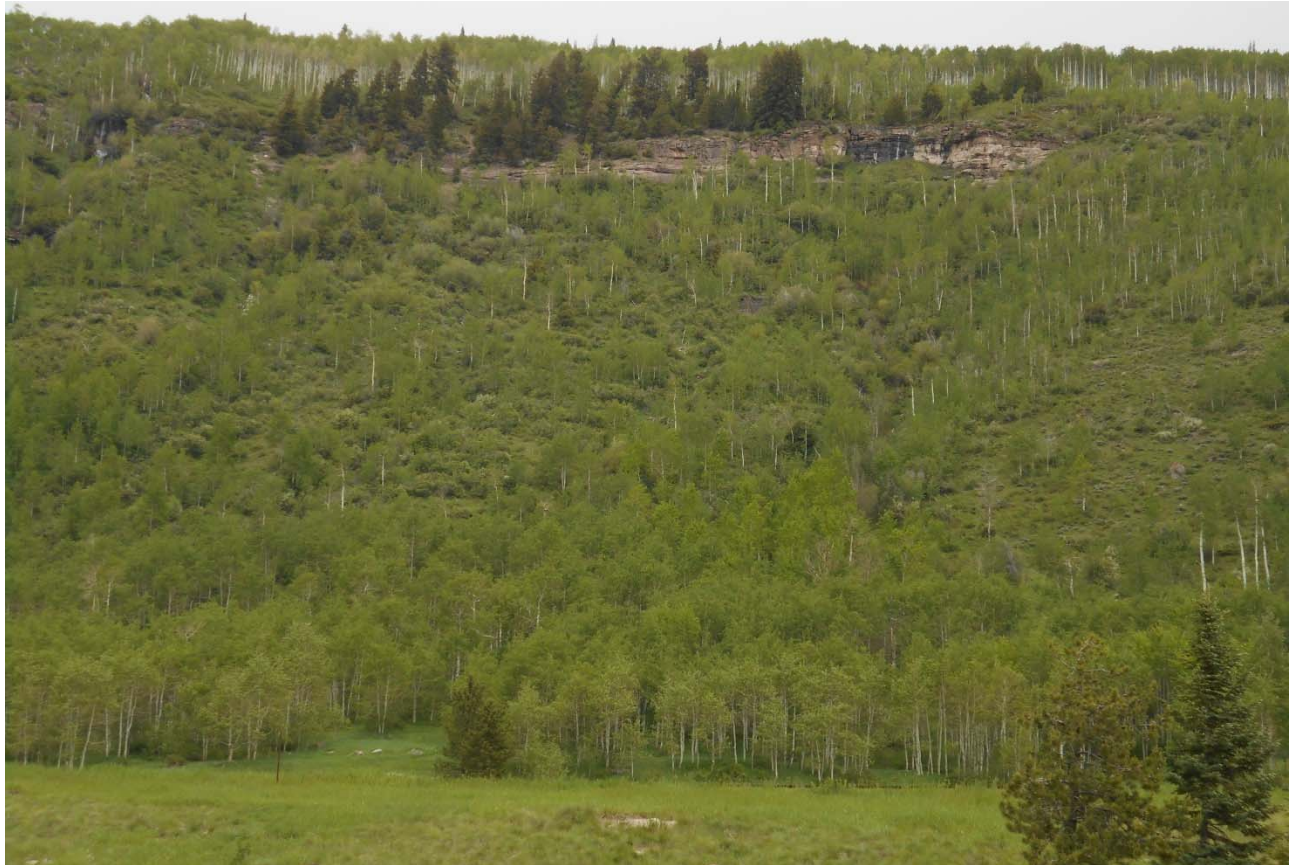
Photograph 14. View looking upslope along the rockfall study section. Notable features include the limestone bedrock exposures visible at the top of the slope and the dense vegetation on the slope. The limestone bedrock forming the cliffs at the top of the slope are considered the primary rockfall source zone.

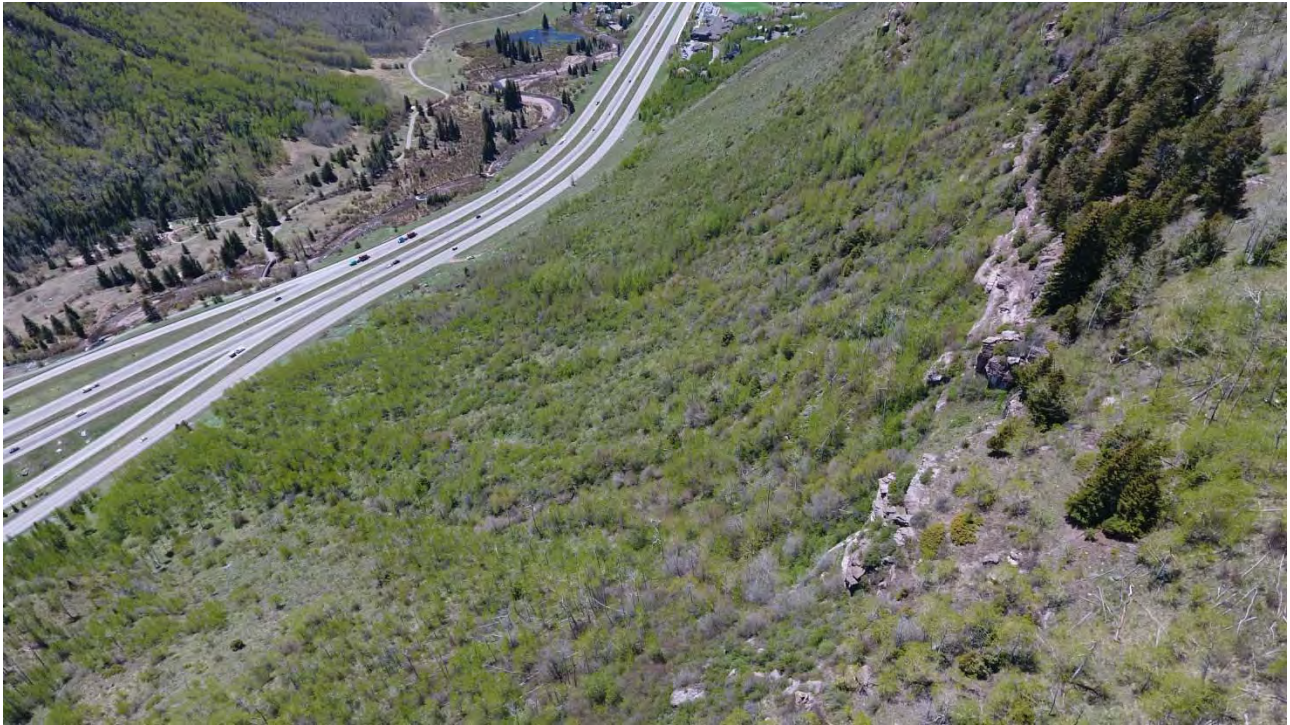
Photograph 15. View looking downslope along the rockfall study section. Notable features include the rock exposures visible at the top of the slope, the steepness of the slope, and the density of the vegetation. Fall Line Drive, I-70, and East Vail are visible in the background.

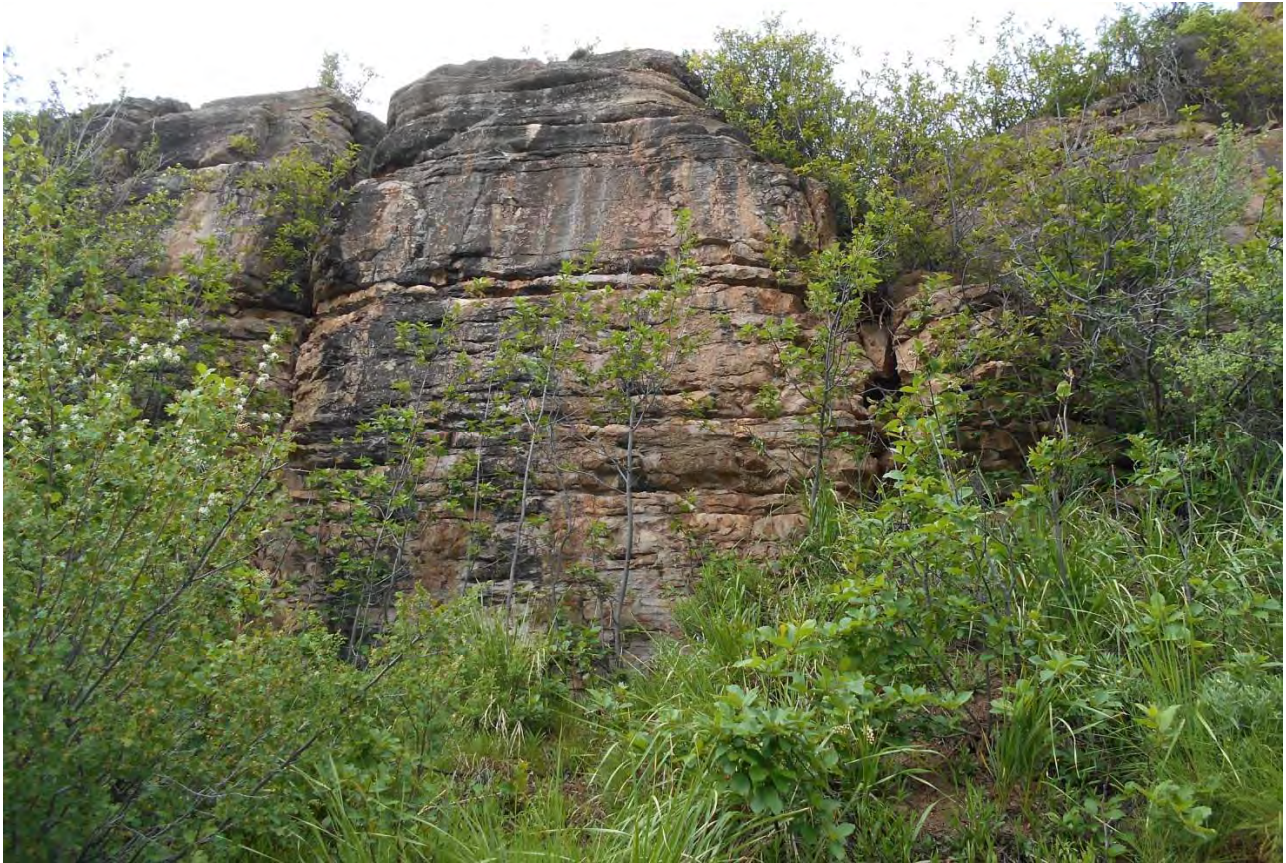
Photograph 16. View of limestone bedrock exposure at the primary rockfall source zone. Note the eroding shale partings and vertical fractures (spaced about 10 to 15 feet apart).

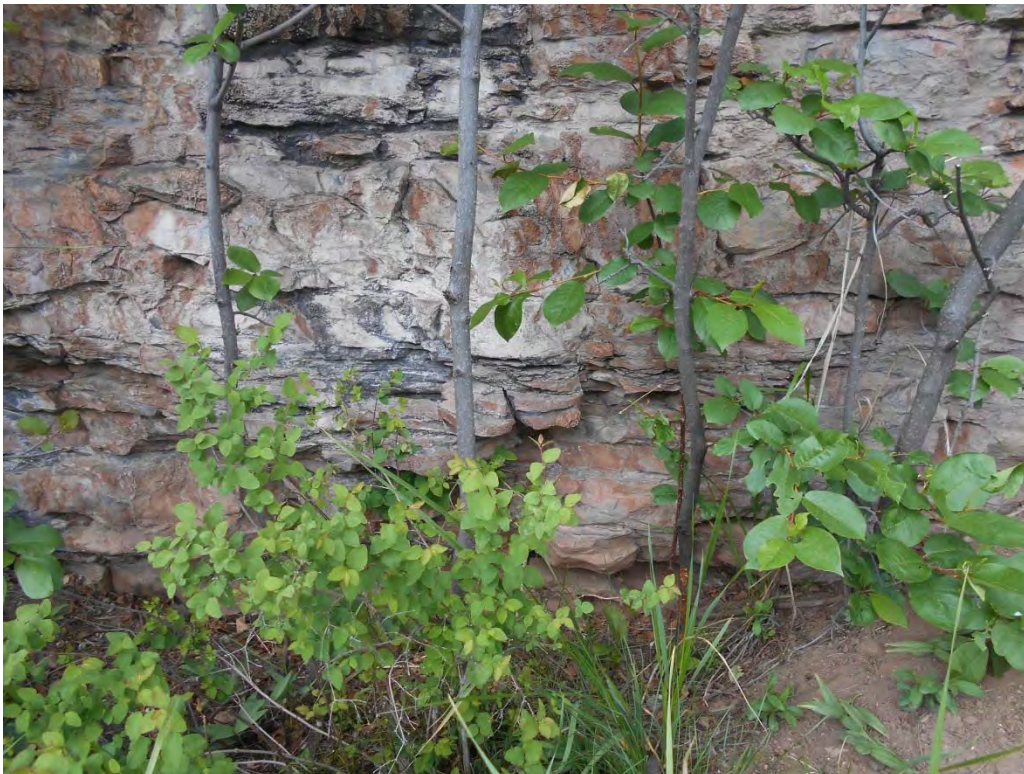
Photograph 17. Close-up view of primary rockfall source zone bedrock. Gray, hard limestone interbedded with thin, weak shale layers.

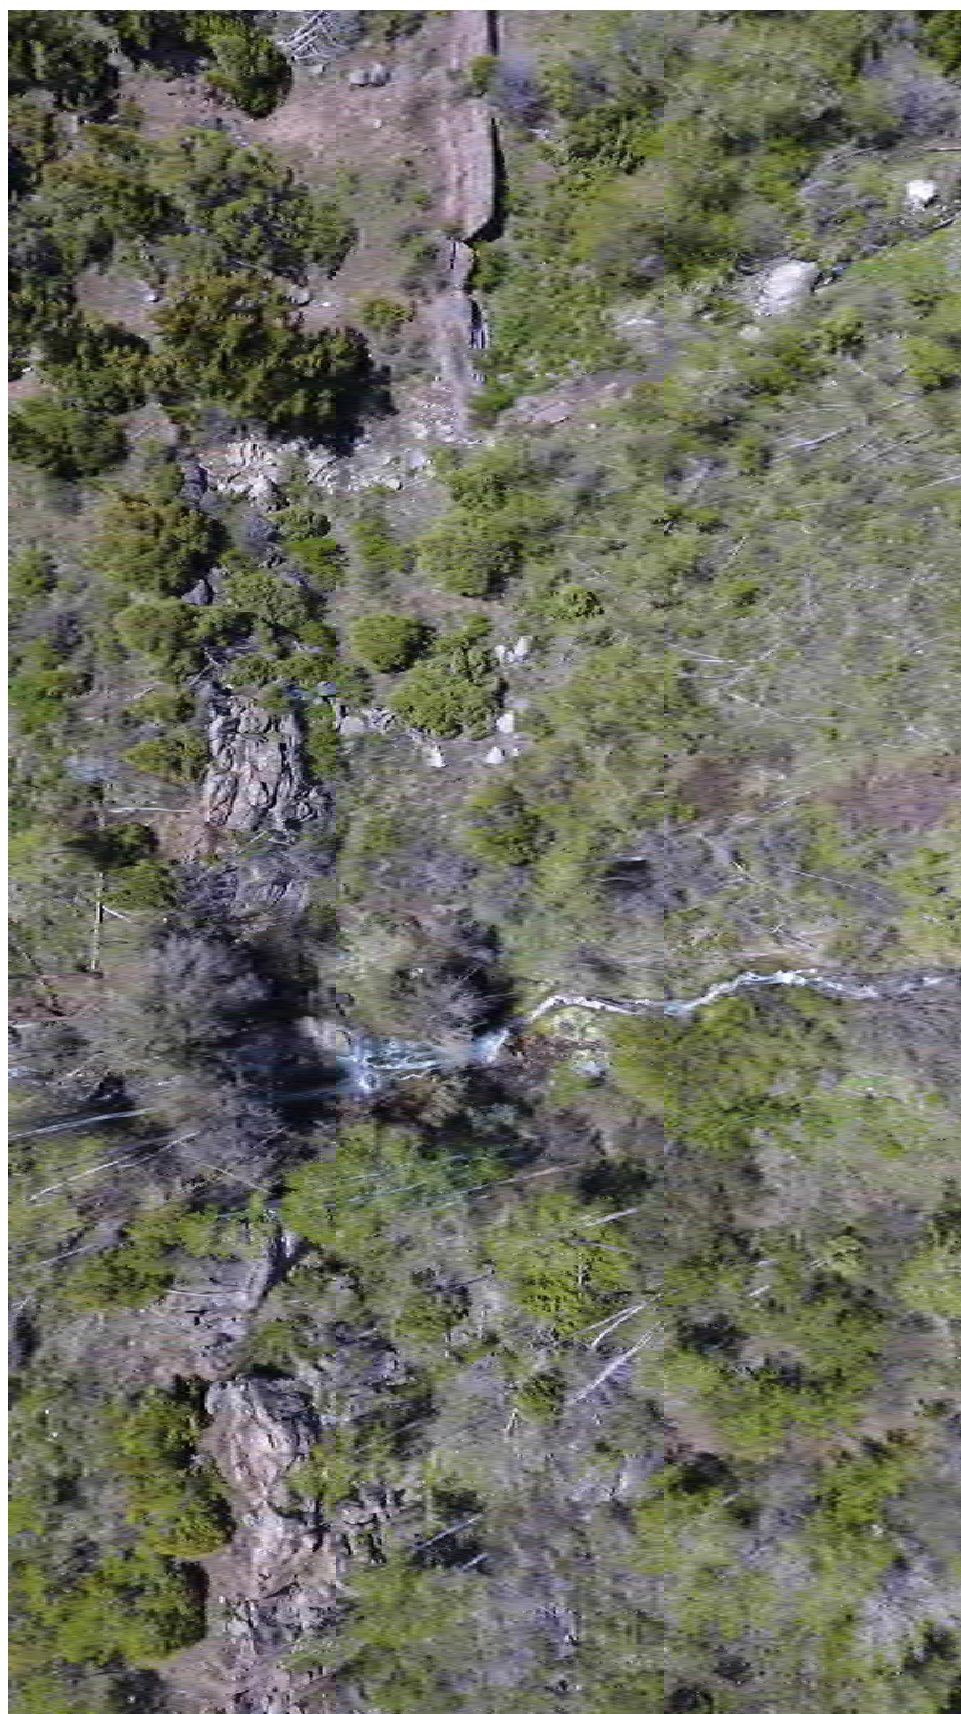
Photograph 18. Aerial view of the rockfall source zone. This photograph shows the steep cliff forming exposures of Robinson Limestone member of the Minturn Formation, dense vegetation in the form of trees and large shrubs, and flowing water in one of the drainages on the west side of the site. The bedrock exposures are fractured, blocky, and ledge-forming.

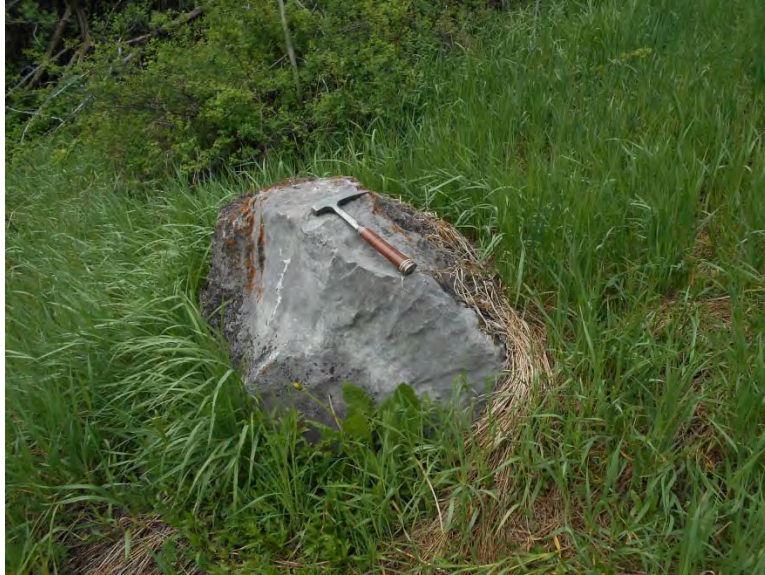
Photograph 19. View of limestone boulder, embedded. Blocky, angular, and about 3 feet in diameter. Boulders like this one are common on the property and are either embedded in the soil (older, ancient rockfall events) or are sitting on top of the soil with minimal soil embedment or vegetation overgrowth.

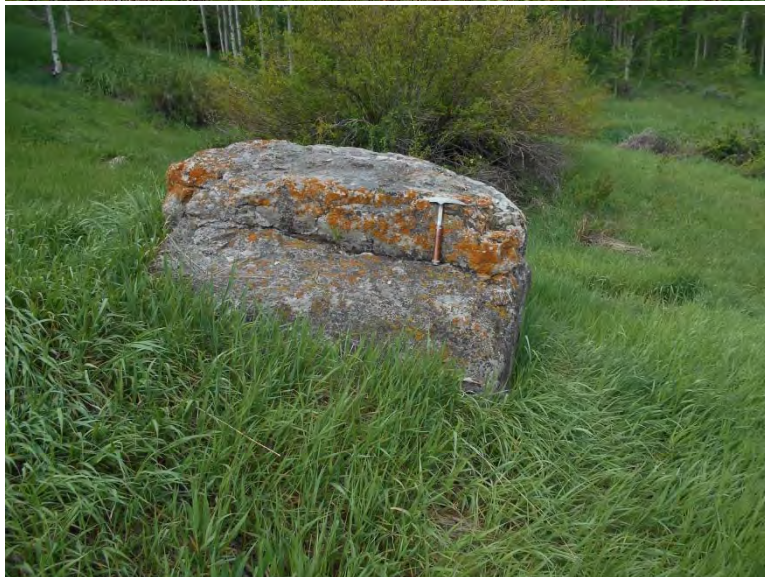
Photograph 20. Limestone boulder, embedded, lichen growth. Blocky, angular, and about 4 foot by 3 foot by 2 foot.

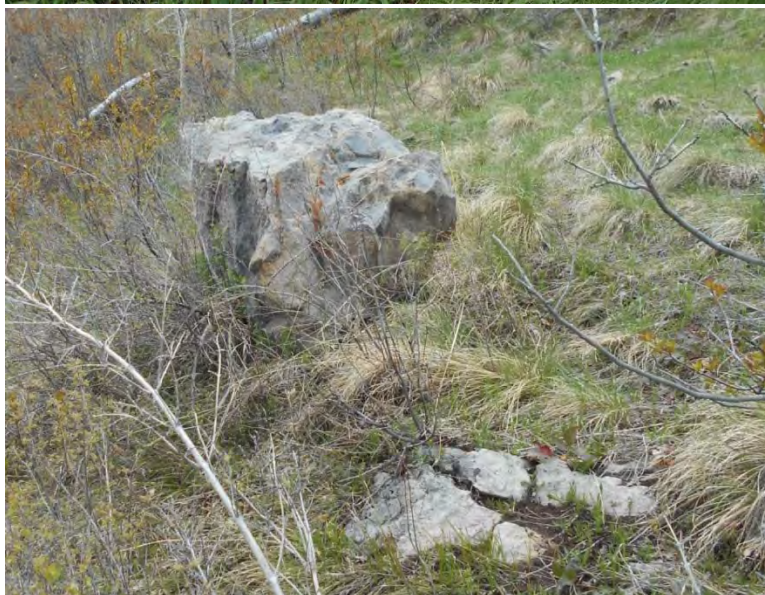
Photograph 21. Limestone boulder, minimal soil embedment. Blocky, angular, and about 3 feet in diameter.

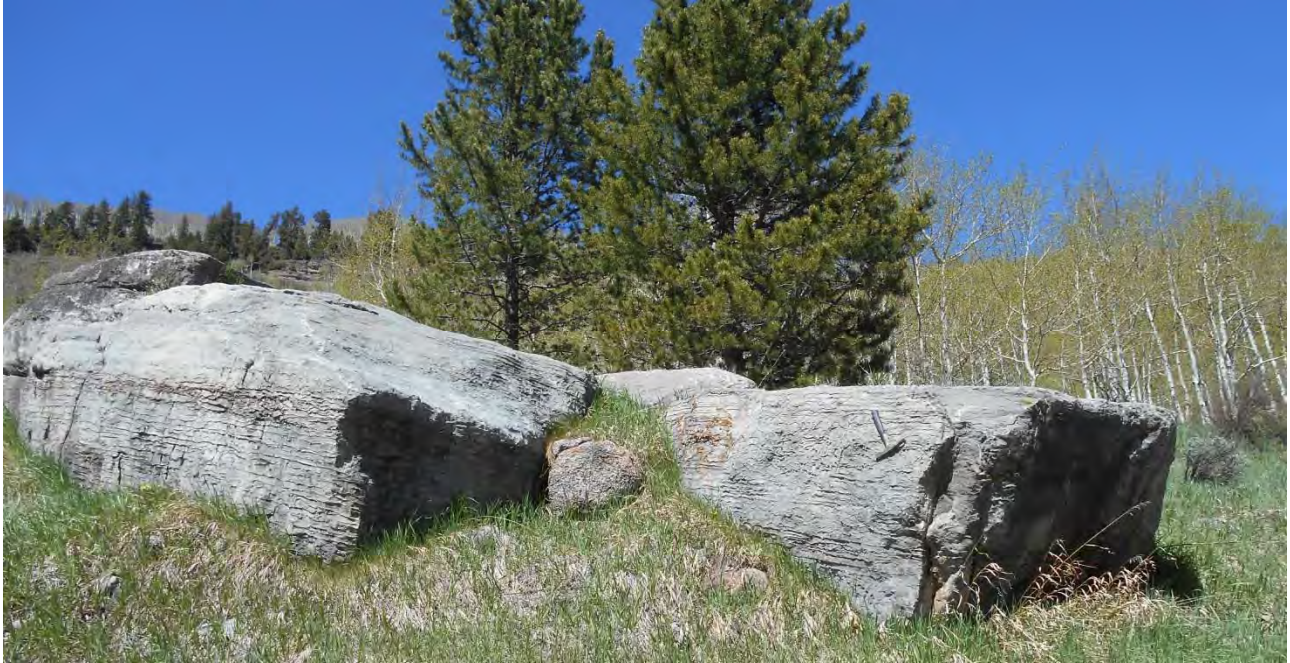
Photograph 22. View of large, angular, slab shaped boulders near the base of the slope within the area most likely to be developed in the future. Boulder sizes were observed to be at least (1) 12 foot by 8 foot by 5 foot, (2) 7 foot by 7 foot by 3 foot, and (3) 21 foot by 12 foot by 9 foot. These boulders are embedded in the soil and have been resting here for some time.
