ROCKFALL HAZARD STUDY

East Vail Parcel
Vail, Colorado

**Project No. 17.5029
June 19, 2017**

**ROCKFALL HAZARD STUDY
East Vail Parcel
Vail, Colorado**

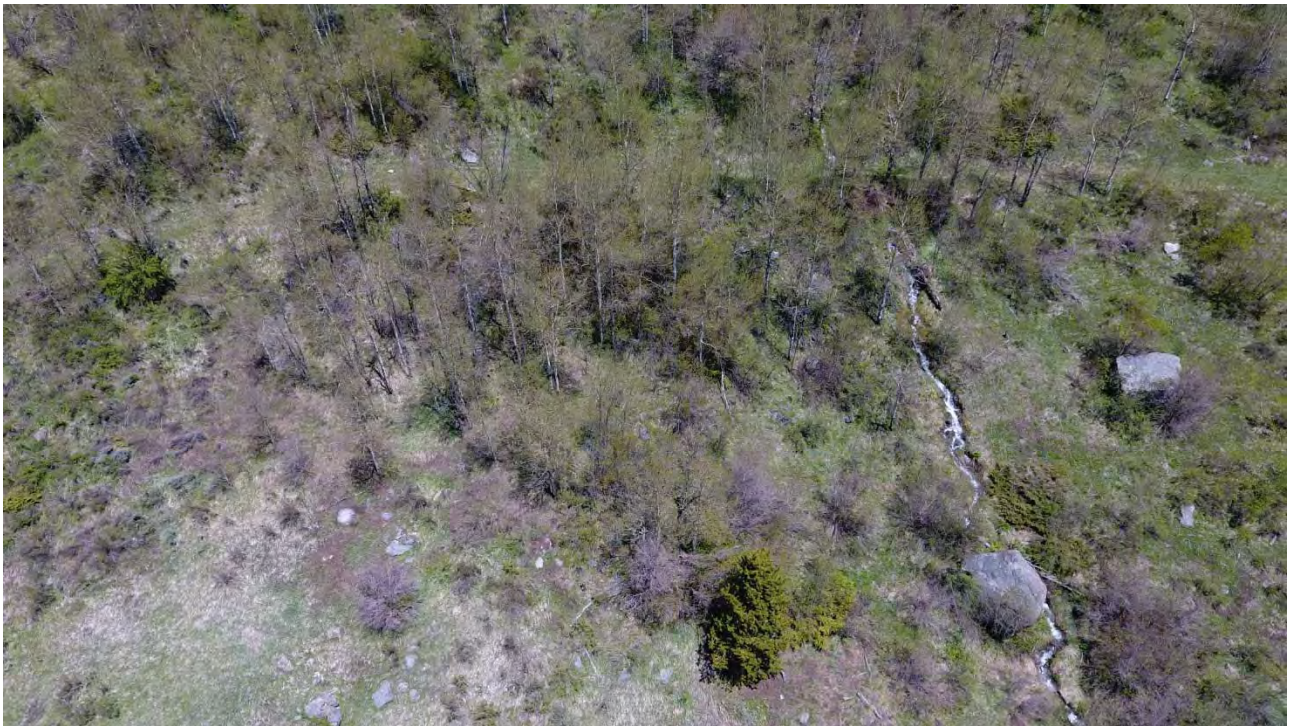
Photograph 23. Aerial view of lower slope in western part of the site. North is toward the top of the photograph. Notice scattered boulders as large as about 7 to 8 feet in longest dimension and slab shaped. Most boulders are 3 feet or less in dimension and are embedded in the soil, representing older, ancient rockfall events.
