PROJECT NO:	17.5029		
PROJECT NAME:	Rockfall Hazard Study, East Vail Parcel		
DRAWN BY:	RAB	CHECKED BY:	JMF
DWG DATE:	06.16.17	REV. DATE:	--

**ROCKFALL HAZARD ASSESSMENT AT BOOTH FALLS
CONDOMINIUMS
AND PROPOSED MITIGATION**

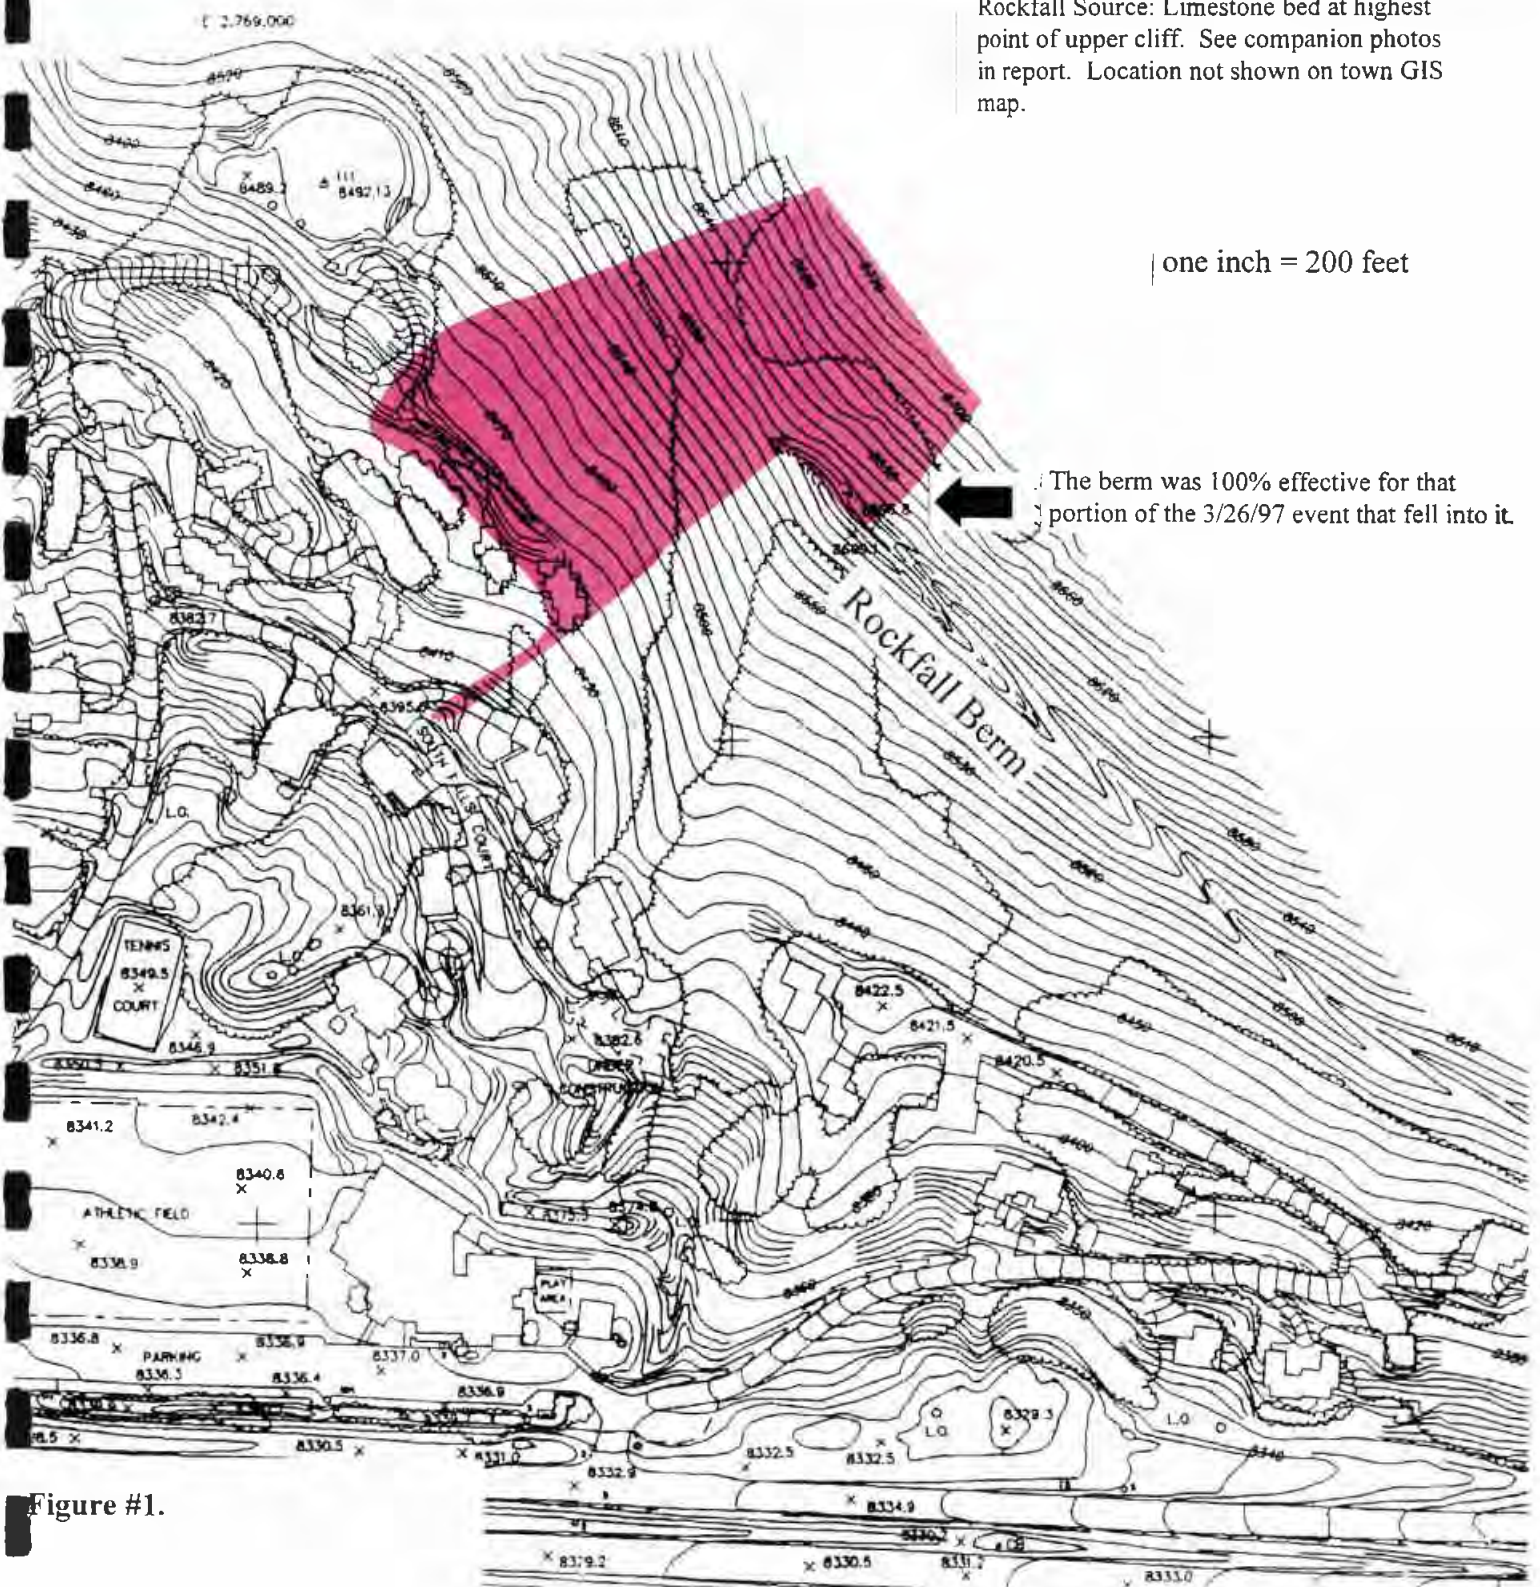
Approximately one third of the swath of rolling rocks were retained by the ditch and berm. See Figure #1. The remaining two-thirds of the event came to rest, scattered around the condominiums. The condo structures received three rock impacts and several near misses. Rock sizes ranged from 2 to 5+ feet in average diameter. Surrounding the condos several items were also damaged or destroyed, (i.e., small haul trailer, trampoline frame, small wooden deck and chairs, wood walkway). Of the three impacts, one was minor and the other two major. The minor impact was from a ~3 foot diameter rock that obviously had slowed almost to a stop upon impacting the westernmost condo structure. The rock came to rest, ominously so, next to a large boulder from an earlier rockfall. A major impact, also about 3-4 feet in diameter at high velocity, had just missed the ditch and berm catchment. The rock impacted and smashed the corner of the easternmost condo, snapped off the side balcony support, and destroyed a trampoline frame along its path before coming to rest in the subdivision below. The third and worst impact was a 5+ foot block that broadsided the easternmost condo. Sufficient rock velocity enabled the boulder to smash through the outside wall, interior walls, and the floor, finally being caught in the crawlspace below. Luckily the resident, whose bedroom this rock smashed through, was not home at the time of the rockfall.

The berm was 100% effective for that
portion of the 3/26/97 event that fell into it.

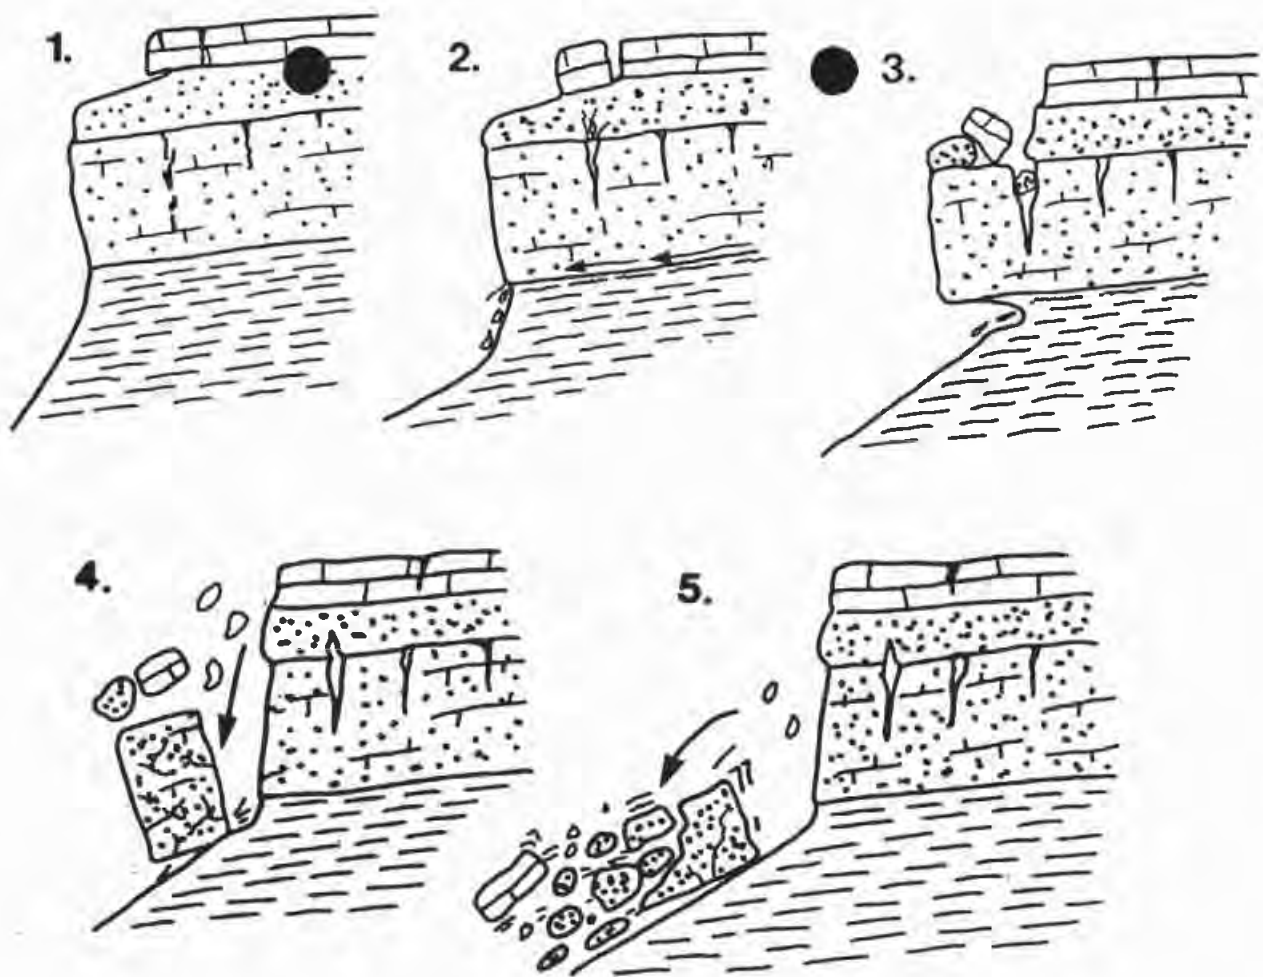
Joint patterns in the cliff forming rocks are caused by stress relief and physical properties of the rock. The joints so formed define planar, vertical cliff faces and act to separate large sections of the cliff into slabs along joints subparallel to the cliff face. Once a slab has detached from the sedimentary bed, it begins to creep outwards owing to gravity and frost wedging in the joints. The joints widen with time, and are often wedged farther apart by tree roots, and smaller rocks that fall into the cracks formed by the joints. (Figure 3)

Figure 3. Toppling Slab-failure Sequence. 1. Initial cliff configuration. 2. Differential weathering of soft shale begins to undercut massive cliff forming slabs. Joints open and widen due to slope creep and frost wedging. Springs issue from contact beneath cliff. 3. Undercutting continues. Joints widen and are wedged open by smaller rocks, causing slab to tilt outwards. 4. Slab falls from cliff face onto acceleration slopes, bringing down overlying rocks. 5. Slab topples and shatters, showering runout zone below with boulders, and exposing new cliff face to erosion.
