ROCKFALL HAZARD STUDY

East Vail Parcel
Vail, Colorado

Project No. 17.5029
June 19, 2017

**Julia M. Frazier, P.G.
Senior Geologist**

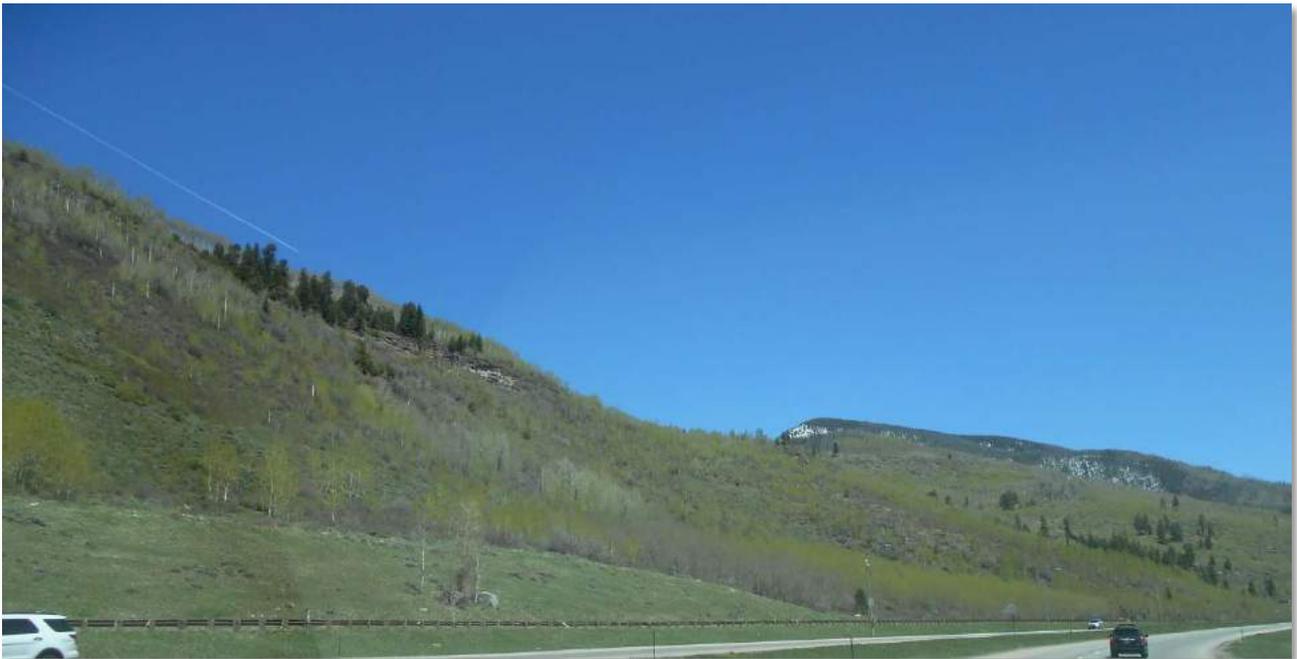
Photograph 1. View of the project site. Photograph taken from the eastbound lane of I-70 looking east across the site. The photograph shows the relatively steep slope of the site and the rock outcrops present upslope from the site.

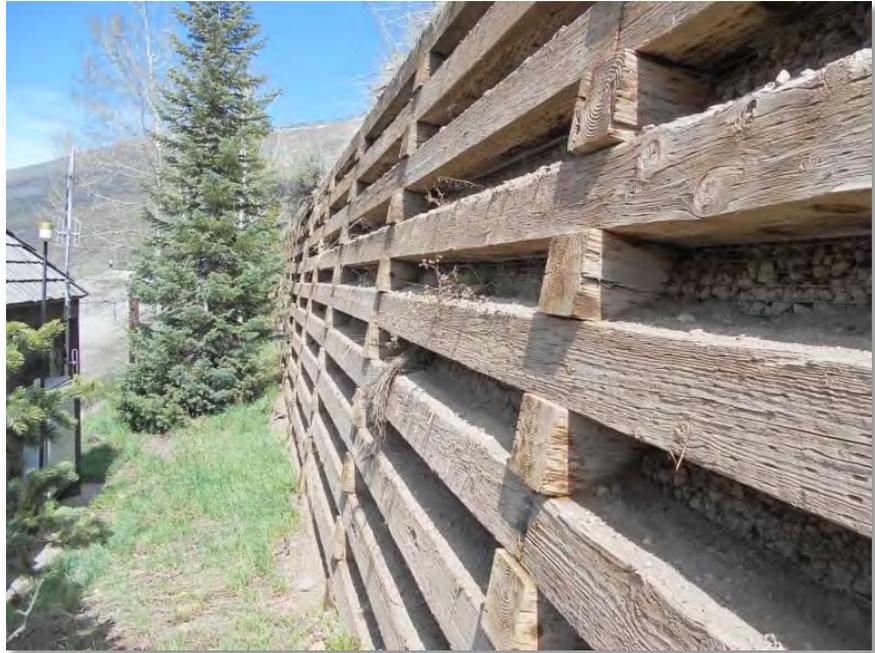
Photograph 2. View of retaining wall located along edge of site that borders Fall Line Drive. Town of Vail shuttle stop is visible in the left side of the photograph.

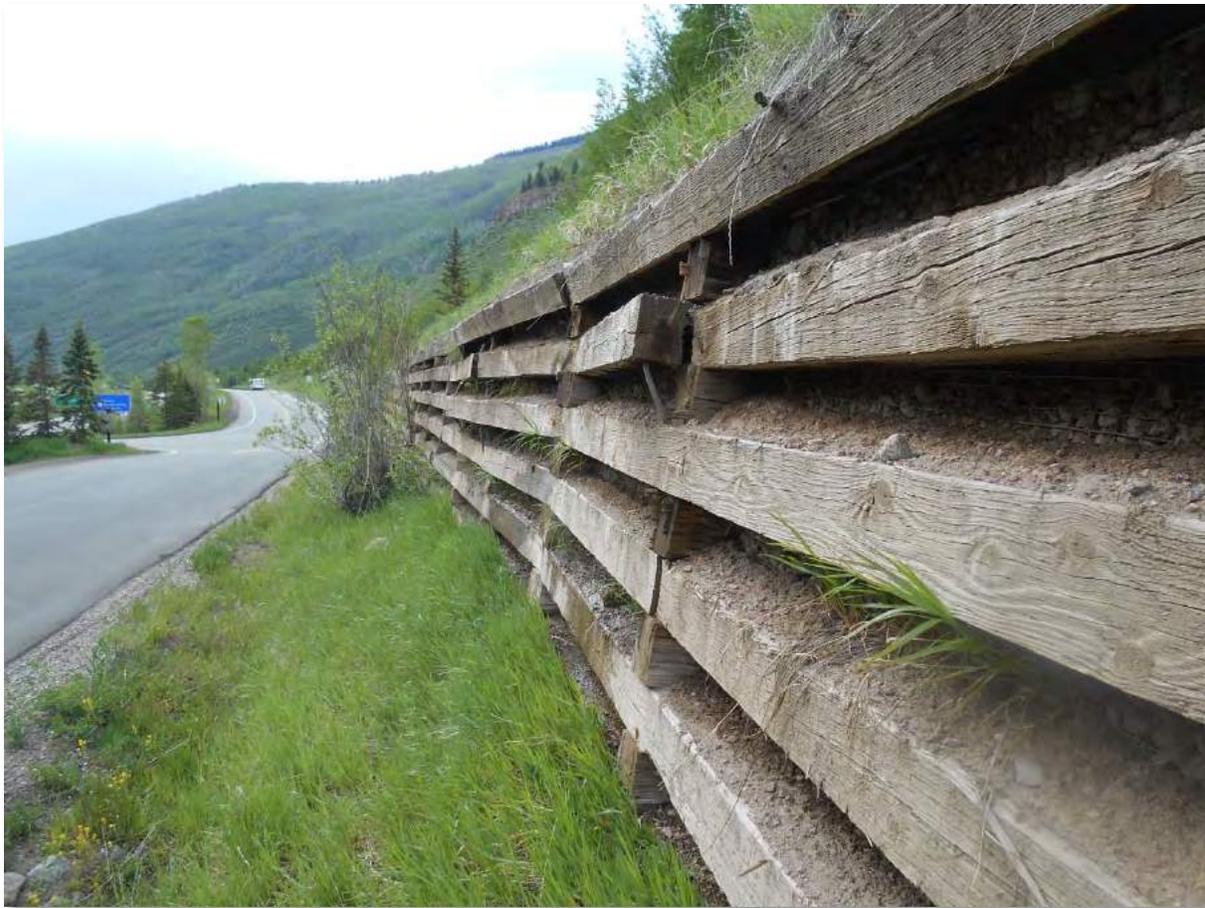
Photograph 3. View of distressed part of the retaining wall along the edge of the site that borders Fall Line Drive. The slope rises steeply upward to the north at the top of the wall. This photograph was taken near the east end of the wall.

Cesare did not observe evidence of recent landslide movement at the project site. The retaining wall for the Town of Vail shuttle stop which is located at the toe of the landslide, appears to be performing adequately. The landslide area displays benched and hummocky topography with over-steepened toe and flank areas, however, fresh landslide features, such as tension cracks, scarps, slumps, and other features, were not observed. Figure 7 shows the bare earth land surface and provides a convincing depiction of the landslide extents. Cesare is not aware of landslide movement causing distress to the townhomes in the Pitkin Creek subdivision notched into the toe near the southeast corner of the site.

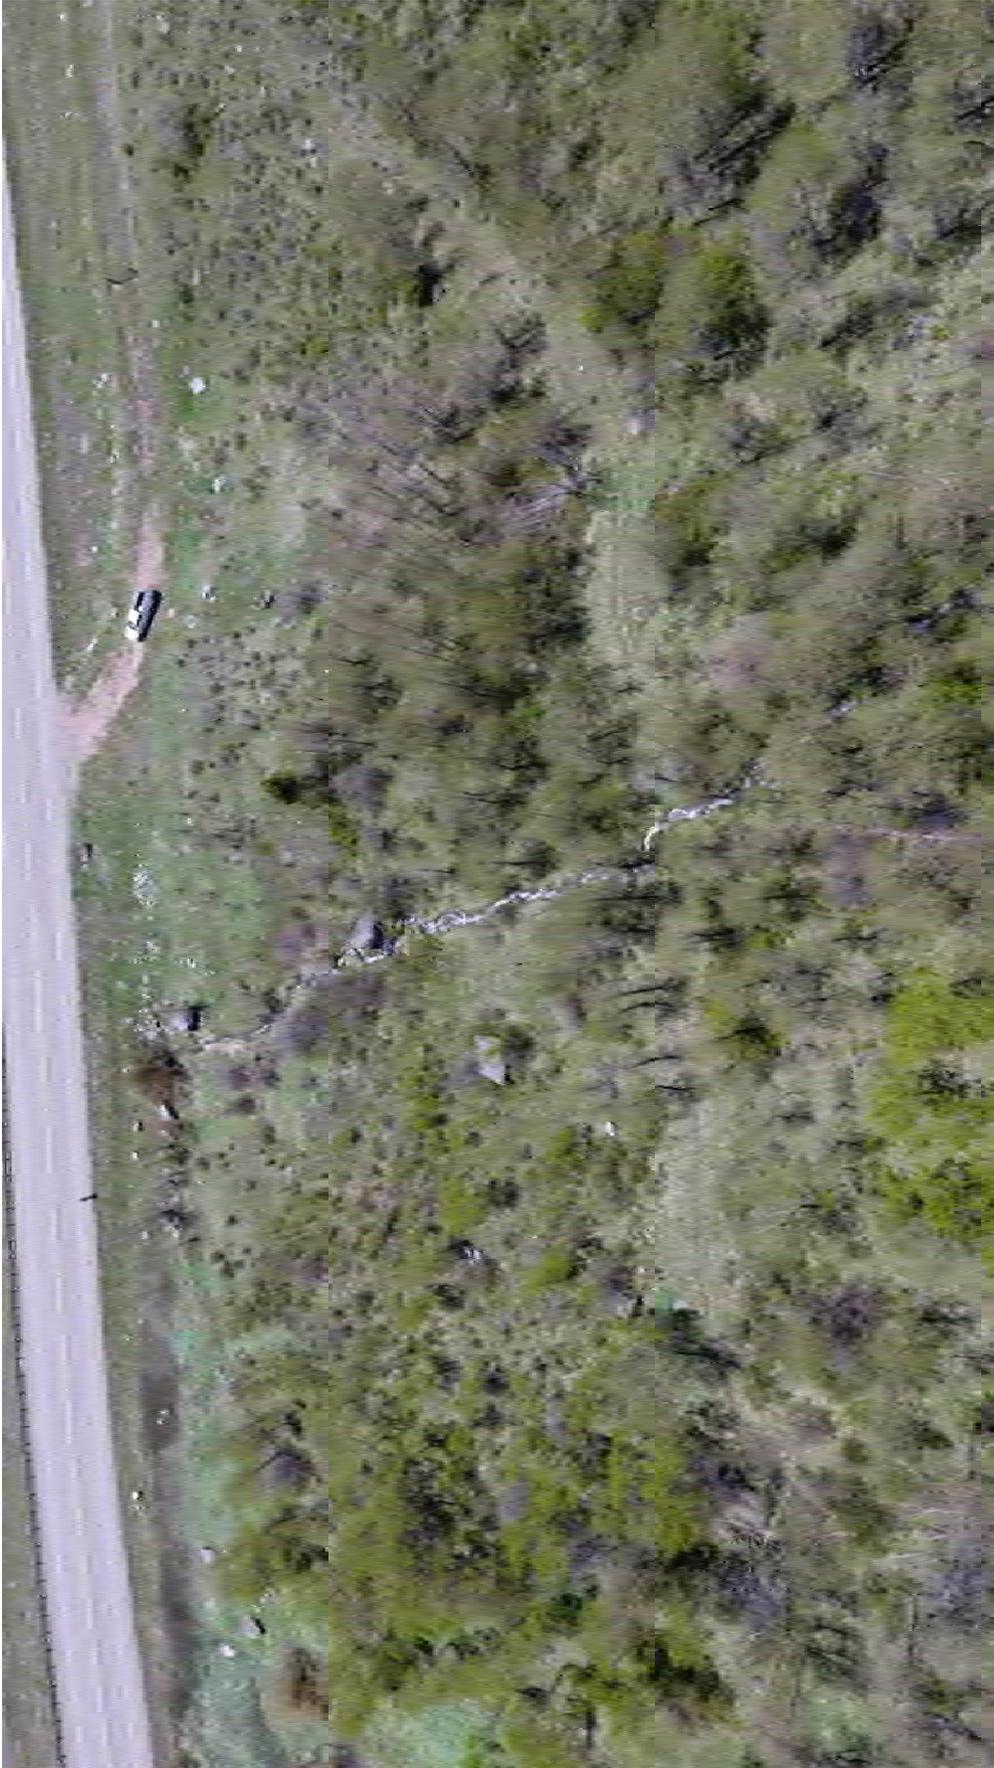
Photograph 4. Aerial view of the west side of the site. The single track road that traverses the site is visible, along with one of the drainages onsite (with flowing water). The white Cesare truck is parked at the beginning of the access road for the rockfall berm, constructed on the neighboring property to the west (Booth Creek). Large, gray limestone boulders which have come to rest on the lower slope are visible in the photograph.

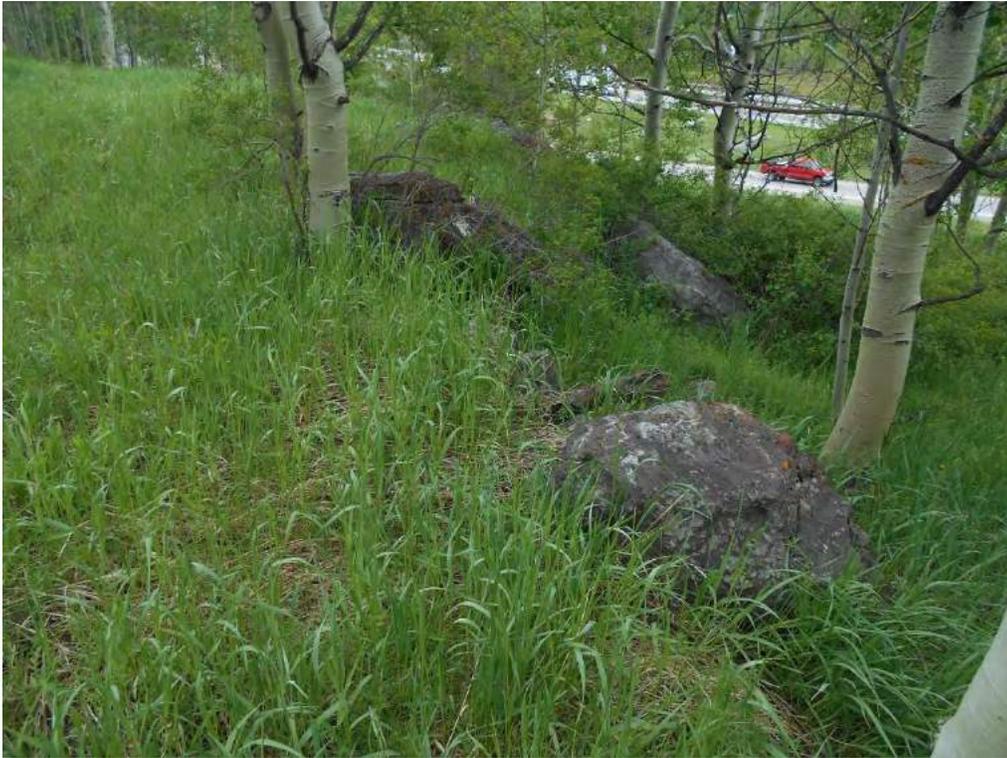
Photograph 5. View of limestone boulders which have come to rest near the base of the slope in the western part of the site. Boulders are about 3 to 4 feet in longest dimension, embedded in the soil, surrounded by mature vegetation, and show lichen on the surface.

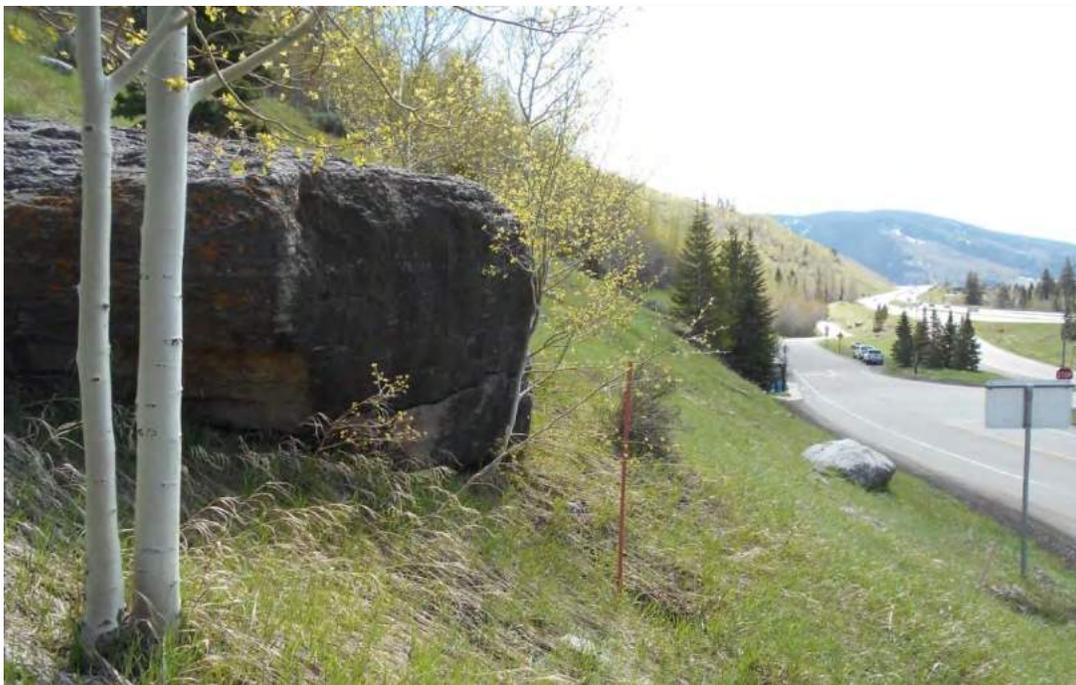
Photograph 6. View of large sized limestone boulder located in the southern area of the site. Boulder measures about 21 feet long by 16 feet wide by 6 feet high. A survey marker has been placed on this boulder (Eagle County Survey Control, 1998).

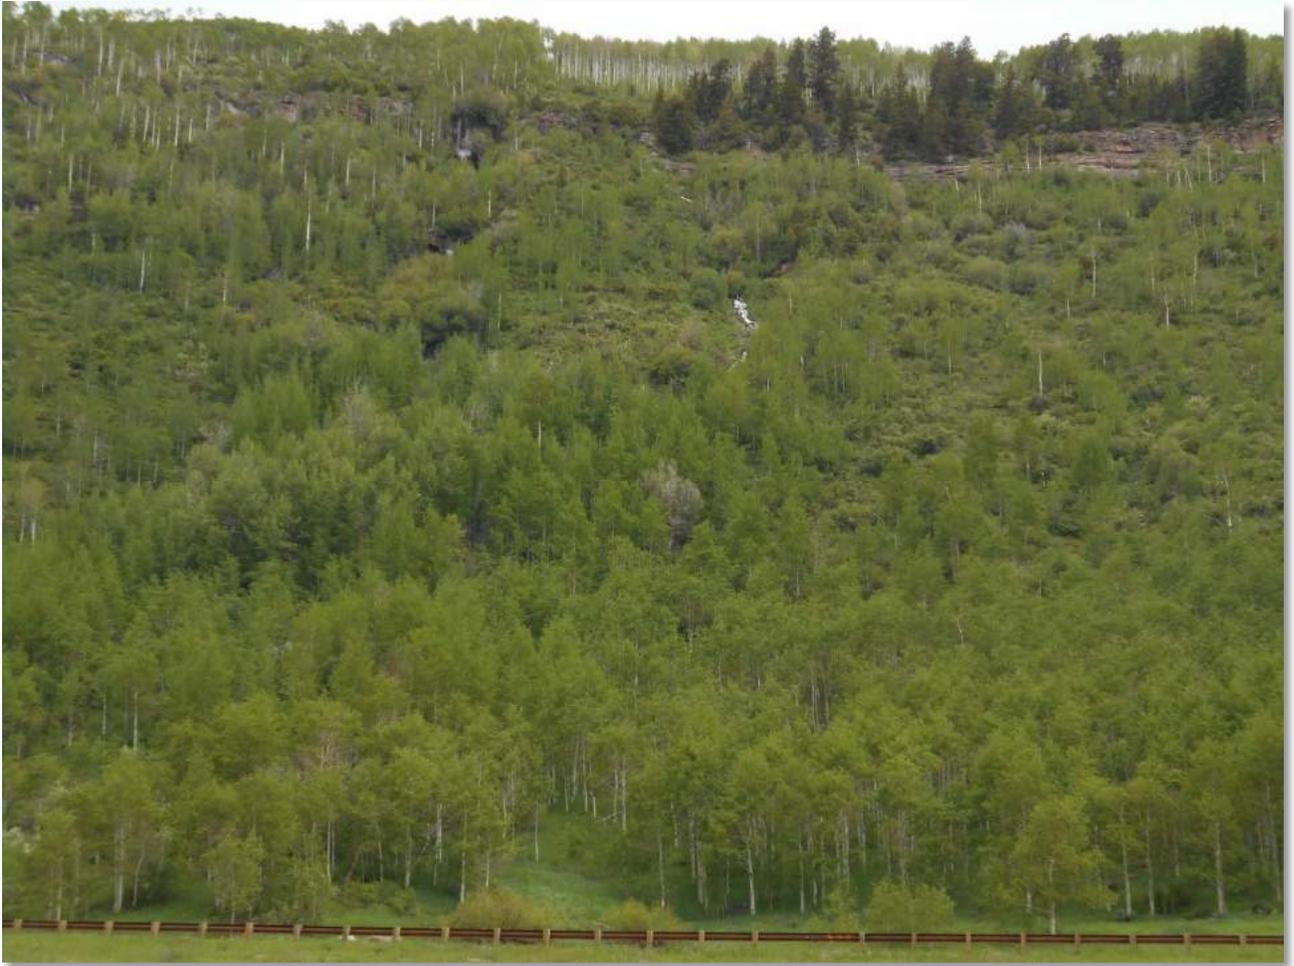
Photograph 7. View of the western part of the site. Note the dense vegetative cover, flowing water, and exposed bedrock outcrops near the top of the slope.

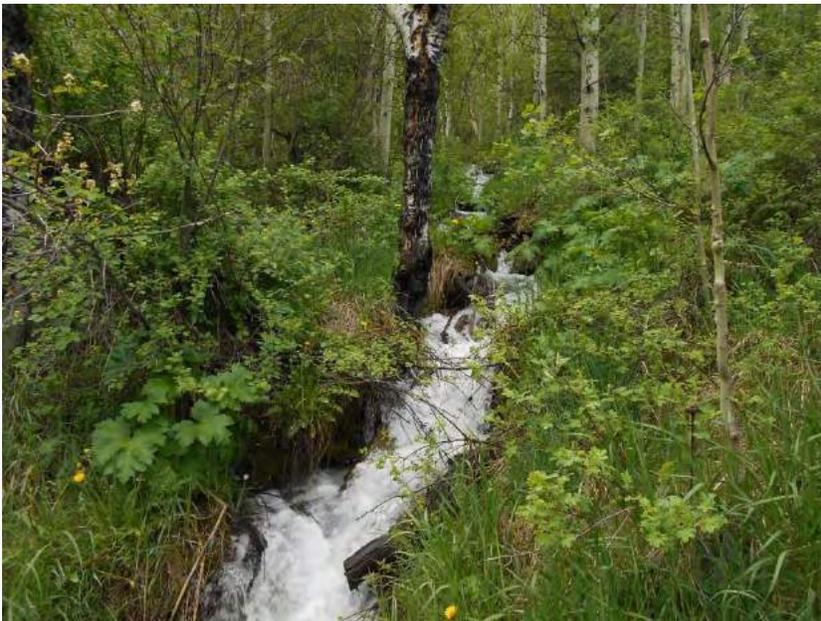
Photograph 8. View of flowing water in the western part of the site.

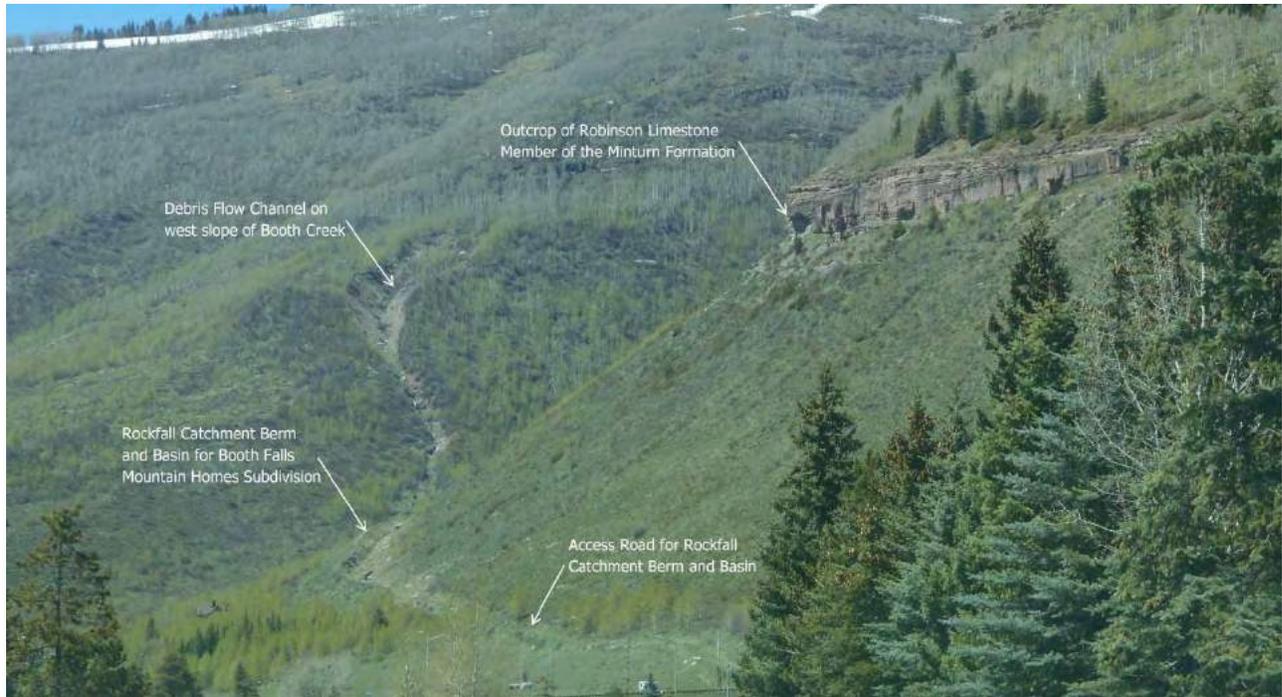
Photograph 12. View looking west toward Booth Creek. The project site is located beyond the trees in the right side of the photograph. Features are labeled.

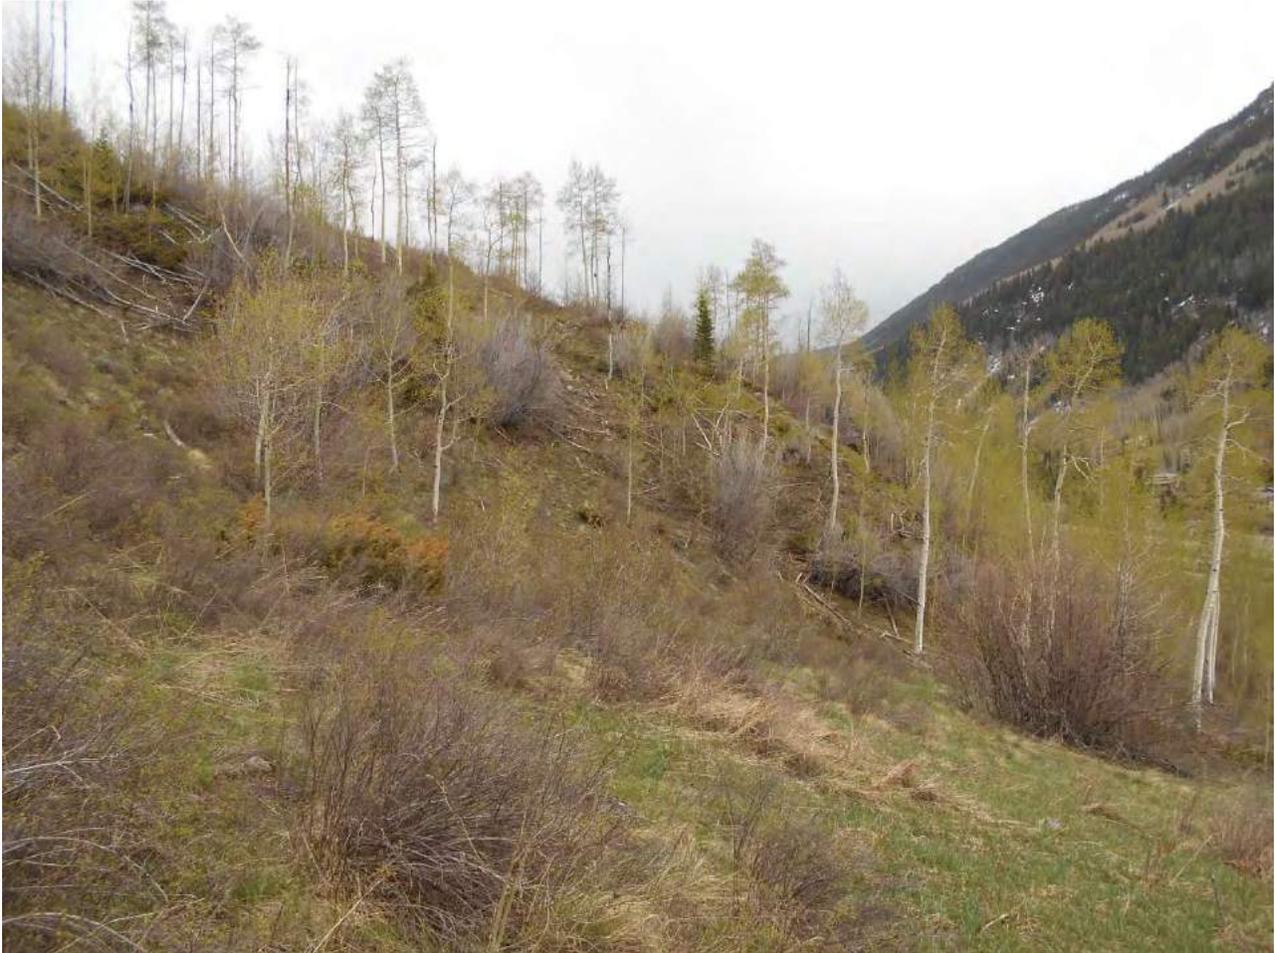
Photograph 13. View looking eastward from the western flank of the landslide toe. The ground surface is relatively steep along the toe and flanks of the slide mass, visible in the photograph.

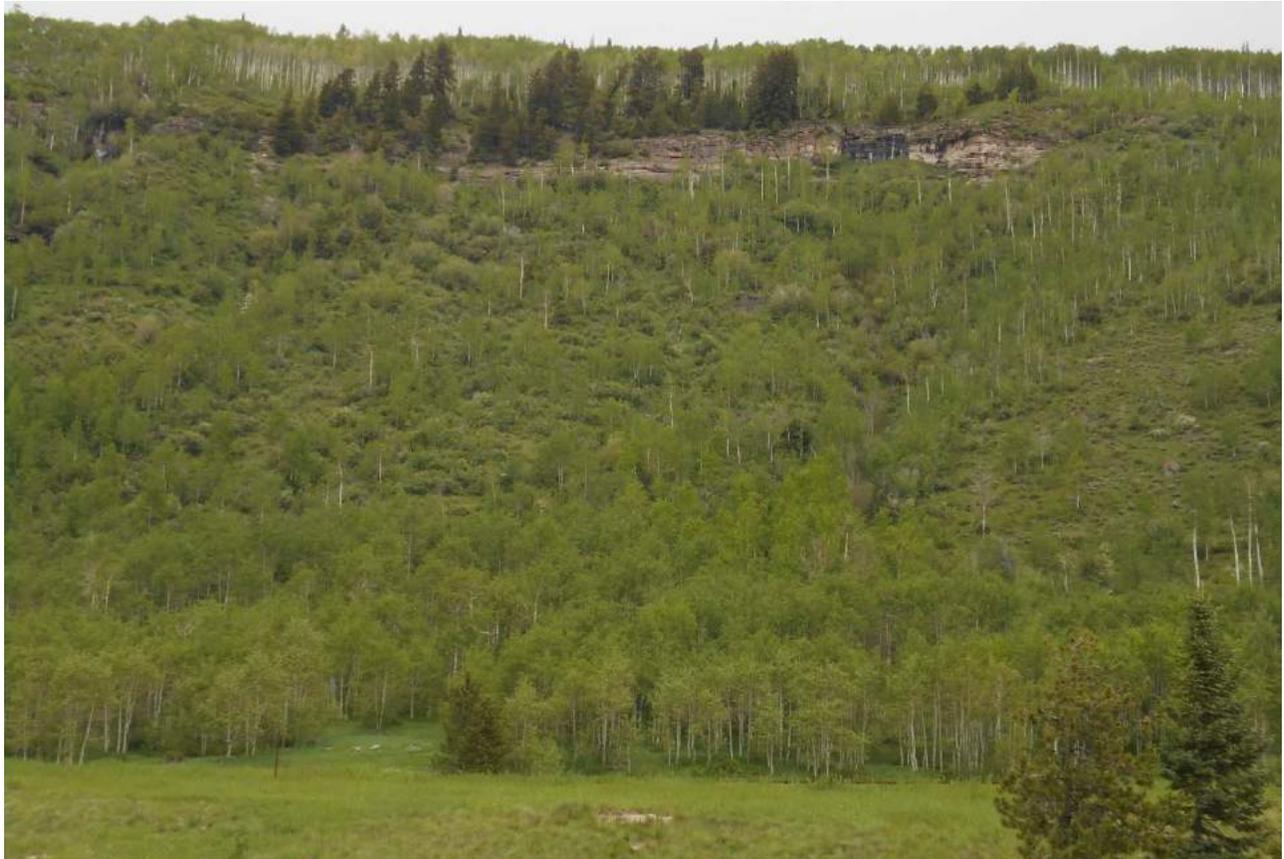
Photograph 14. View looking upslope along the rockfall study section. Notable features include the limestone bedrock exposures visible at the top of the slope and the dense vegetation on the slope. The limestone bedrock forming the cliffs at the top of the slope are considered the primary rockfall source zone.

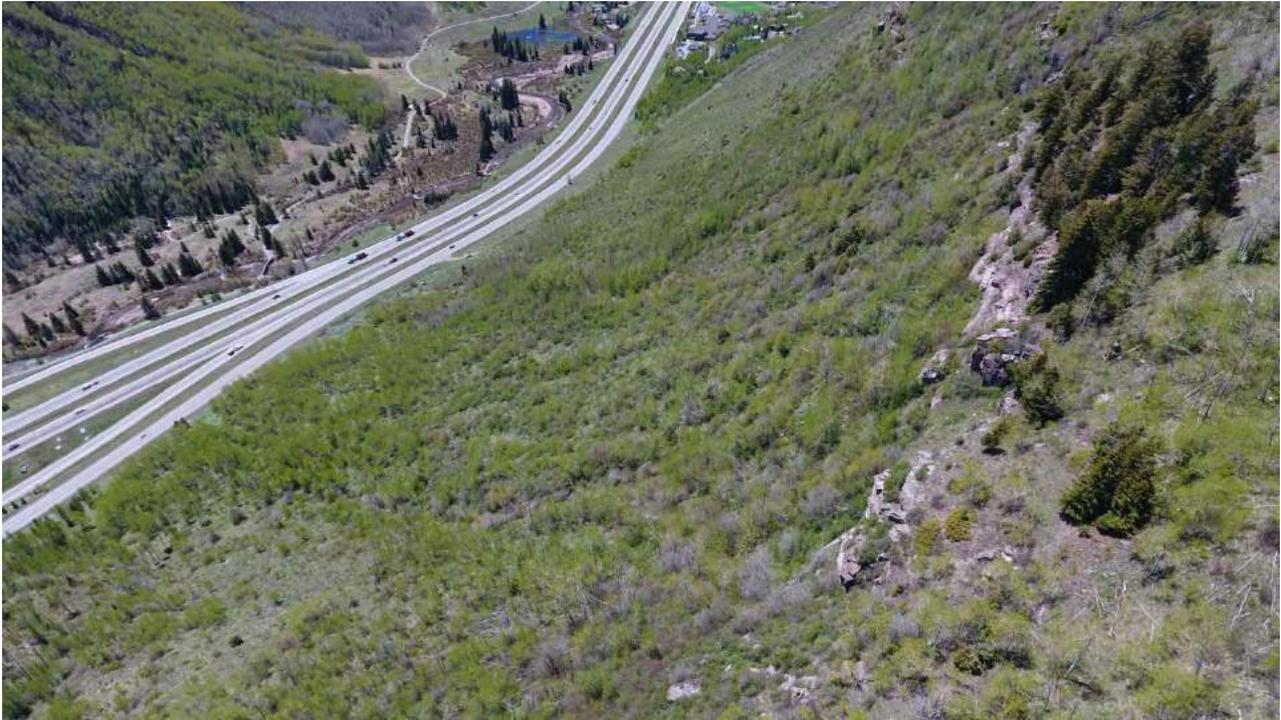
Photograph 15. View looking downslope along the rockfall study section. Notable features include the rock exposures visible at the top of the slope, the steepness of the slope, and the density of the vegetation. Fall Line Drive, I-70, and East Vail are visible in the background.

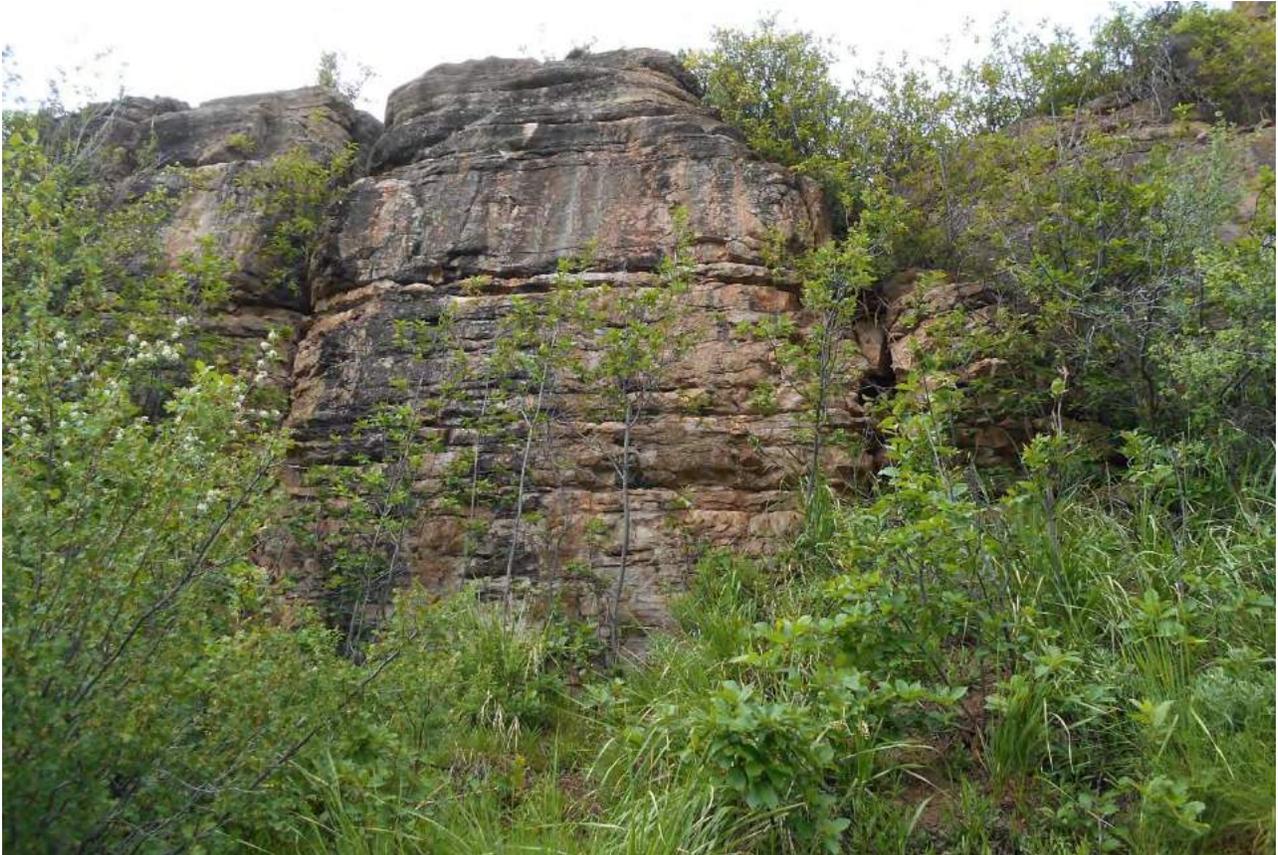
Photograph 16. View of limestone bedrock exposure at the primary rockfall source zone. Note the eroding shale partings and vertical fractures (spaced about 10 to 15 feet apart).

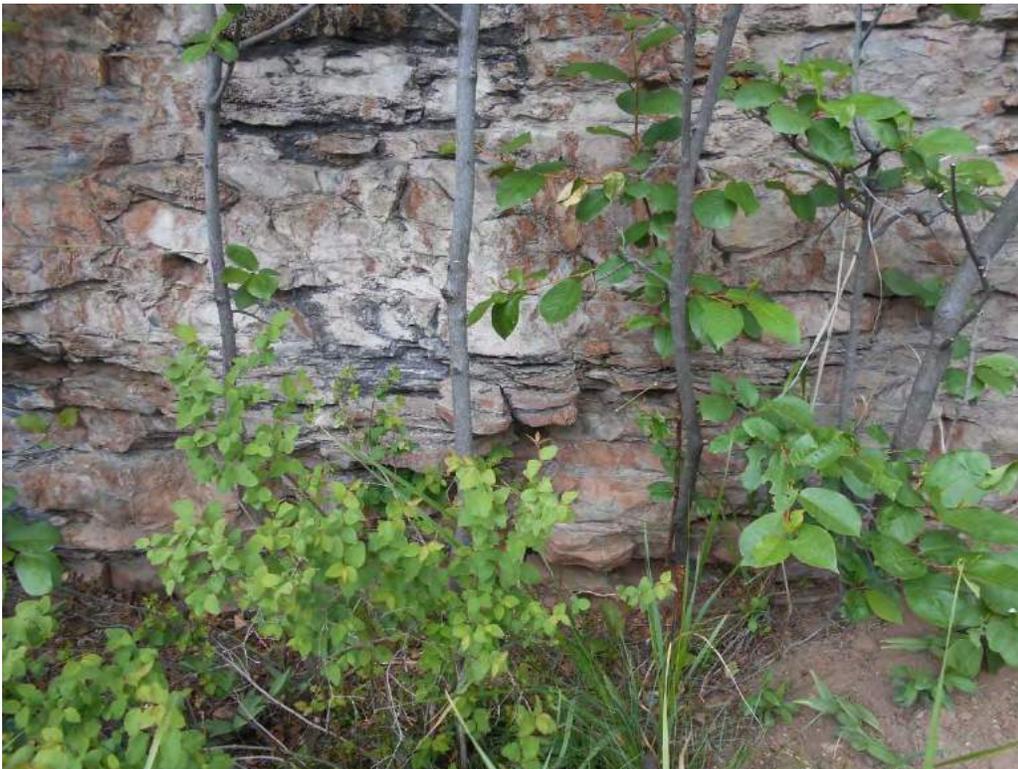
Photograph 17. Close-up view of primary rockfall source zone bedrock. Gray, hard limestone interbedded with thin, weak shale layers.

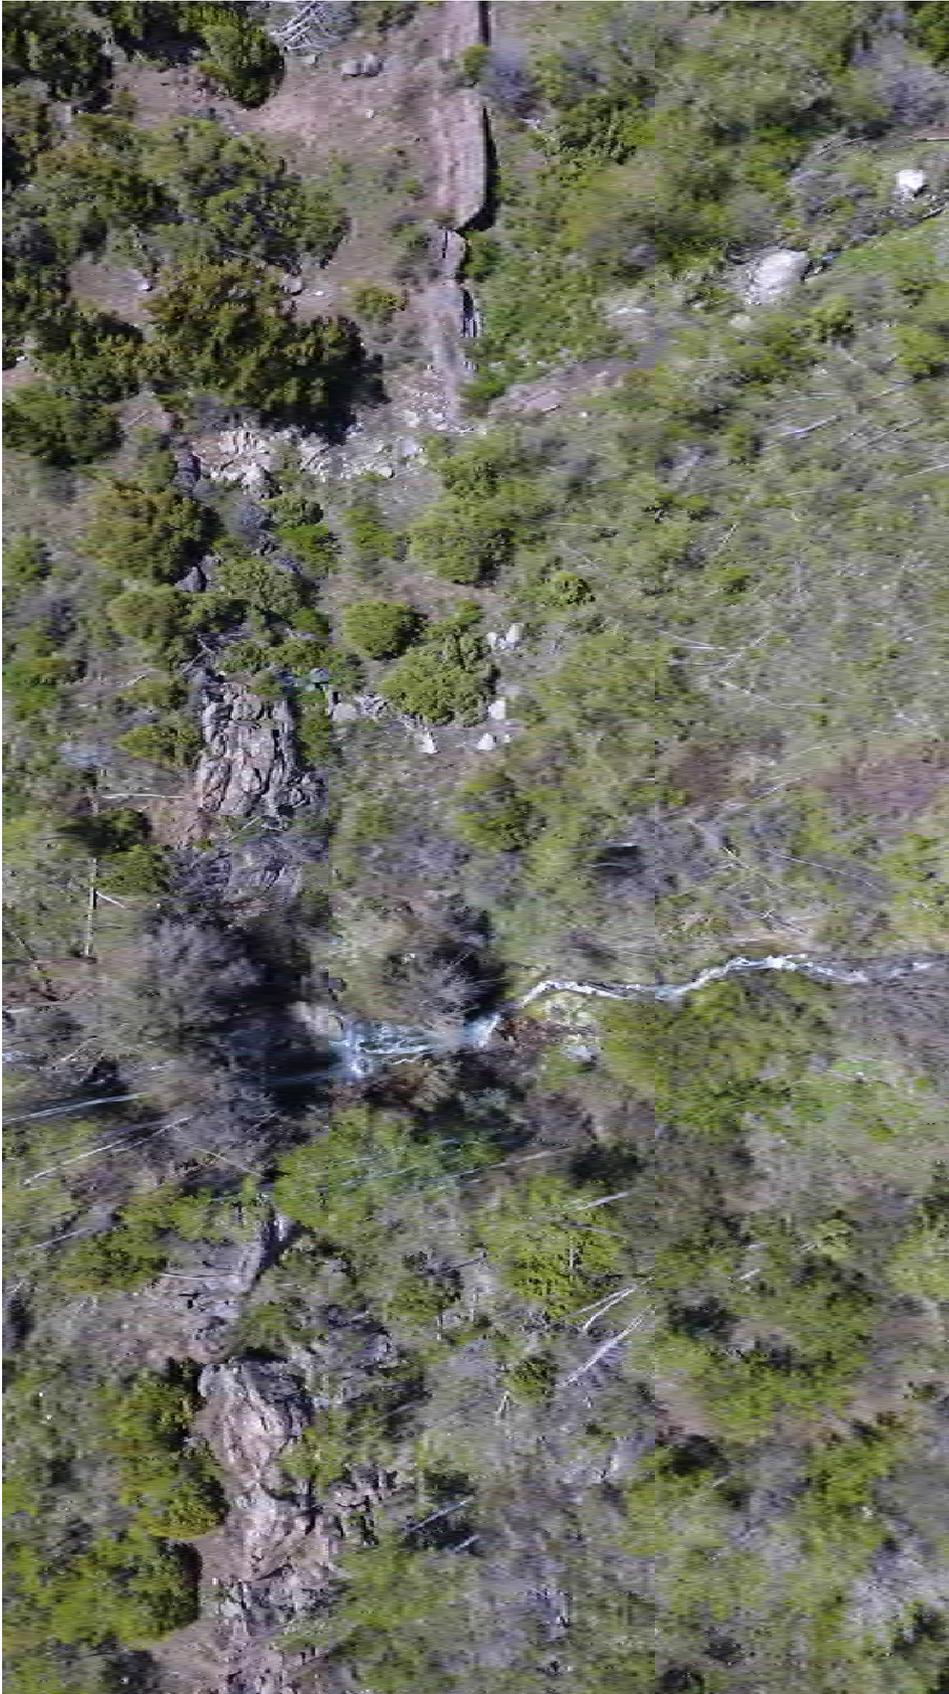
Photograph 18. Aerial view of the rockfall source zone. This photograph shows the steep cliff forming exposures of Robinson Limestone member of the Minturn Formation, dense vegetation in the form of trees and large shrubs, and flowing water in one of the drainages on the west side of the site. The bedrock exposures are fractured, blocky, and ledge-forming.

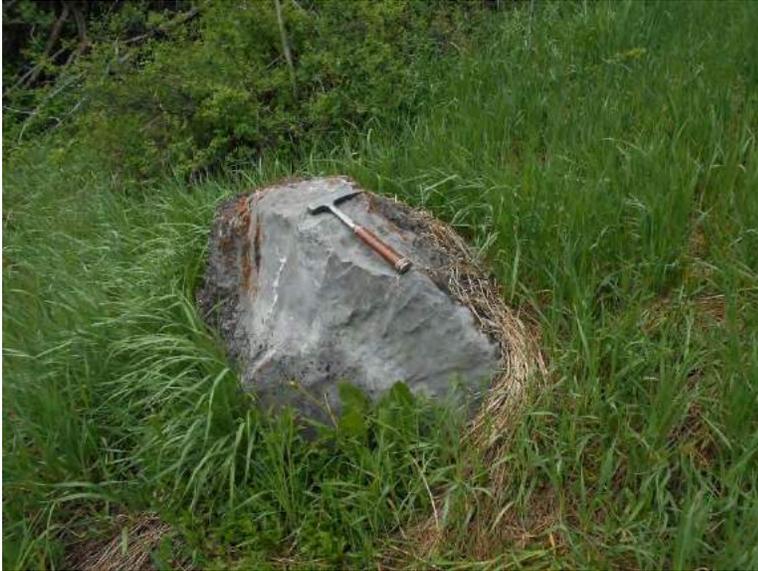
Photograph 19. View of limestone boulder, embedded. Blocky, angular, and about 3 feet in diameter. Boulders like this one are common on the property and are either embedded in the soil (older, ancient rockfall events) or are sitting on top of the soil with minimal soil embedment or vegetation overgrowth.

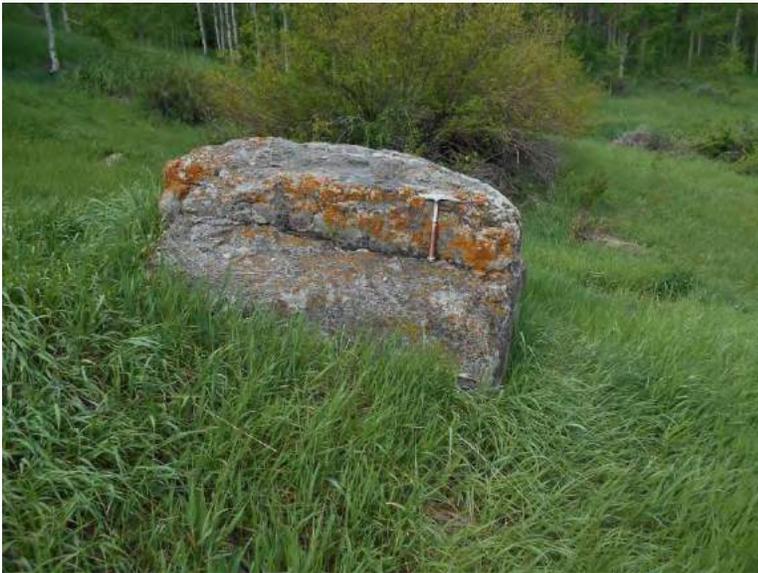
Photograph 20. Limestone boulder, embedded, lichen growth. Blocky, angular, and about 4 foot by 3 foot by 2 foot.

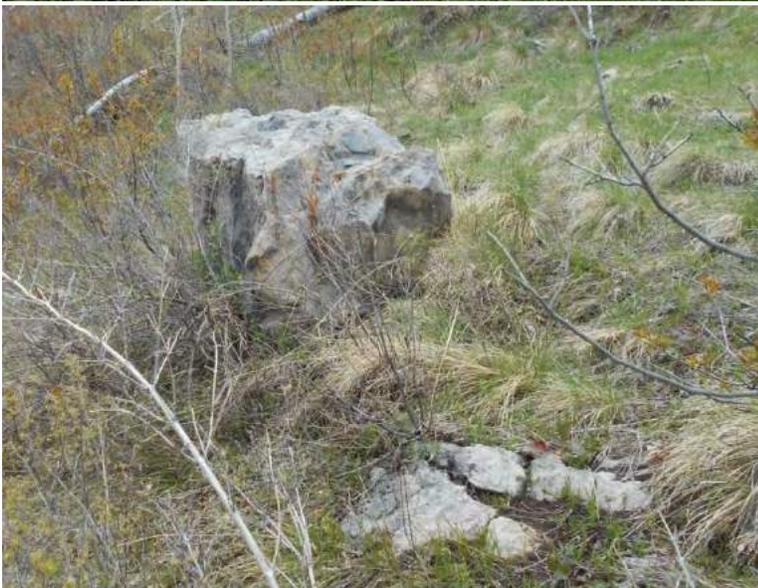
Photograph 21. Limestone boulder, minimal soil embedment. Blocky, angular, and about 3 feet in diameter.

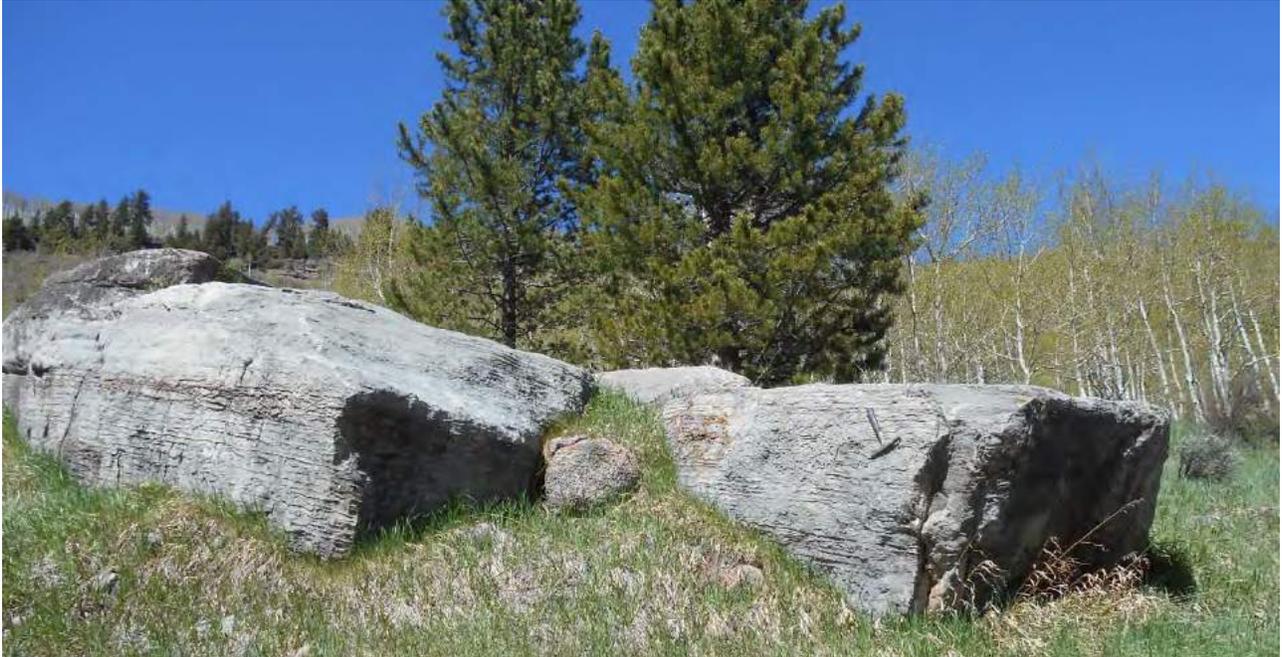
Photograph 22. View of large, angular, slab shaped boulders near the base of the slope within the area most likely to be developed in the future. Boulder sizes were observed to be at least (1) 12 foot by 8 foot by 5 foot, (2) 7 foot by 7 foot by 3 foot, and (3) 21 foot by 12 foot by 9 foot. These boulders are embedded in the soil and have been resting here for some time.

Based on the CRSP analysis results and existing rockfall mitigation structures on the neighboring site to the west, a rockfall barrier or wall at least 12 feet in height is recommended. Based on site conditions, including such aspects as slope angle and property boundaries, a rigid wall would be more ideal than a flexible fence or berm/basin. The flexible fence system would require a downslope buffer zone for flexure during rockfall events. A berm and basin system would require a significantly sized footprint on the slope, something this project site does not necessarily have flexibility towards. Cesare's CRSP model represents an estimate of rockfall energies at the analysis point placed at the upslope property boundary along the section line and is not representative of other locations on the slope. Changing the placement of the rockfall barrier will require changing the location of the analysis point. Rockfall energies were modeled to be significantly higher at Analysis Point 1 located 200 feet upslope from the property.

A catchment zone large enough for accumulation of boulders and for equipment to access the area behind the barrier will be necessary, a width of at least 10 or more feet. It is the responsibility of the wall designer to provide criteria for a wall that will withstand impacts with the sizes and energies predicted by the CRSP analysis, and one which will allow for successful implementation of recommended maintenance requirements. For rigid rockfall walls similar to those constructed at the Booth Falls site, the height to width ratio is typically a 1:1 relationship. The rockfall catchment will be reducing the rockfall hazard for a potential residential development and should be designed with consideration for the nature of the structures (full-time occupancy).

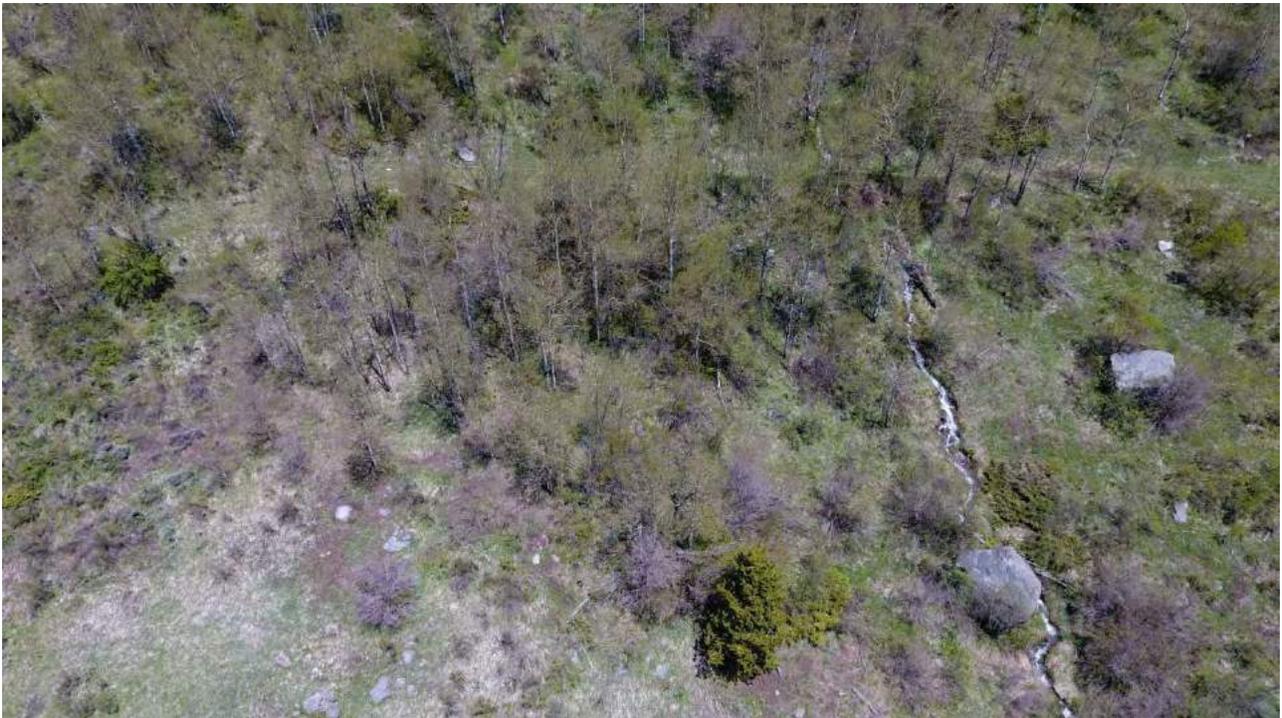
Photograph 23. Aerial view of lower slope in western part of the site. North is toward the top of the photograph. Notice scattered boulders as large as about 7 to 8 feet in longest dimension and slab shaped. Most boulders are 3 feet or less in dimension and are embedded in the soil, representing older, ancient rockfall events.

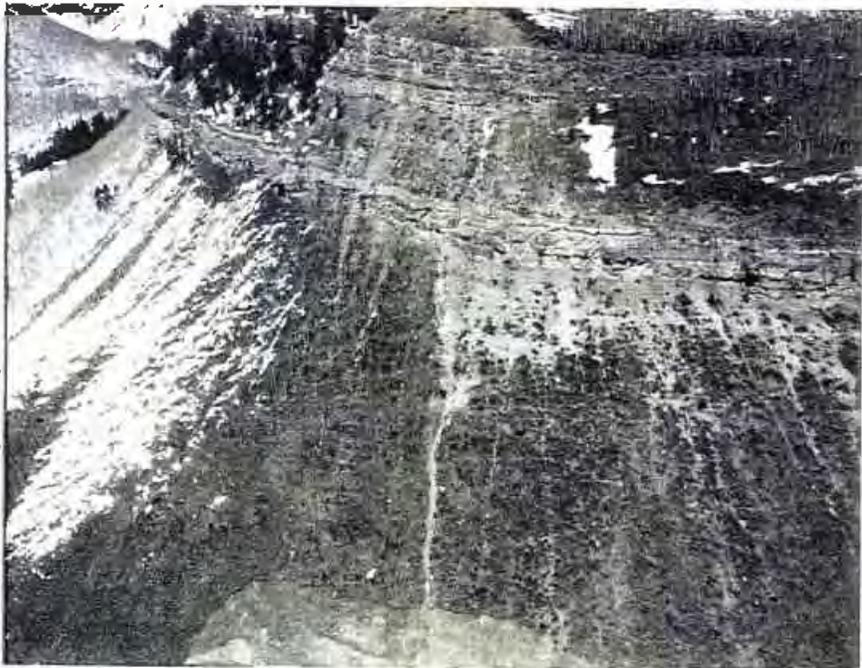
Photo #1. Booth Creek rockfall source area. Note enlargement of upper cliff exposure and corresponding rockfall source area, northwest of the ditch and berm terminus.

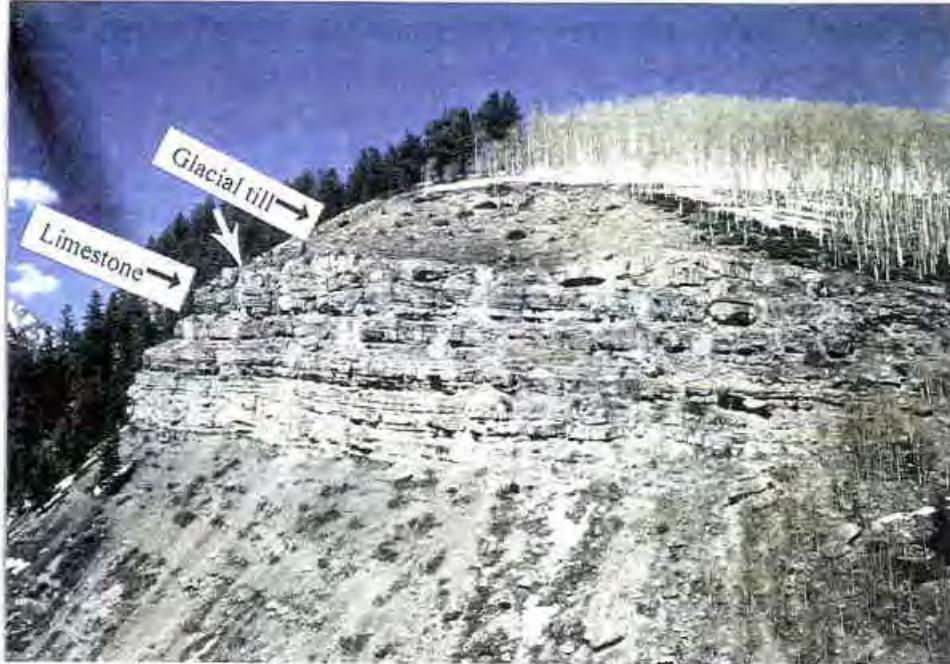
Photo #2. Top cliff rockfall source area. White arrow marks location of March 26, 1997 rockfall.

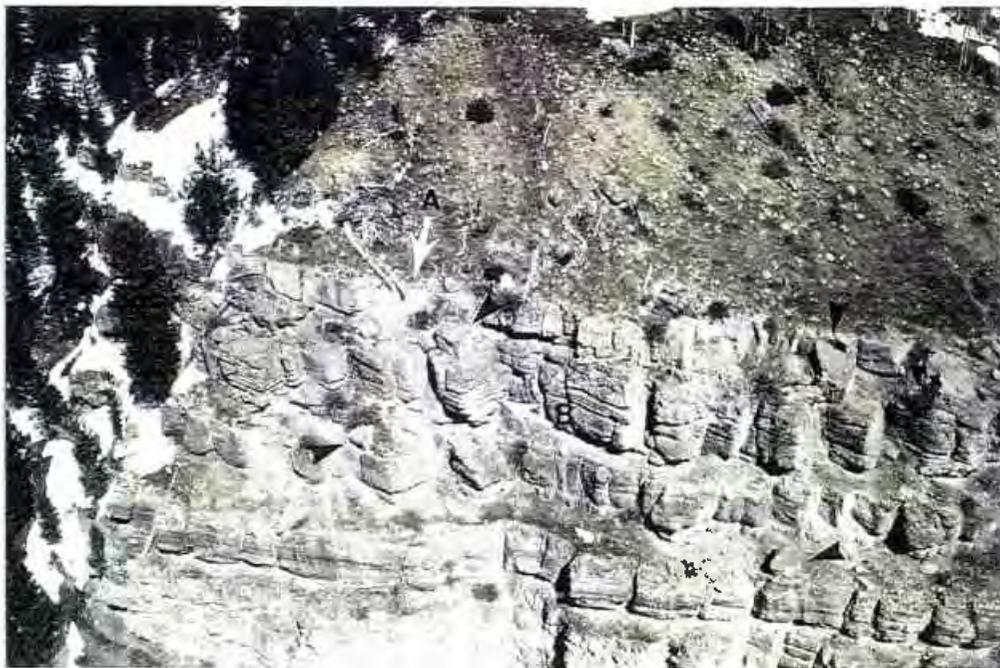
eroding interbedded shale partings. Also in Photo #3 are several slumped and isolated limestone blocks on the rock slope that have not yet fallen. The history of reported rockfall events at Booth Creek and the physical nature of the slope merits our assessment that, **Booth Falls Condominiums is in a severe rockfall hazardous area.**

Photo #3. Close-up aerial view of source area. Note ledgy appearance with joint defined blocks undermined by eroding shale partings. White arrow A marks scar from March 26, 1997 rockfall. White arrow B marks rock pedestal that was hit by rockfall and may be destabilized. Note loose blocks, marked by black arrows.

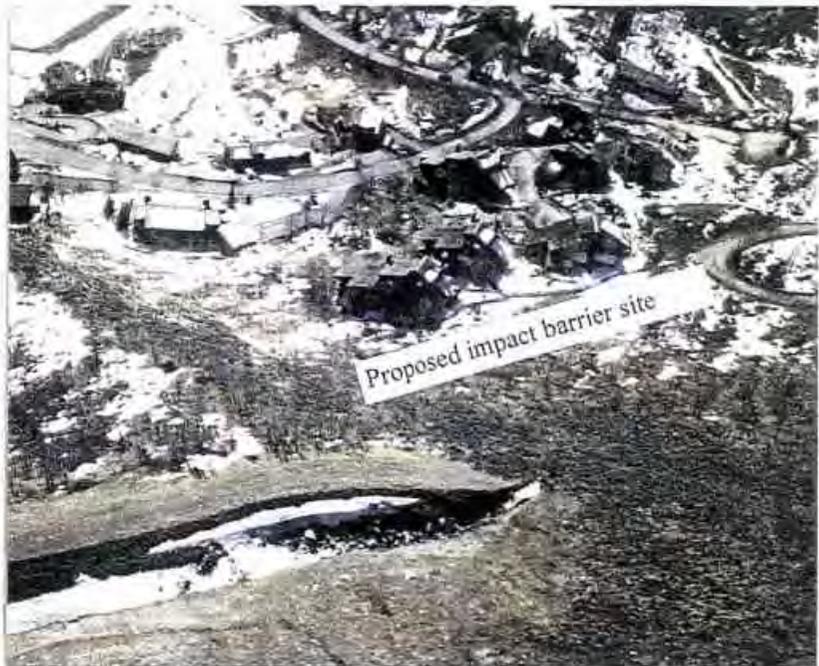
Photo #4. Location of proposed impact barrier or berm site. Note accumulation of rocks in existing ditch. The largest are 5 feet in diameter.

Only a stout protection system can be designed at the criteria stated above. Both ditch and berm systems and inertial impact barriers, or a combination of both, can be designed for the site and be cost effective. No rockfall fence on the market can probably withstand the impact forces that are being contemplated. The rockfall protection must be designed to begin at the road and extend to the southeast to a point where sufficient overlap exists with the existing berm above, a length no less than 350 feet. Rocks that skirt the edge of the top berm must be caught by the lower. See Photo #4. At the high impact velocities and
