ROCKFALL HAZARD STUDY

East Vail Parcel
Vail, Colorado

Project No. 17.5029
June 19, 2017

**Julia M. Frazier, P.G.
Senior Geologist**

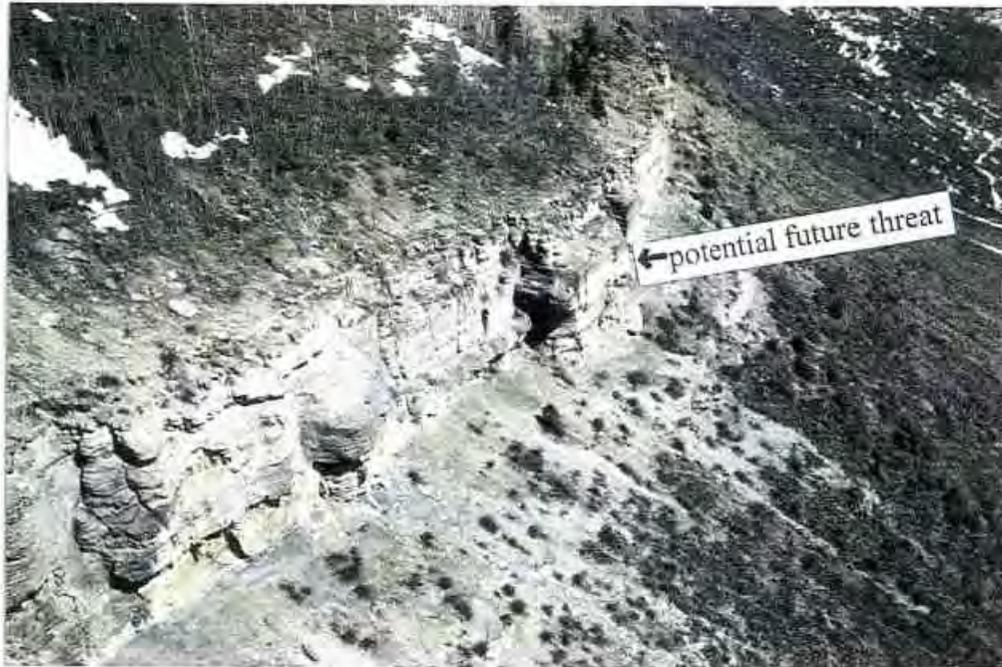
Photo #5. Lower sandstone cliff above district ditch and berm. The CGS will visit this feature this spring and install movement gauges for future monitoring.

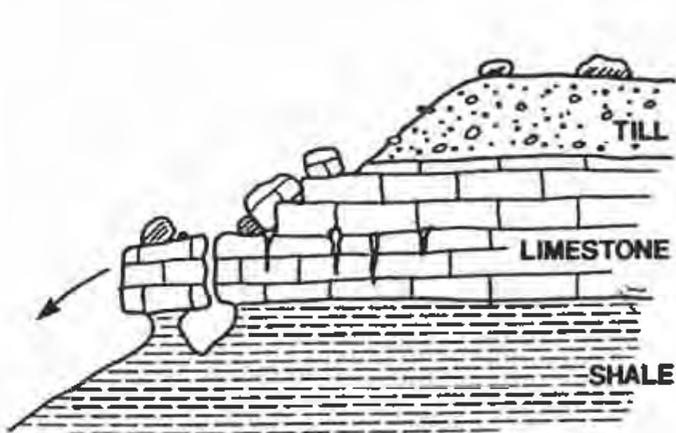
Figure 4. Limestone slabs resting on weak shale pedestals, upper cliff source area.

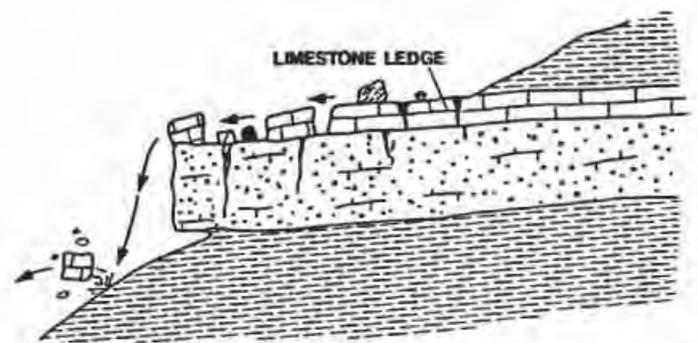
Figure 5. Slope creep causing limestone blocks to move down bedding planes and off lower cliff edge. Blocks are generally 2 ft x 3 ft. This mechanism is responsible for frequent rock falls in the study area.
