WETLAND DELINEATION REPORT

East Vail Workforce Subdivision
Eagle County, Colorado

BIRCH ECOLOGY, LLC

FEBRUARY 2019

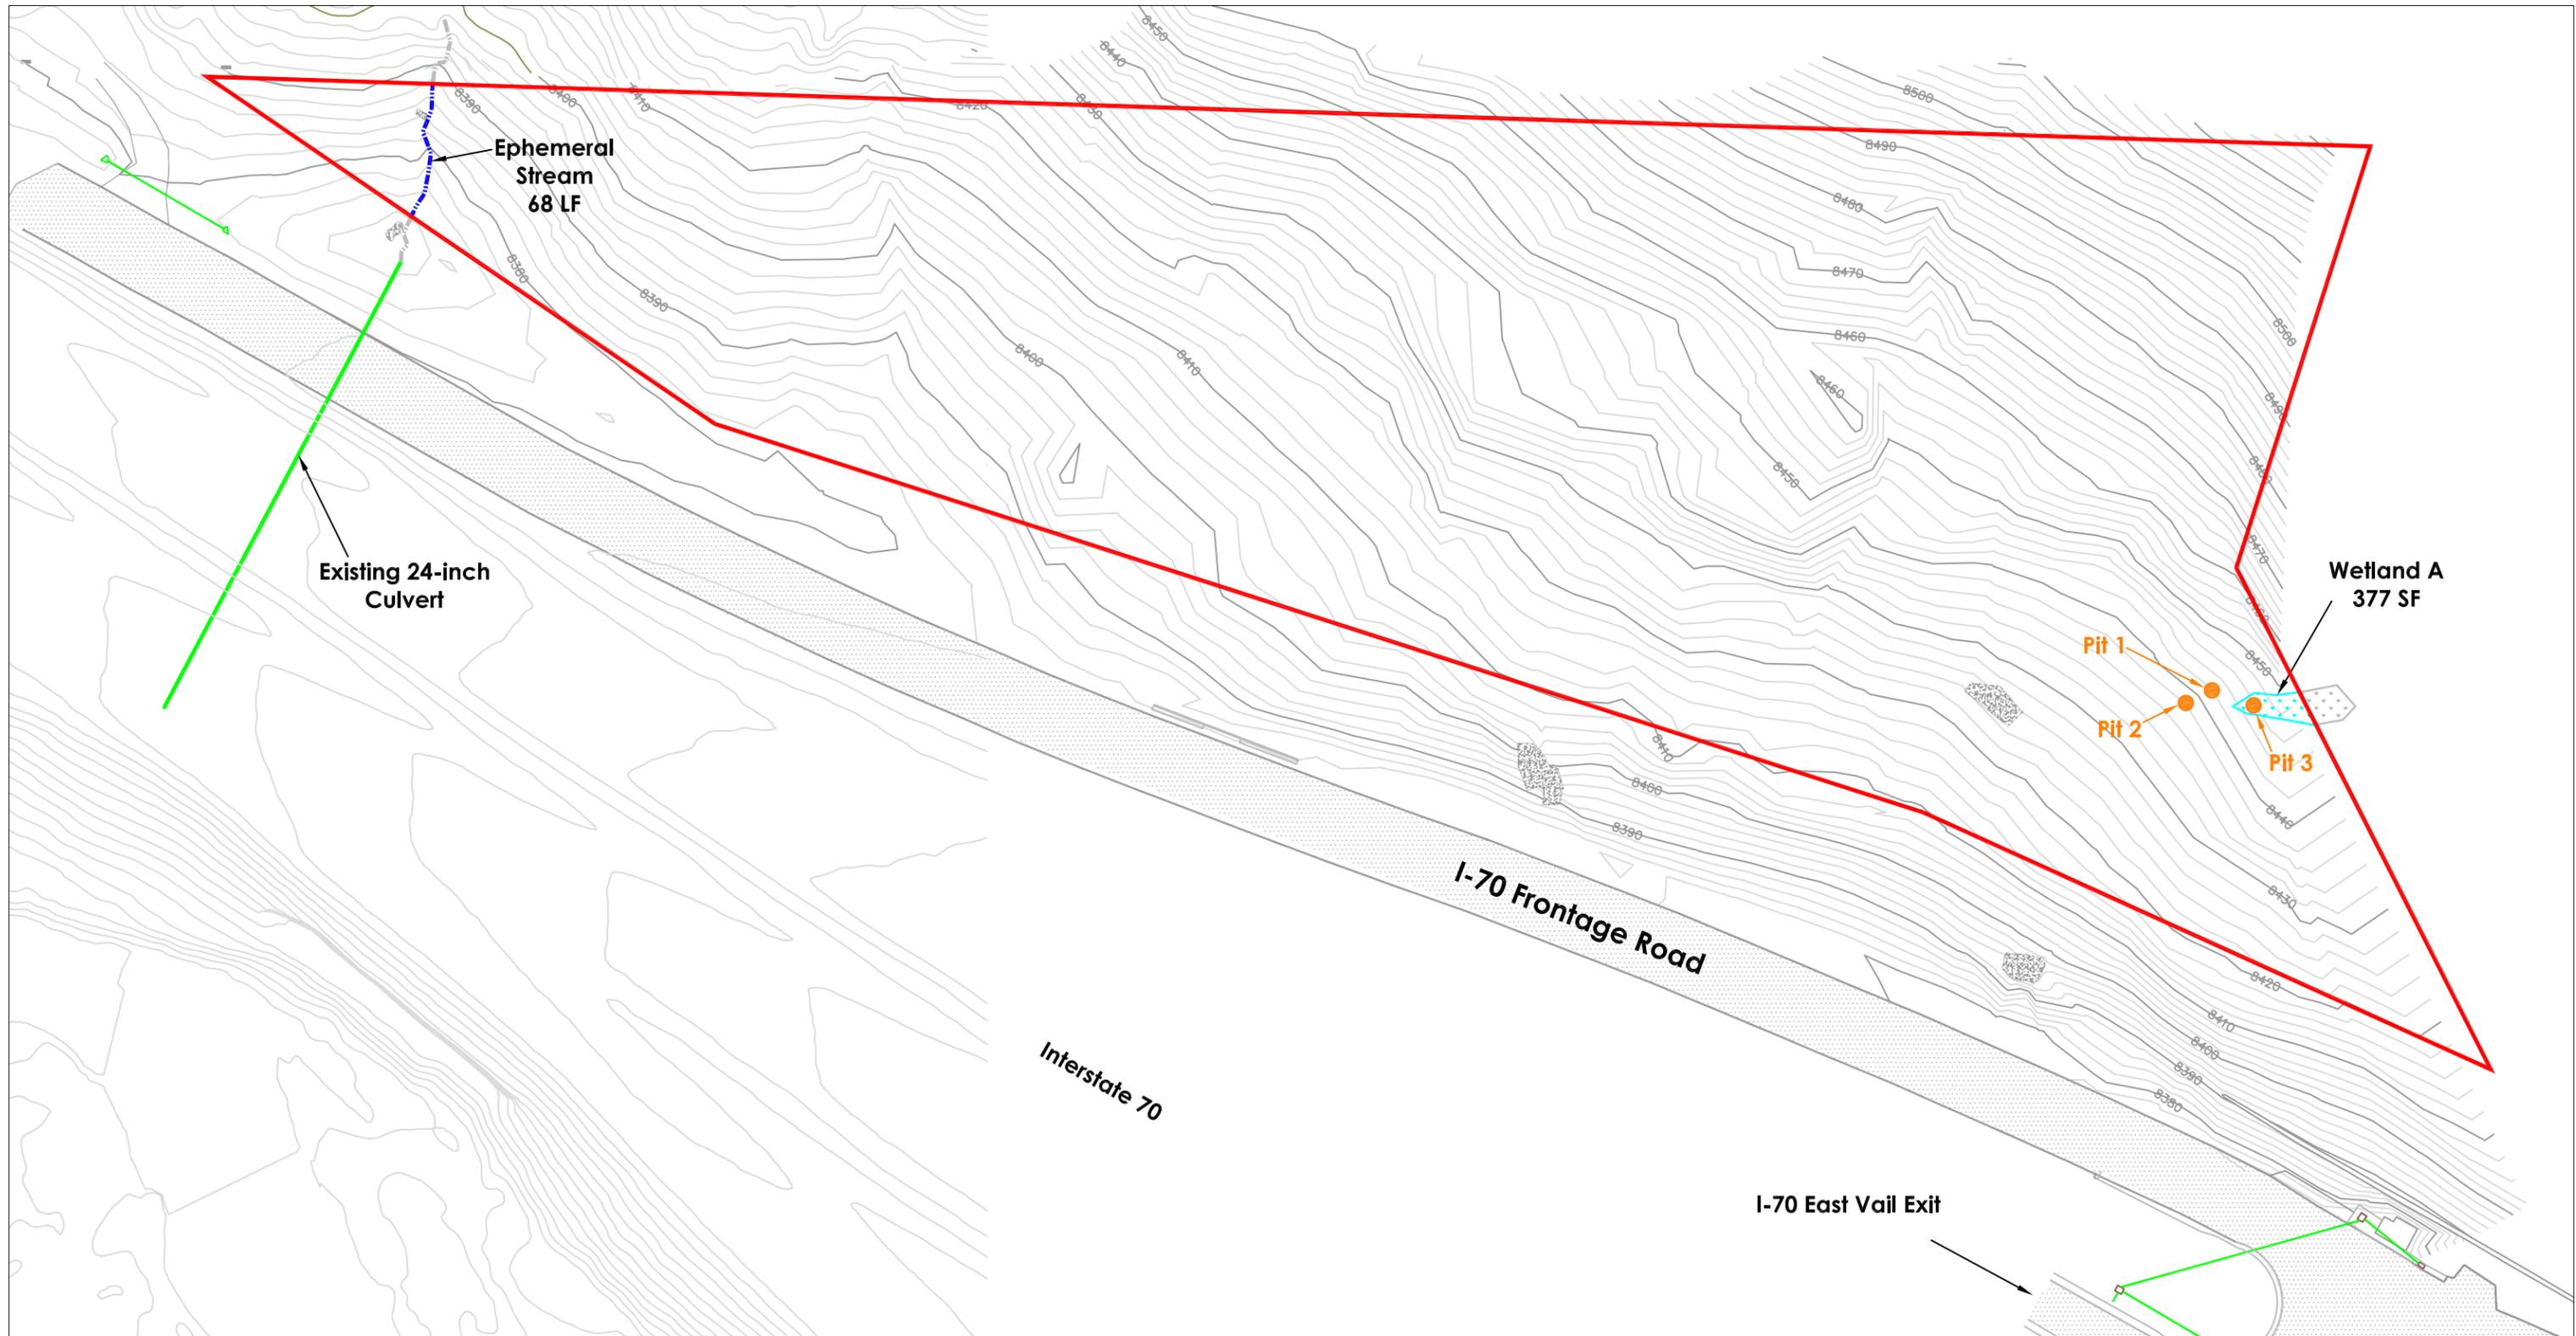
**Figure 3. Wetland Map
 East Vail Workforce Housing**

Approximately 377 square feet of a seep wetland are located within the 5.397-acre project area boundary. In addition, approximately 68 linear feet of an ephemeral stream channel bisect the project site, as illustrated by the Wetland Map (Figure 3) and summarized in Table 1.

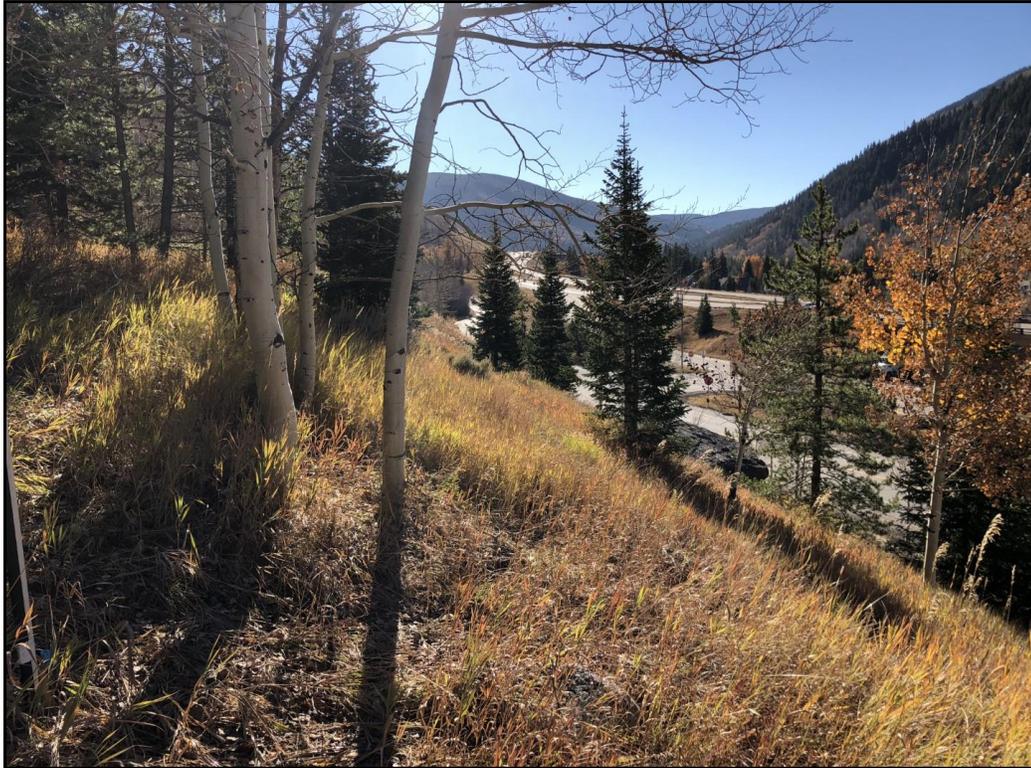
Photo 1. View from the project site to the southeast, toward the I-70 corridor and East Vail Exit. (10/18/17).

The East Vail Workforce Housing project site is located on a south to southwest-facing hillside above the Frontage Road on the north side of I-70 (Photo 1). The 5.397-acre parcel where the development would be located is dominated by aspen (*Populus tremuloides*) forest with scattered Engelmann spruce (*Picea engelmannii*) and a mixed mountain shrub community that includes serviceberry (*Amelanchier alnifolia*), snowberry (*Symphoricarpos rotundifolius*), chokecherry (*Prunus virginiana* var. *melanocarpa*), Woods' rose (*Rosa woodsii*), and mountain mahogany (*Cercocarpus montanus*), among other species (Photo 2). There is a small seep wetland near a landslide area at the eastern boundary (Photos 3 & 4), and a narrow ephemeral stream channel that crosses the western side (Photo 5). Elevations of the delineation area range from a high of 8,520 in the northeastern corner to a low of 8,374 in the southwestern corner where the ephemeral stream channel flows off the project site.

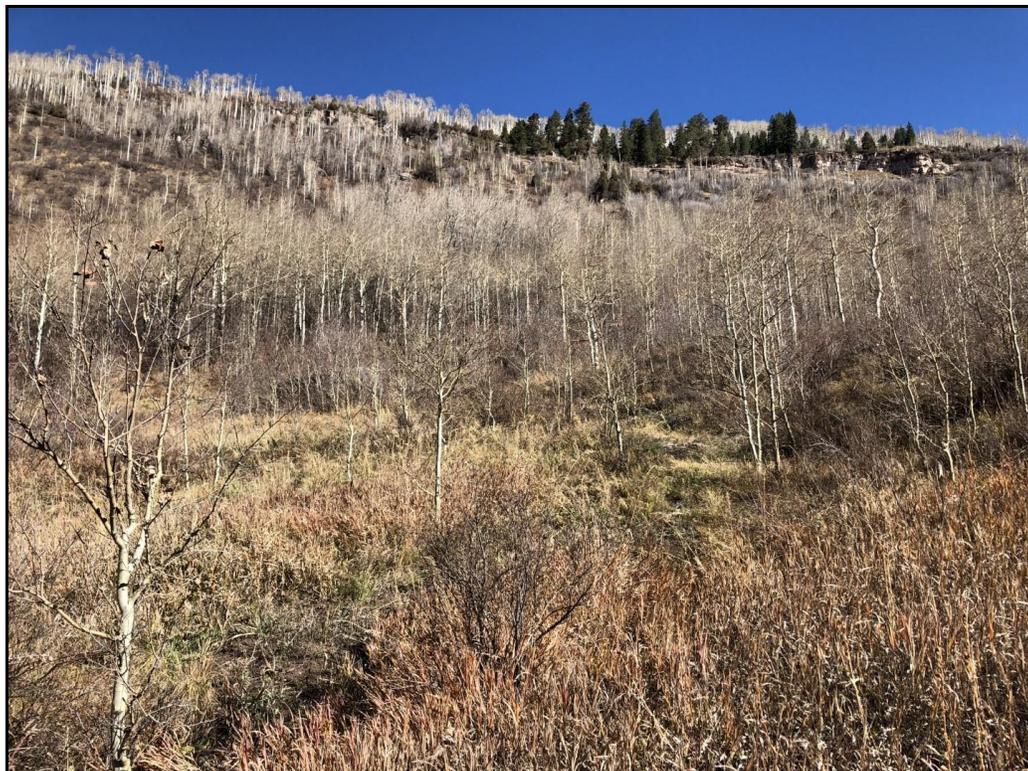
Photo 2. The steep forested hillside above the project site is dominated by aspen. (10/24/17).

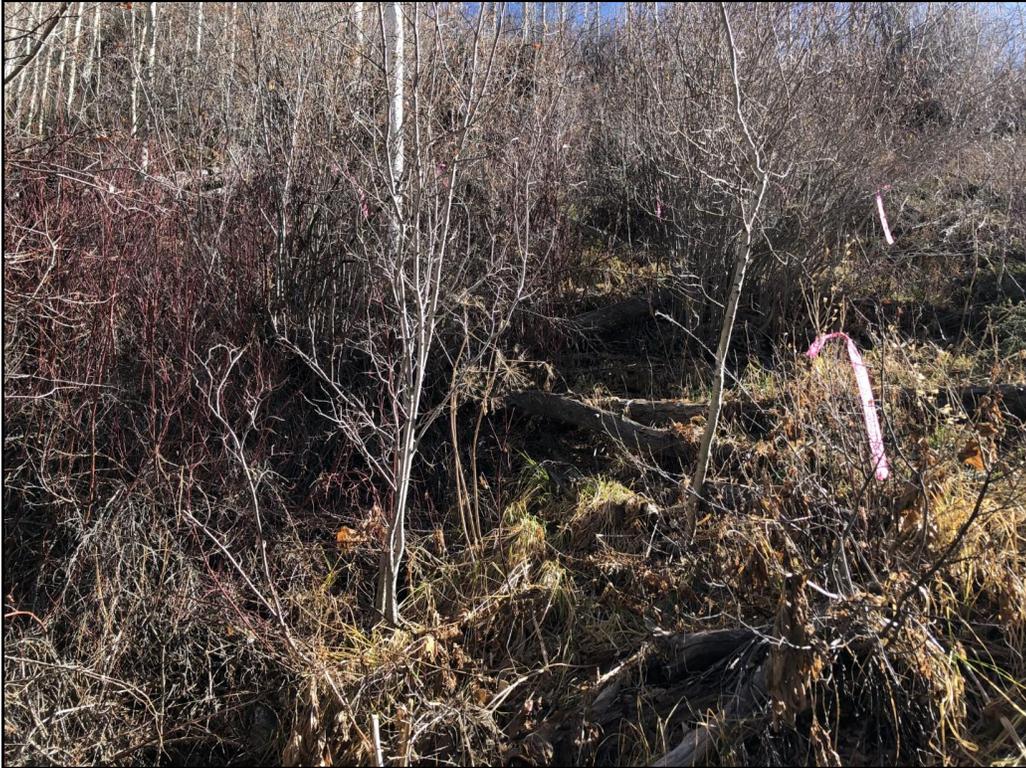
Wetland A is a seep within the aspen forest (Photos 3, 4 & 6). In the area mapped as wetlands, the shrubby overstory is dominated by willows (*Salix bebbiana*, *S. scouleriana*), redosier dogwood (*Cornus sericea*), and bush honeysuckle (*Distegia involucrata*), with serviceberry, snowberry, Woods' rose, common juniper (*Juniperus communis*), and mountain maple (*Acer glabrum*) in the moist soil at the periphery. The understory of the delineated wetland is dominated by a sparse cover of beaked sedge (*Carex utriculata*) growing with cow parsnip (*Heracleum sphondylium* ssp. *montanum*), starry false Solomon's seal (*Maianthemum stellatum*) and monkshood (*Aconitum columbianum*), as well as the shade-tolerant introduced species orchard grass (*Dactylis glomerata*).

Photo 3. Wetland A is a seep with a shrubby overstory dominated by willows and dogwood, with beaked sedge and cow parsnip in the understory. (10/24/17).

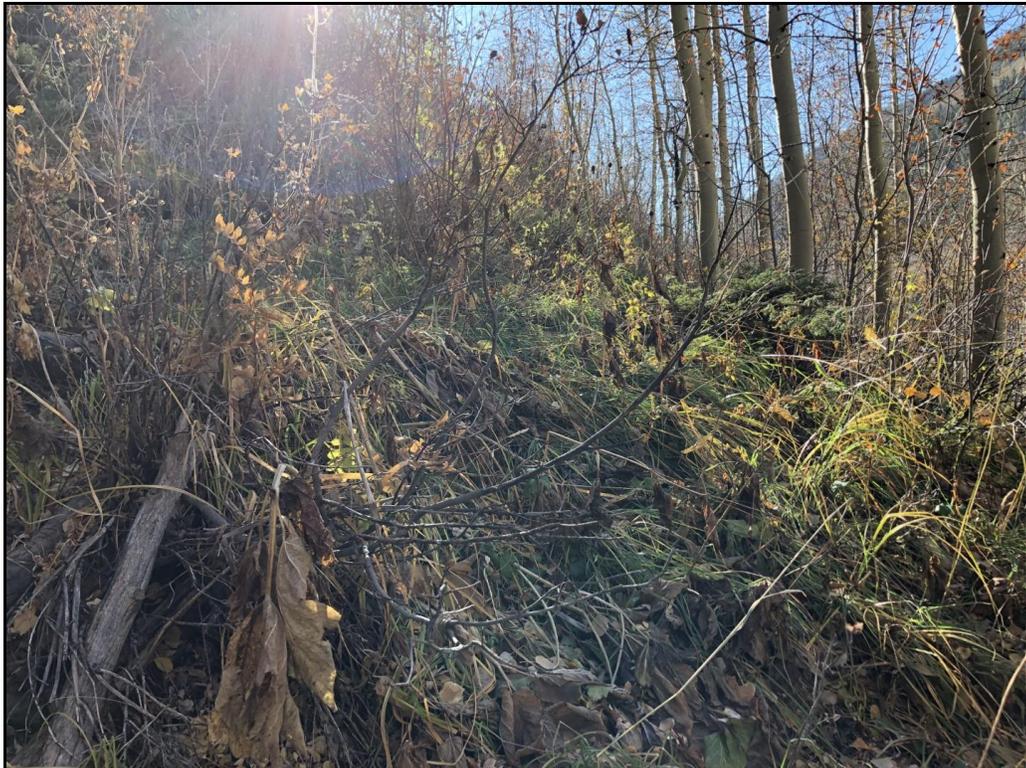
Wetland A is a seep located near the eastern boundary of the project site. The wetland extends into the project area from the Natural Area Preservation parcel to the east. Approximately 377 square feet of this wetland occur within the 5.397-acre project site (Photos 3 & 4).

Photo 4. Wetland A is on a steep, southwestern-facing slope. (10.18/17).

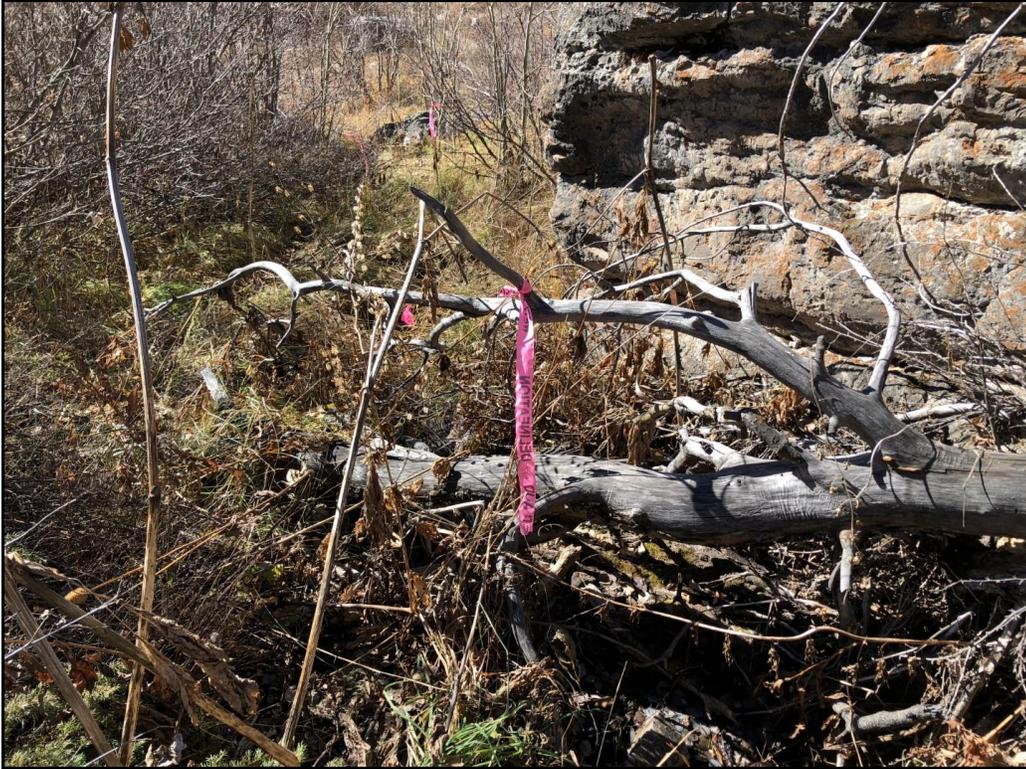
A 2-foot-wide, rocky ephemeral stream channel is located in the western portion of the project site (Photo 5). Approximately 68 linear feet of this channel is within the project boundary.

Photo 5. The rocky ephemeral stream channel has a bed that averages about two feet wide. (10/24/17).

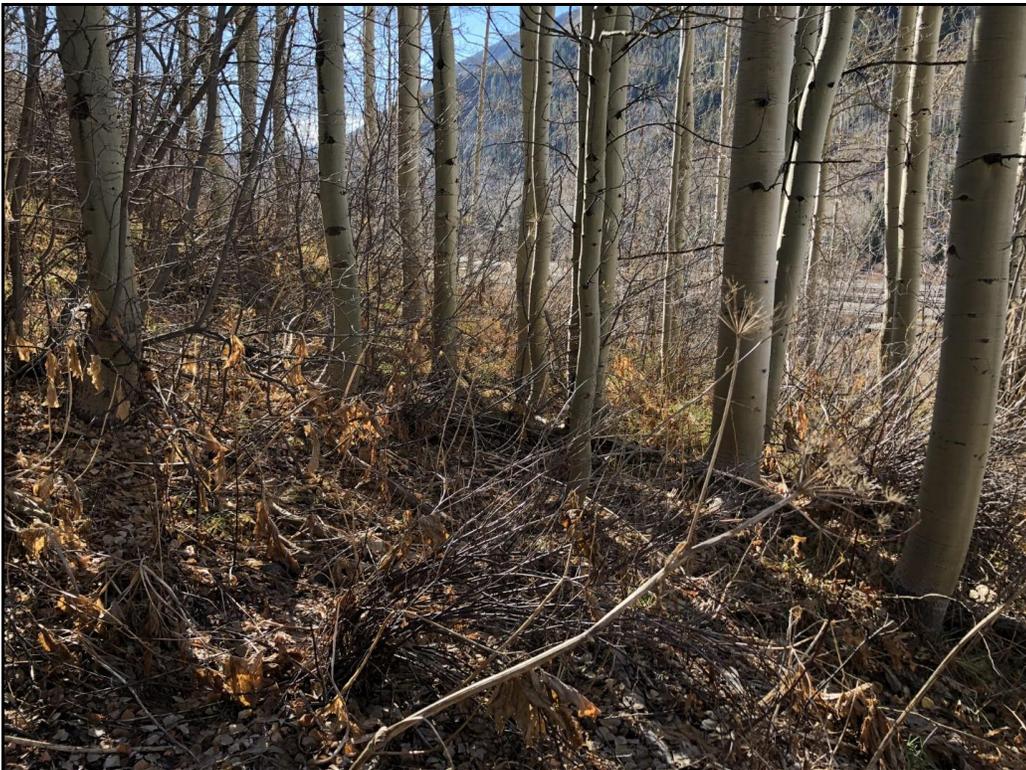
Photo 6. Aspen forest next to Wetland A. (10/24/17).

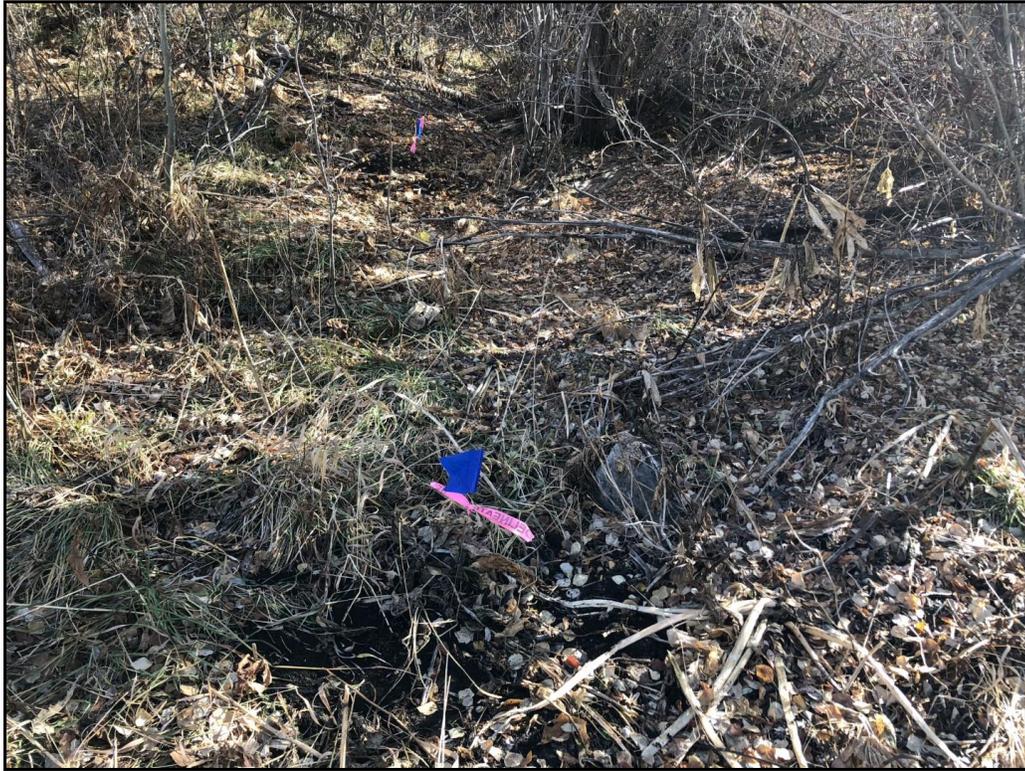
Three soil pits were used to define the limits of Wetland A. Pits 1 and 2 were located just outside the wetland boundary (Photo 7) in a shallow drainage swale. Both pits lacked hydric soil and indicators of a wetland hydrology. Pit 3 was located inside the wetland boundary. The soil was hydric and was saturated below a depth of 11 inches (Photo 8).

Photo 7. Pits 2 (foreground) and 1 (background) are in a drainage swale below Wetland A. (10/24/17).

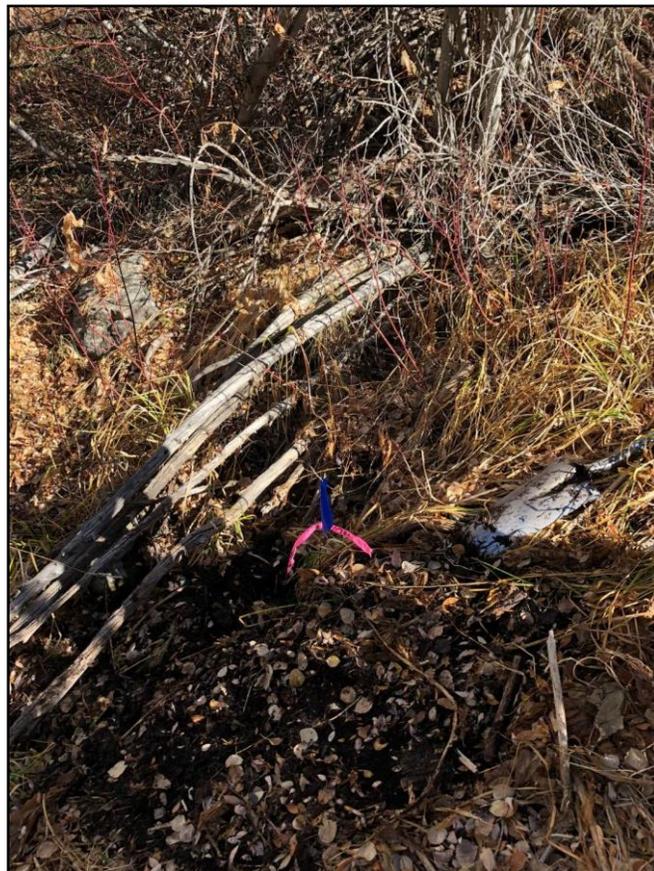
This wetland is a seep fed by groundwater discharge and snowmelt runoff. As noted on the data form for Pit 3, the soil was saturated below a depth of 11 inches on the date of the delineation, and there was flowing water nearby in a small channel.

Photo 8. Pit 3 is within Wetland A.
