## TOWN OF VAIL PUBLIC WORKS

APRIL 2020

### NEW PROPOSAL PHASE 1

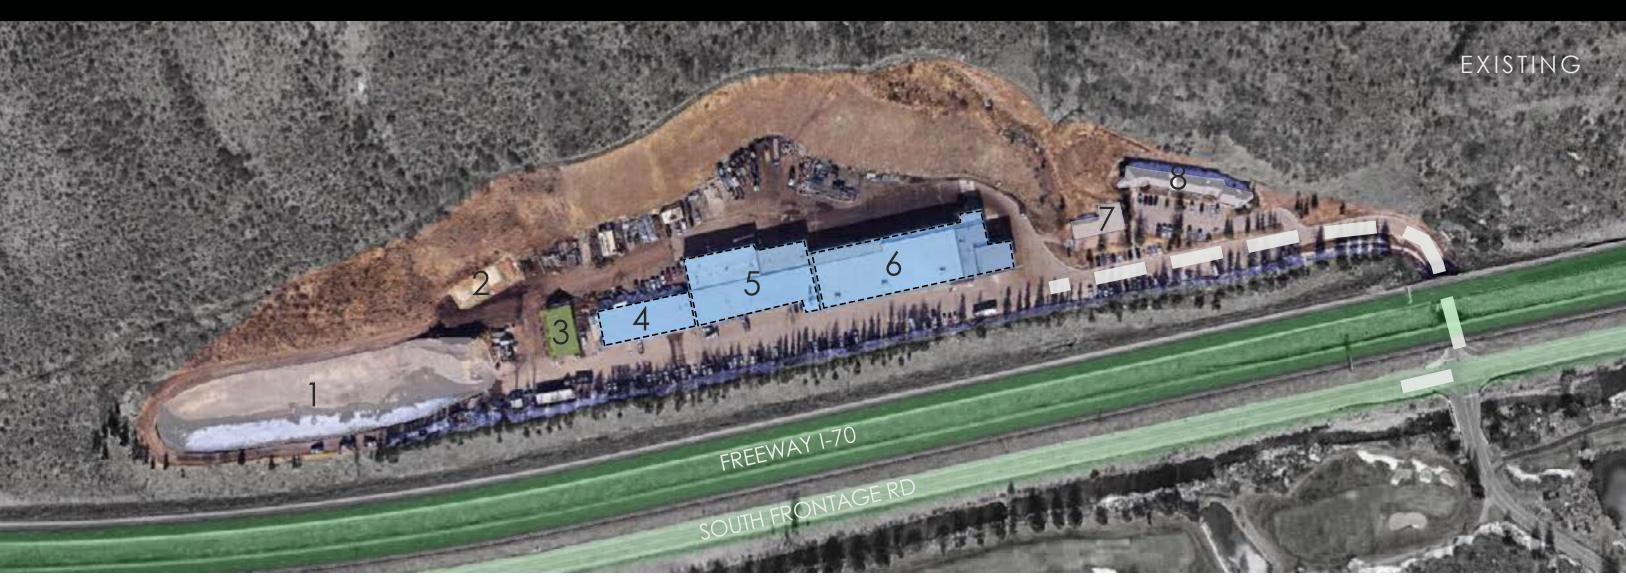
- 1. SNOW STORAGE
- 2. SAND & CINDERS STORAGE
- 3. GREENHOUSE
- 4. STREETS BAYS

- 5. FLEET MAINTENANCE
- 6. BUS GARAGE
- 7. ADMINISTRATION
- 8. APARTMENT BUILDING
