PROJECT NO:	17.5029		
PROJECT NAME:	Rockfall Hazard Study, East Vail Parcel		
DRAWN BY:	RAB	CHECKED BY:	JMF
DWG DATE:	06.16.17	REV. DATE:	--

Rockfall Hazard Assessment at Booth Falls Condominiums and  
Proposed Mitigation  
(Colorado Geological Survey)

**ROCKFALL HAZARD ASSESSMENT AT BOOTH FALLS  
CONDOMINIUMS  
AND PROPOSED MITIGATION**

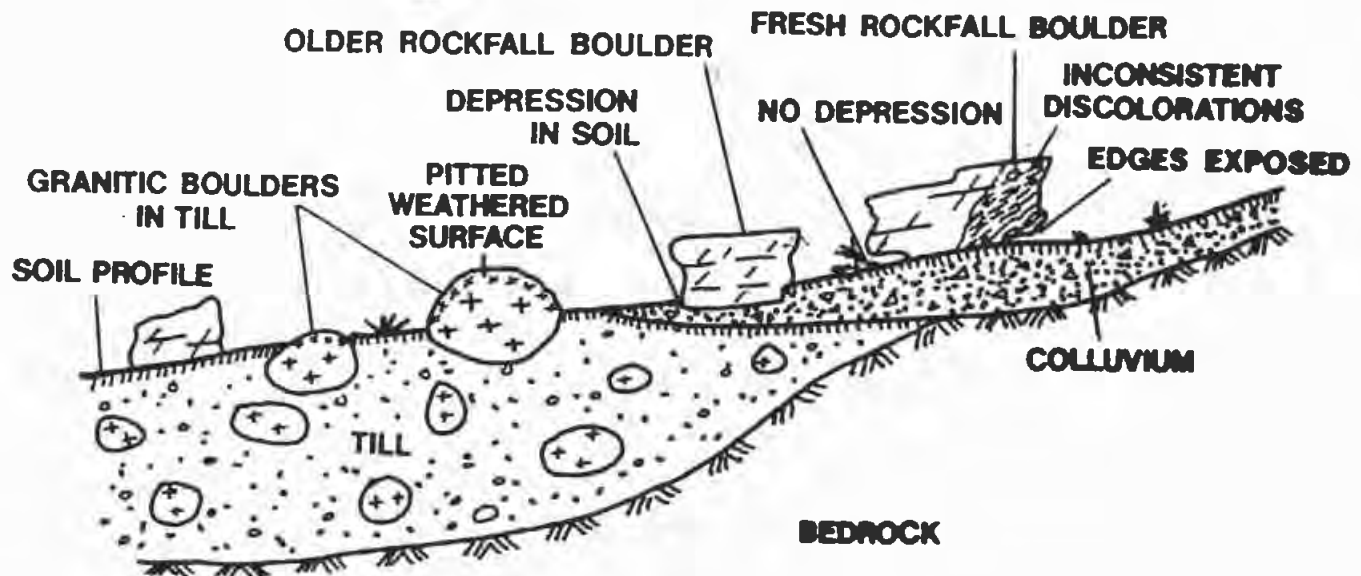
Figure 6. Physical differences between rockfall and glacially deposited boulders in runout zone. Rockfall boulders are all limestone or sandstone, while glacial boulders are mostly rounded granite or metamorphic lithologies. Note that soil exists below rockfall boulders, while it is absent beneath glacial boulders.
