Subject: Geologic Hazards Analysis Report  
East Vail Workforce Housing  
Vail, Colorado  
Project No. 18.5080

Geologic Hazard Analysis  
East Vail Parcel  
Vail, Colorado  
Skyline Project No: 18105

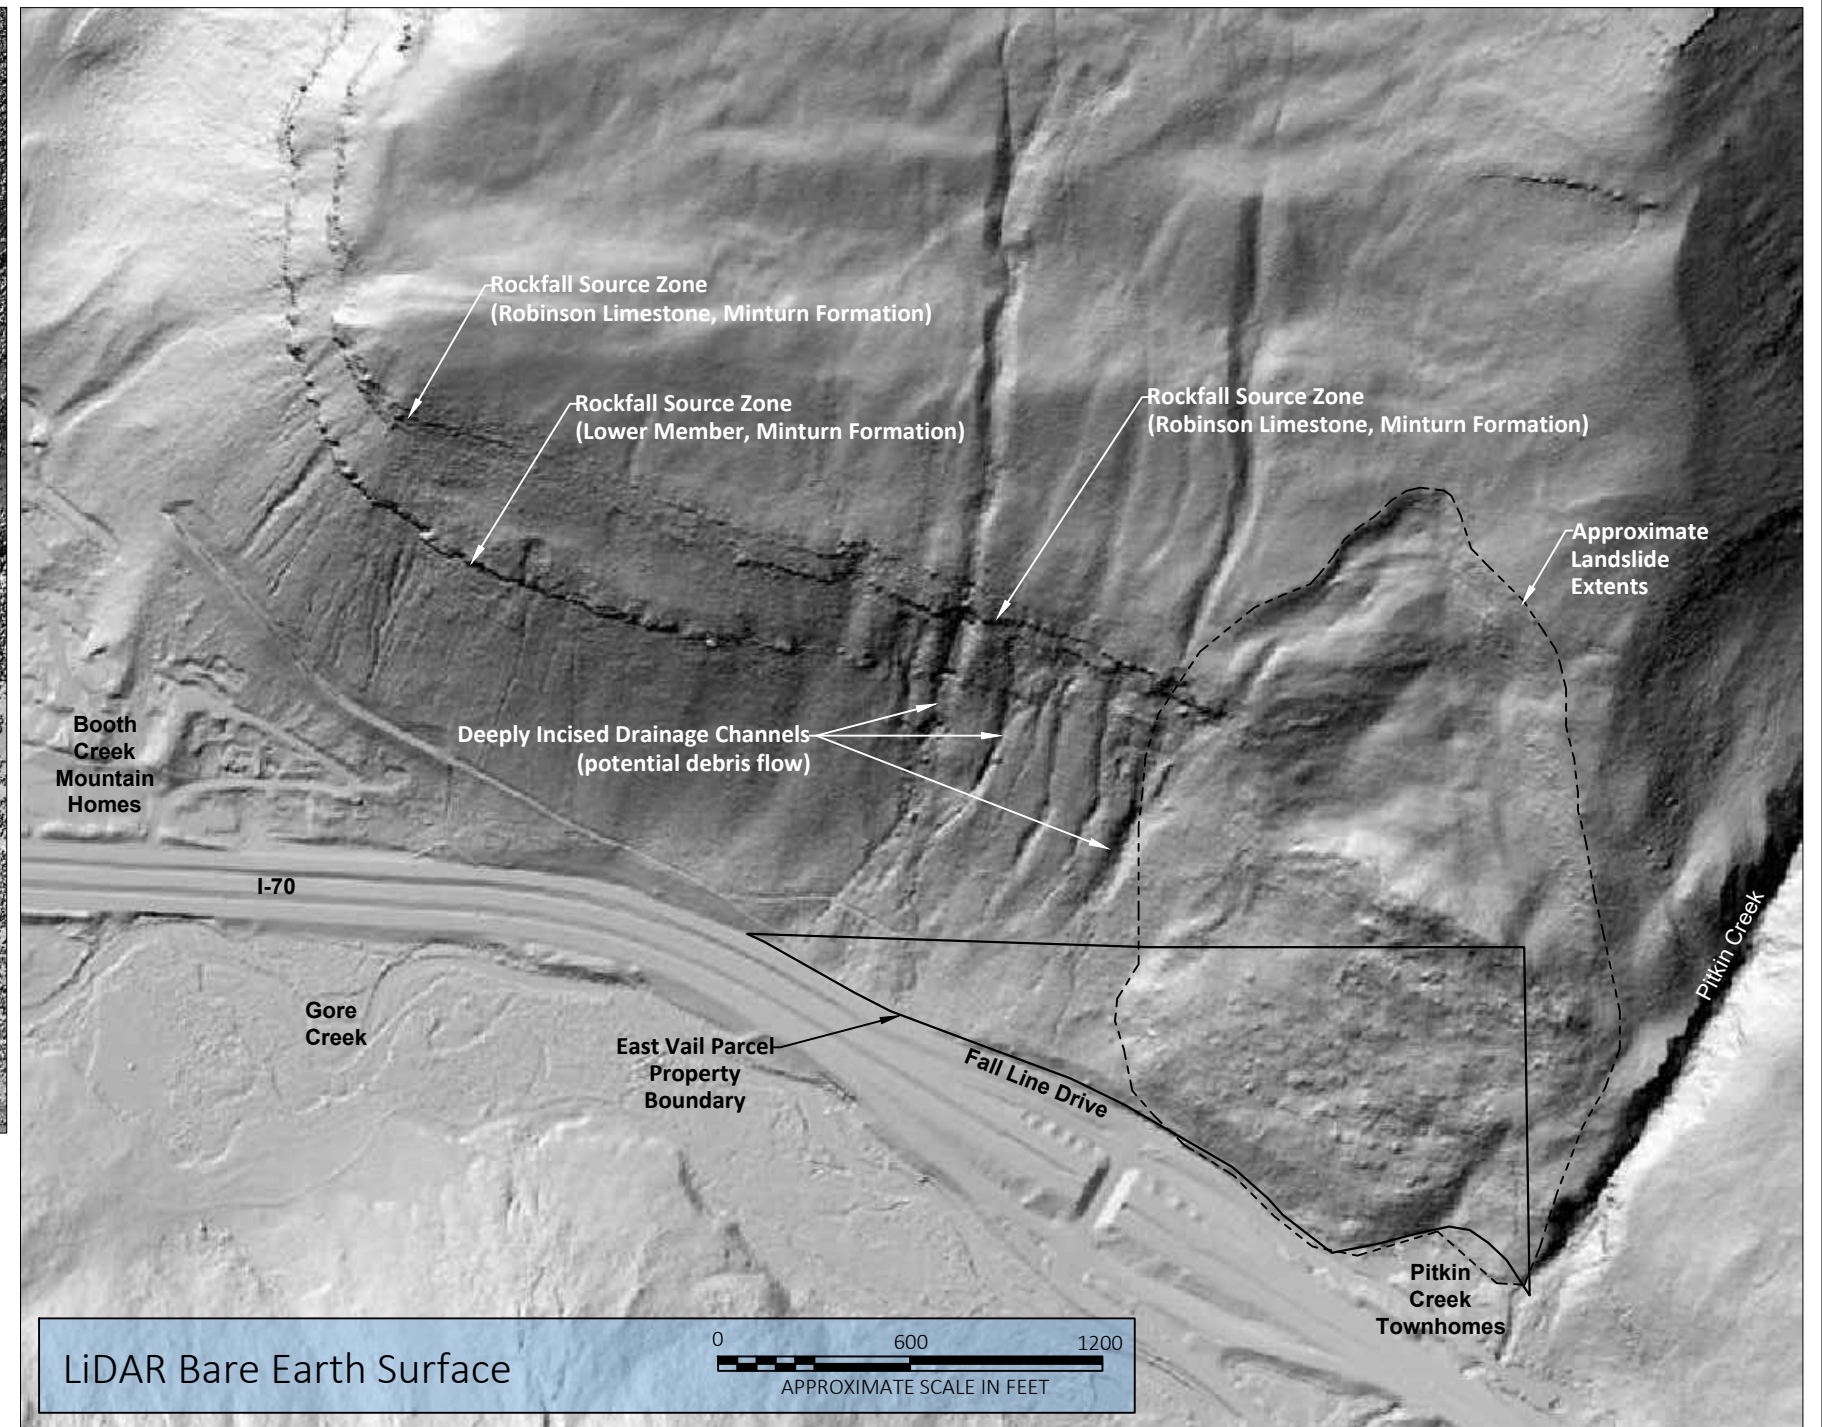
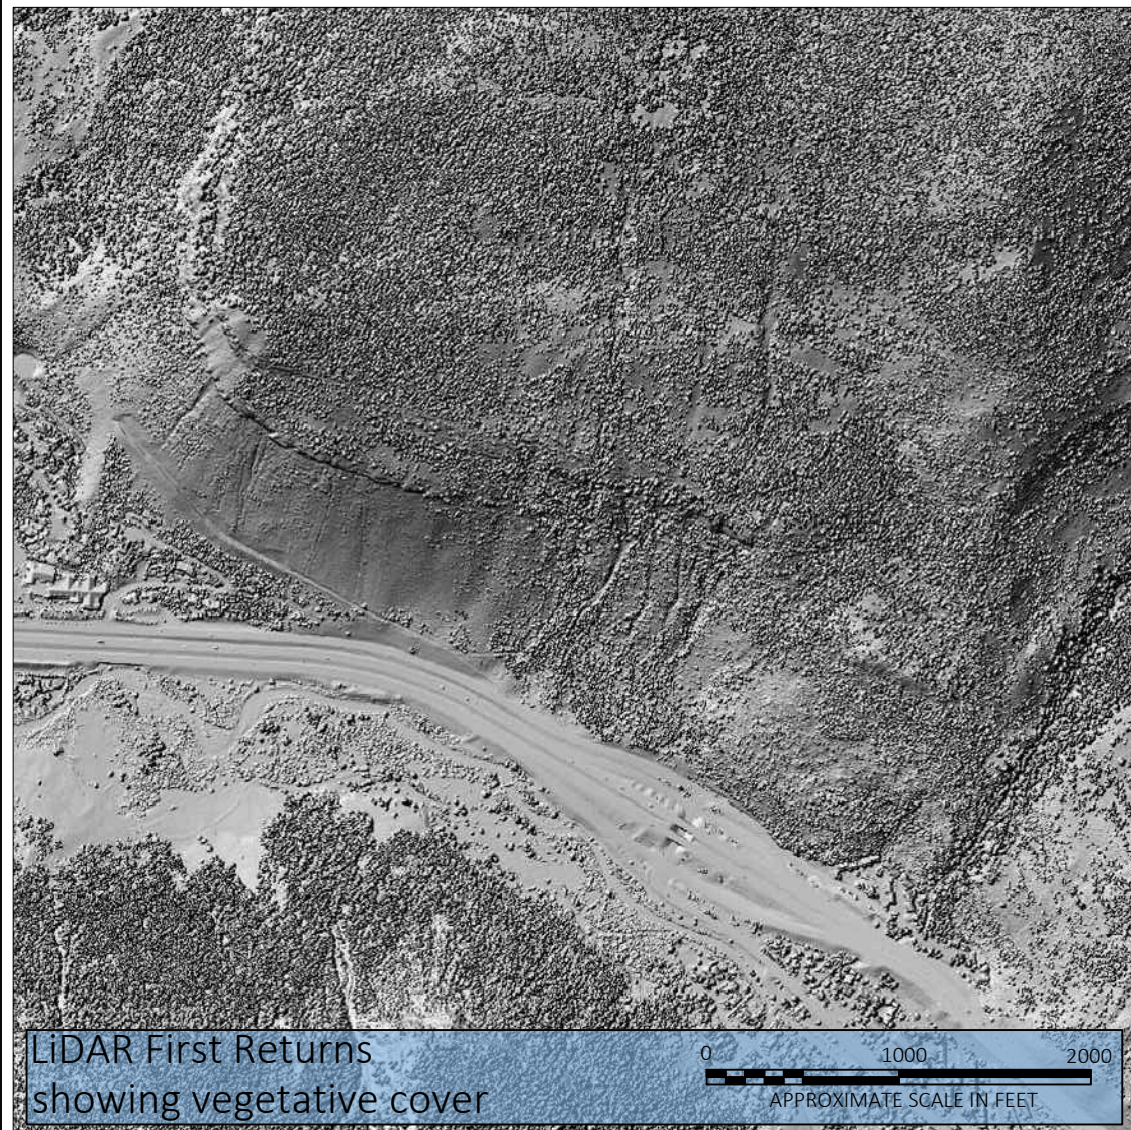
FIGURE 5  
LiDAR Imagery

An existing landslide occupies the eastern approximate 18 acres of the EVP, the area to remain undeveloped (NAP). The landslide is visible in the LiDAR collected for the area, shown on Figure 5. Figure 6 shows a slope map derived from the LiDAR, with marked landslide extents. Geomorphic features of landslide movement have been obscured by heavy vegetative cover and smoothed by natural processes over time. The LiDAR imagery assisted in delineating the extents of the landslide (Figure 7), which extend further upslope than previously identified in published geologic maps (*Kellogg and others, 2003*). The landslide extents delineated in this report are approximate.
