ROCKFALL HAZARD STUDY

East Vail Parcel
Vail, Colorado

Project No. 17.5029
June 19, 2017

**Julia M. Frazier, P.G.
Senior Geologist**

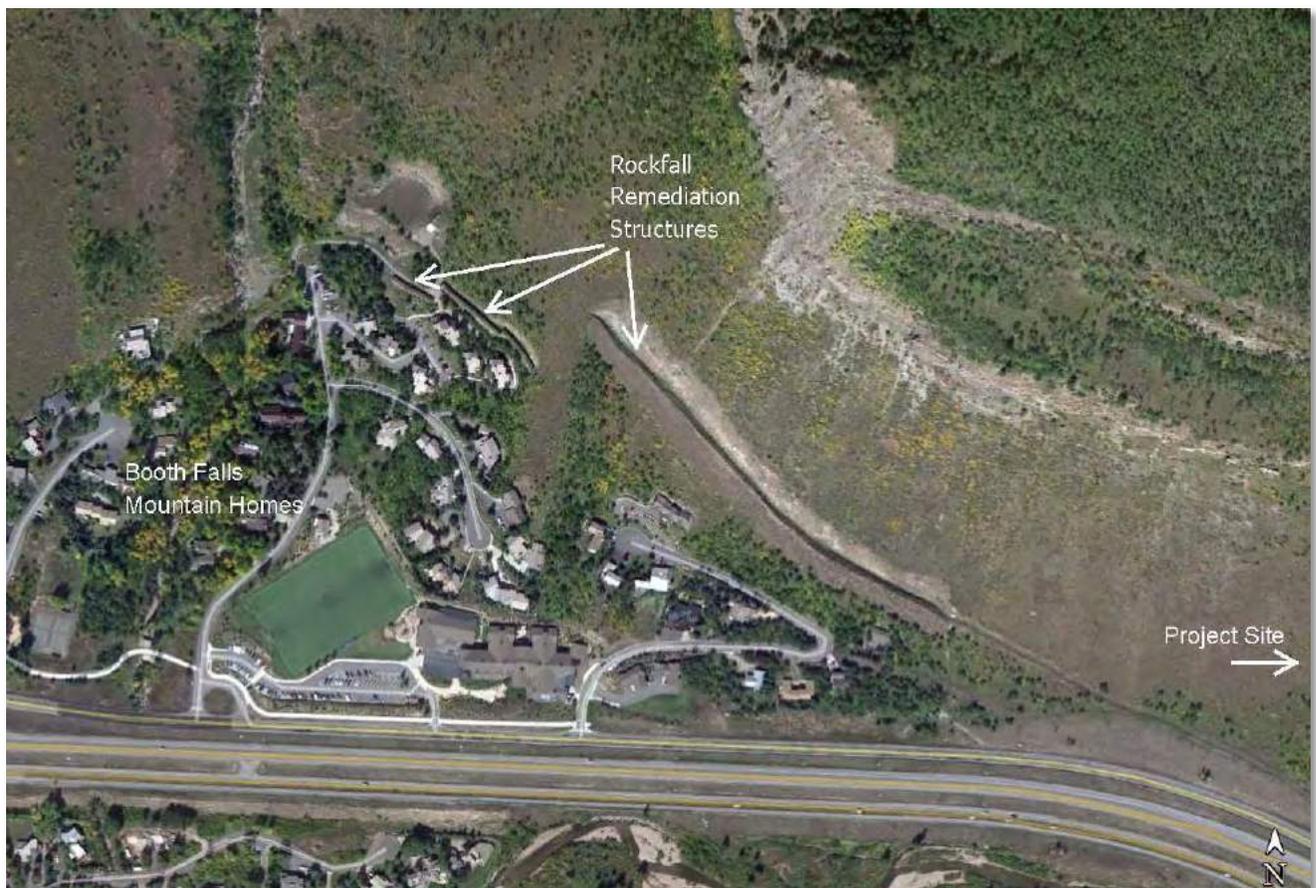
Photograph 9. Google Earth image of Booth Falls Mountain Homes to the west of the project site. Examples of existing rockfall remediation structures are labeled.

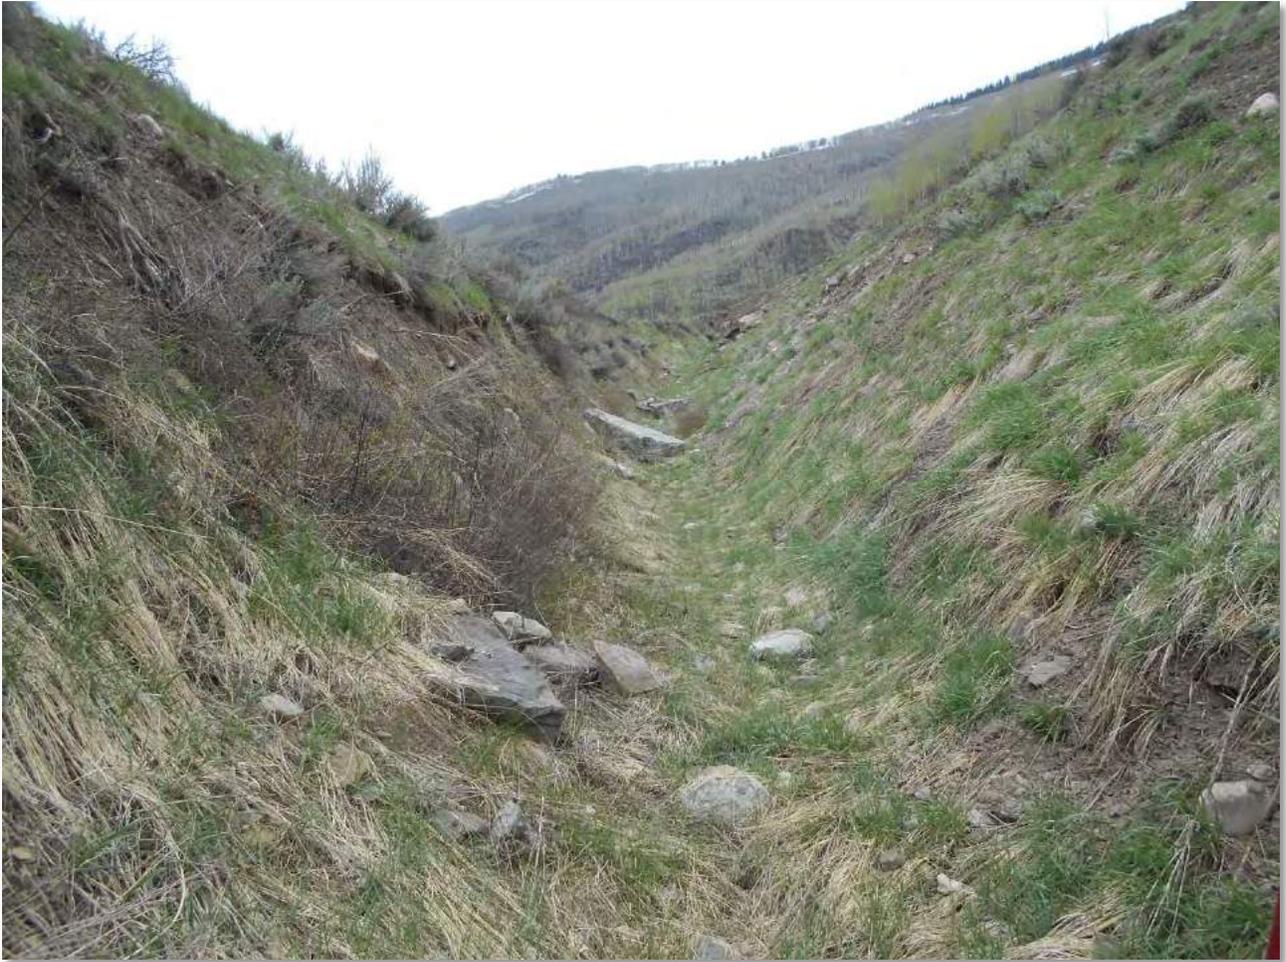
Photograph 10. View of rockfall catchment berm and basin, upslope from Booth Falls Mountain Homes. View looking west toward Booth Creek. The berm is between 10 and 15 feet high, and the ditch is about 20 feet from crest of berm to backslope.

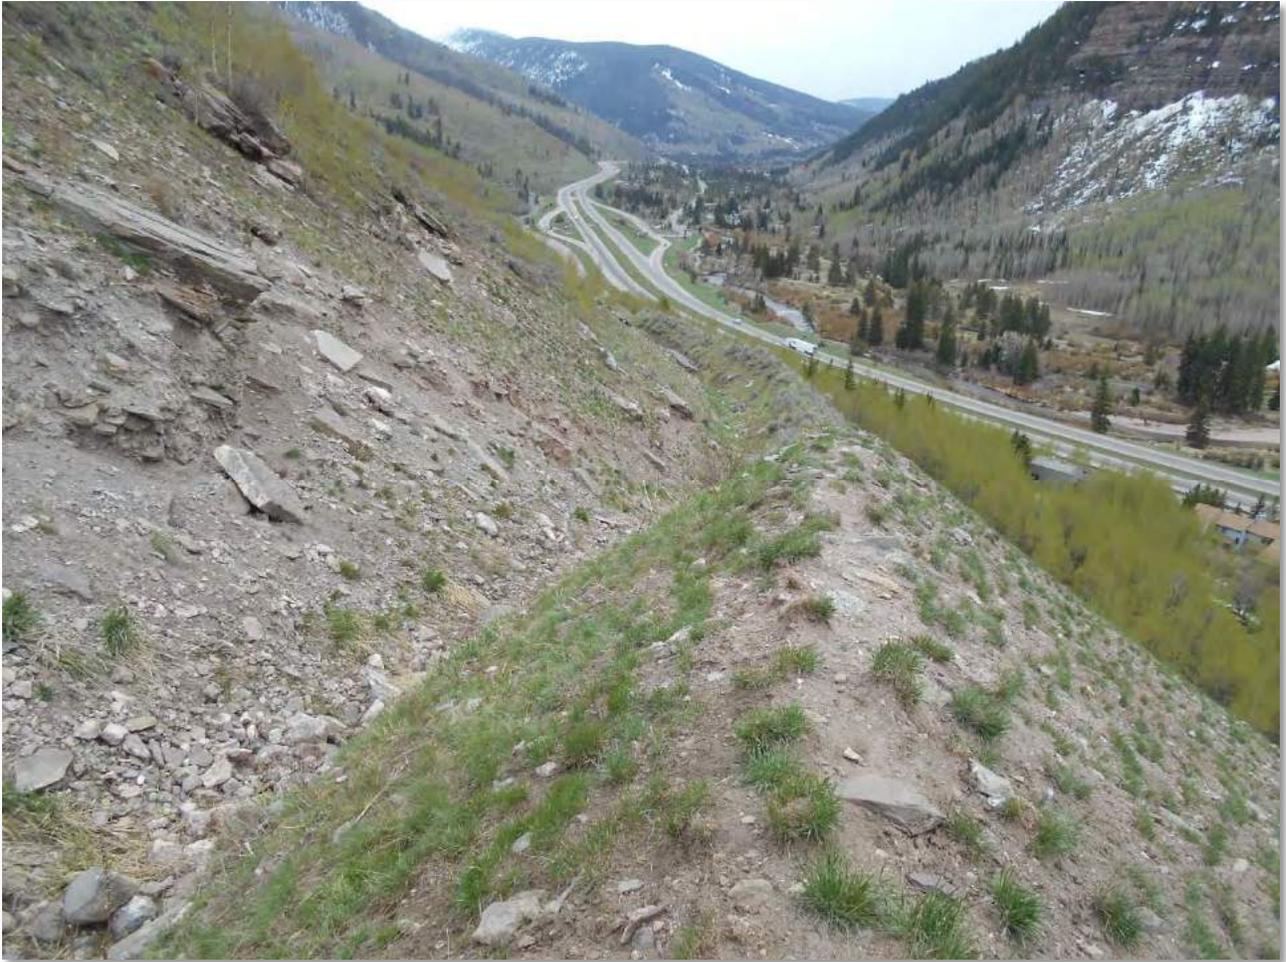
Photograph 11. View of rockfall catchment berm and basin upslope from Booth Falls Subdivision. View looking east toward the project site.

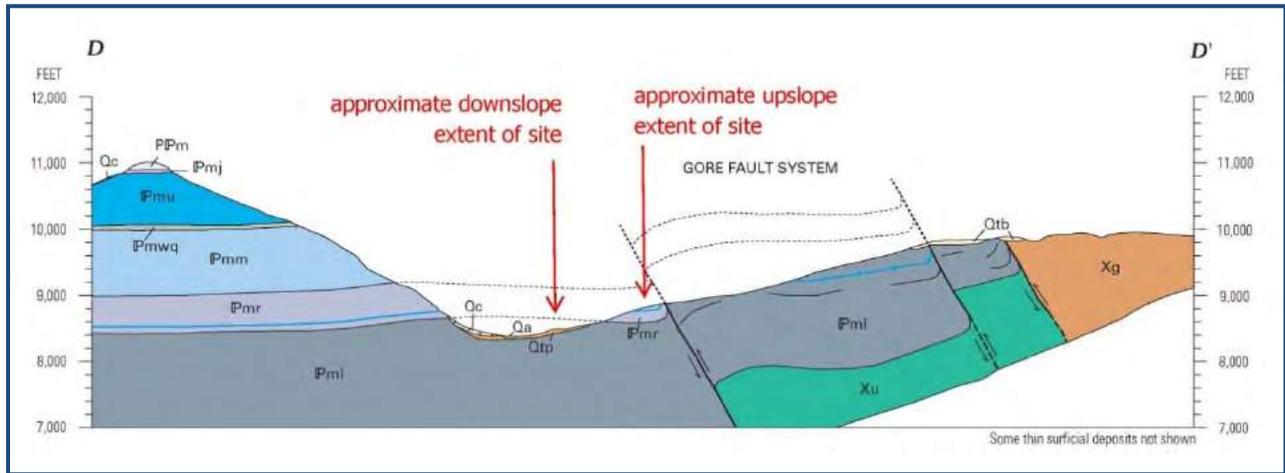
DIAGRAM 1. Cross Section D-D'

Cross section D-D' excerpted from the Geologic Map of the Vail East Quadrangle (Kellogg and others, 2003). This cross section is located immediately east of the project site and schematically depicts the surface and subsurface geologic conditions in the site area.

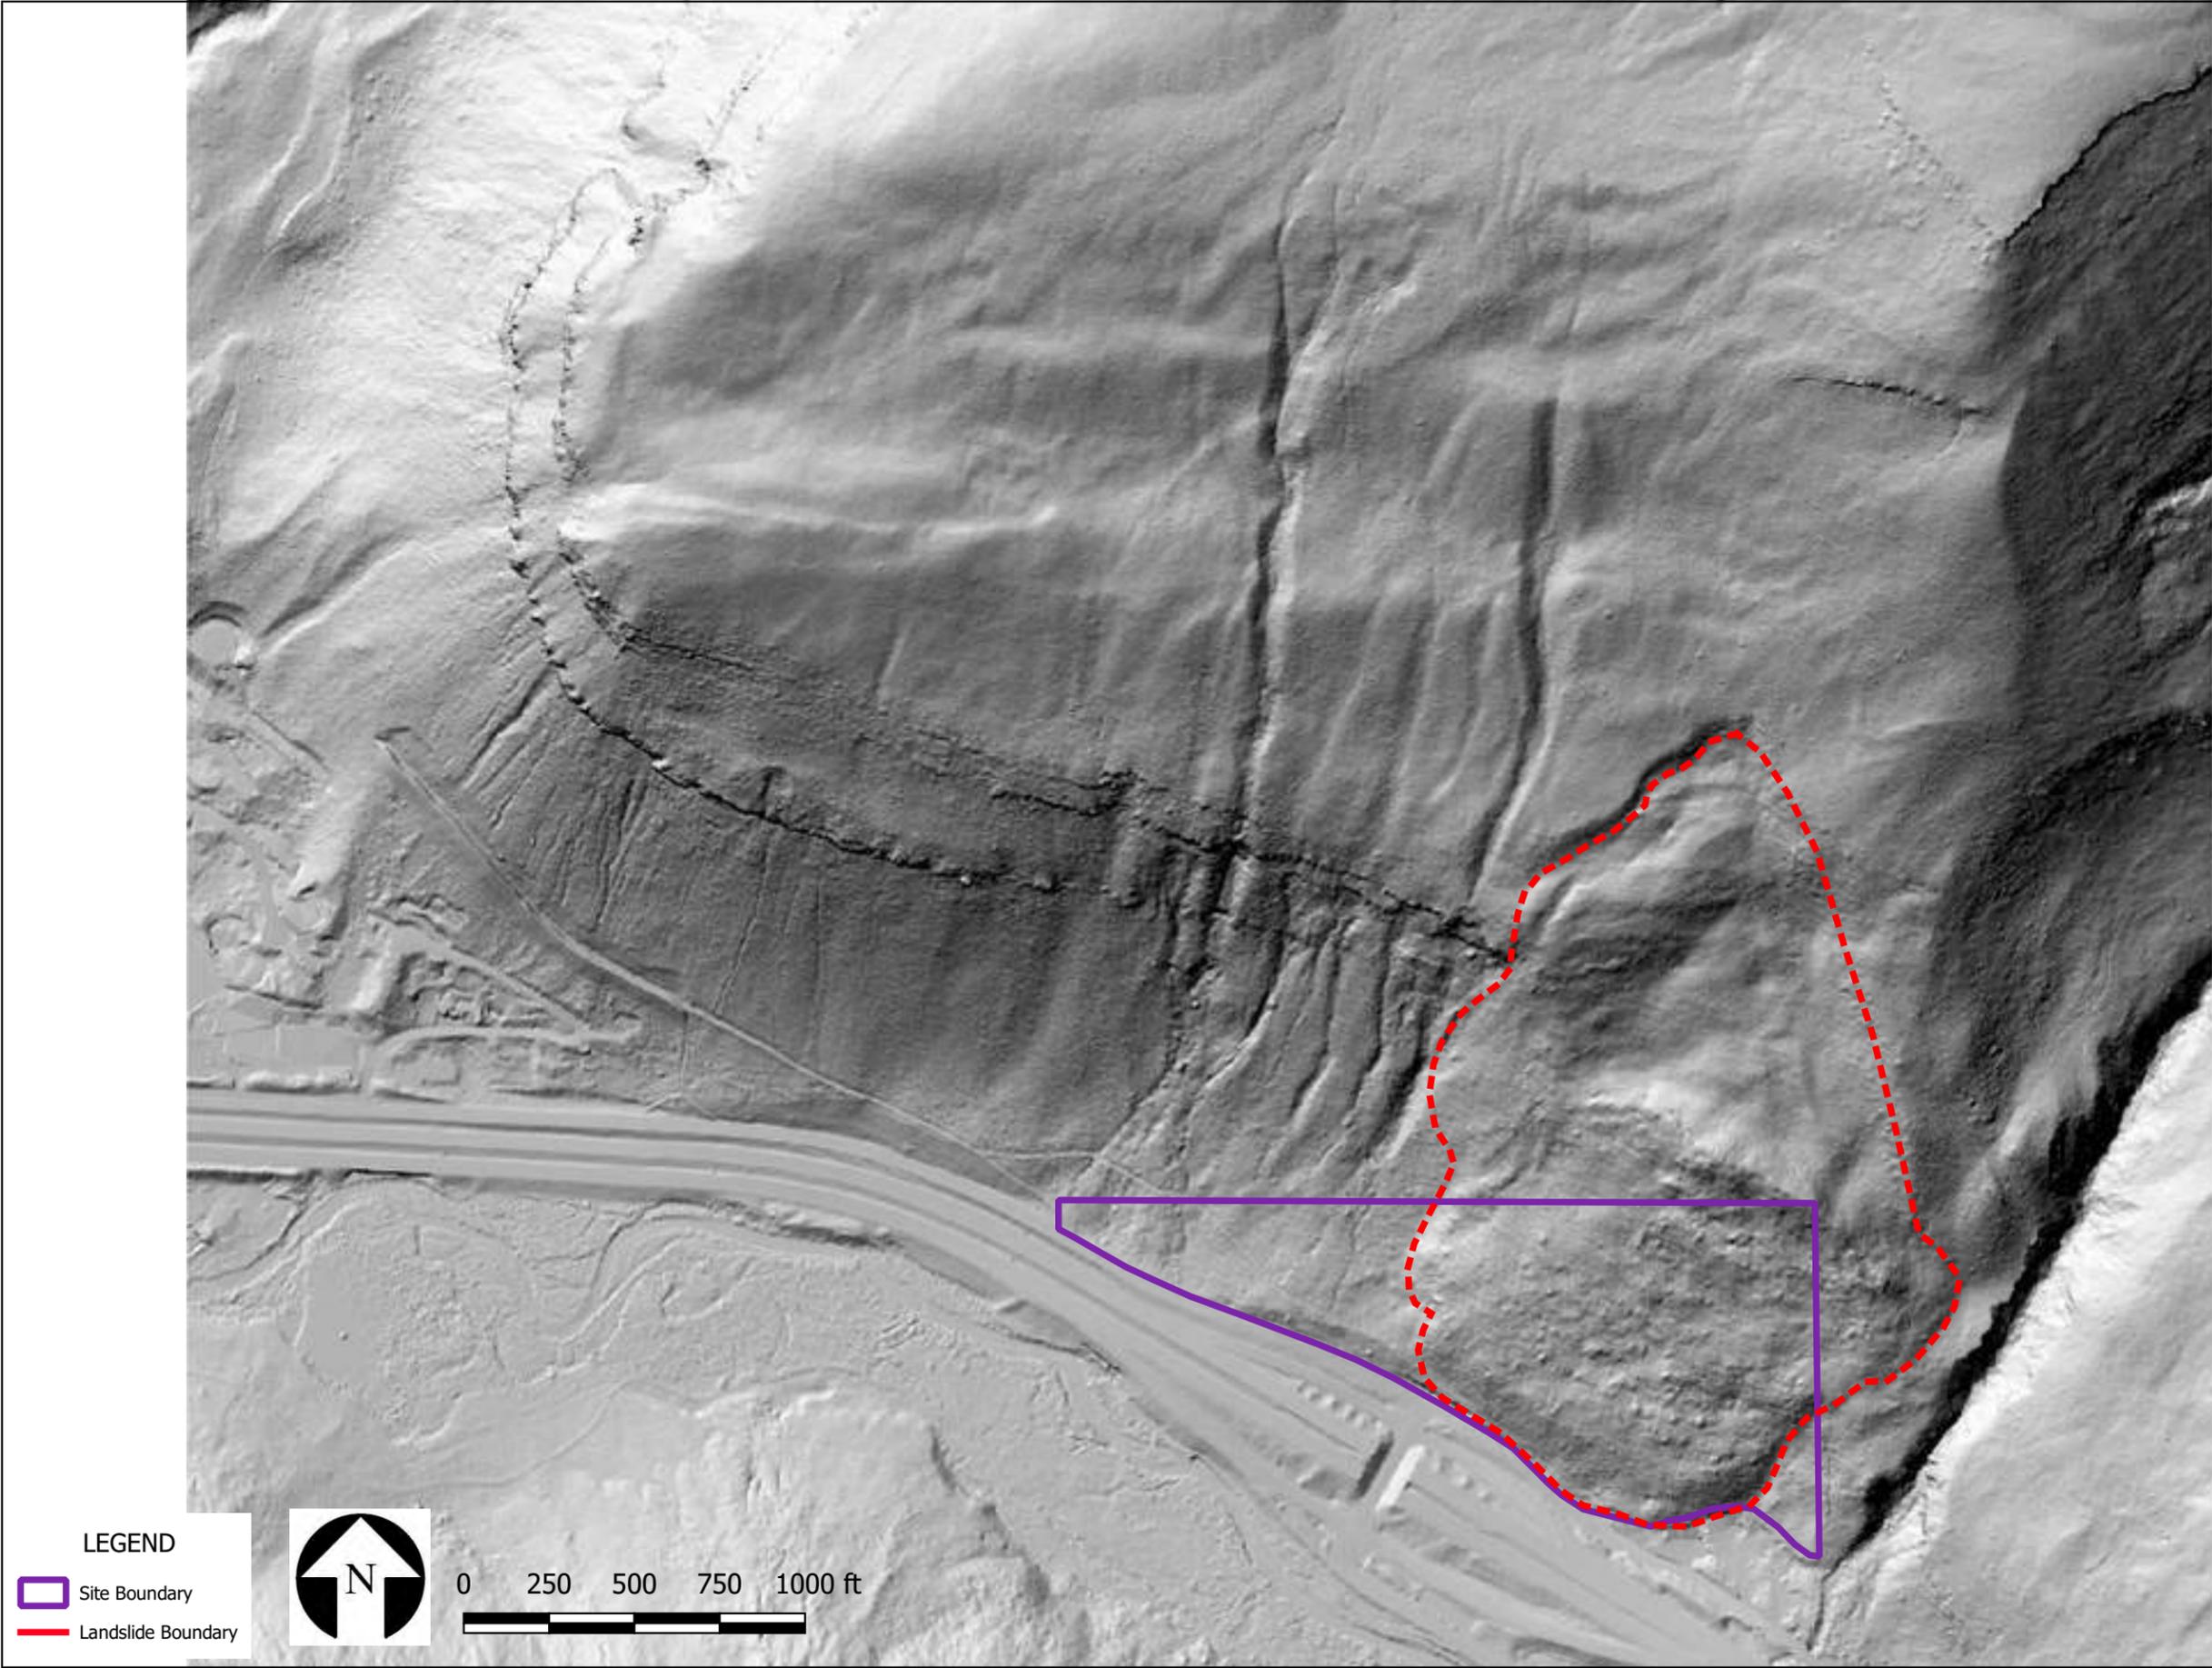
FIGURE 7
 Landslide Extents Map

The extents of a large landslide complex were mapped on the east side of the site (Figure 7). A landslide study section passes through the middle of the landslide, location shown on Figure 8 and profile shown on Figure 10. The landslide study section begins upslope above an exposed outcrop comprised of Robinson Limestone at about 8900 to 8920 feet elevation and extends southward to Fall Line Drive, with a total elevation change of about 588 over a profile length of 1,220 feet. The elevation of the Robinson Limestone bedrock exposure can be correlated to the rock exposures to the west which are the primary rockfall source zone for the Booth Falls subdivision, although the outcrop on the subject site is not as pronounced or as exposed as areas to the west. Based on the landslide morphology visible in the LiDAR image, this bedrock exposure at about elevation 8900 likely slid down from a higher elevation upslope.

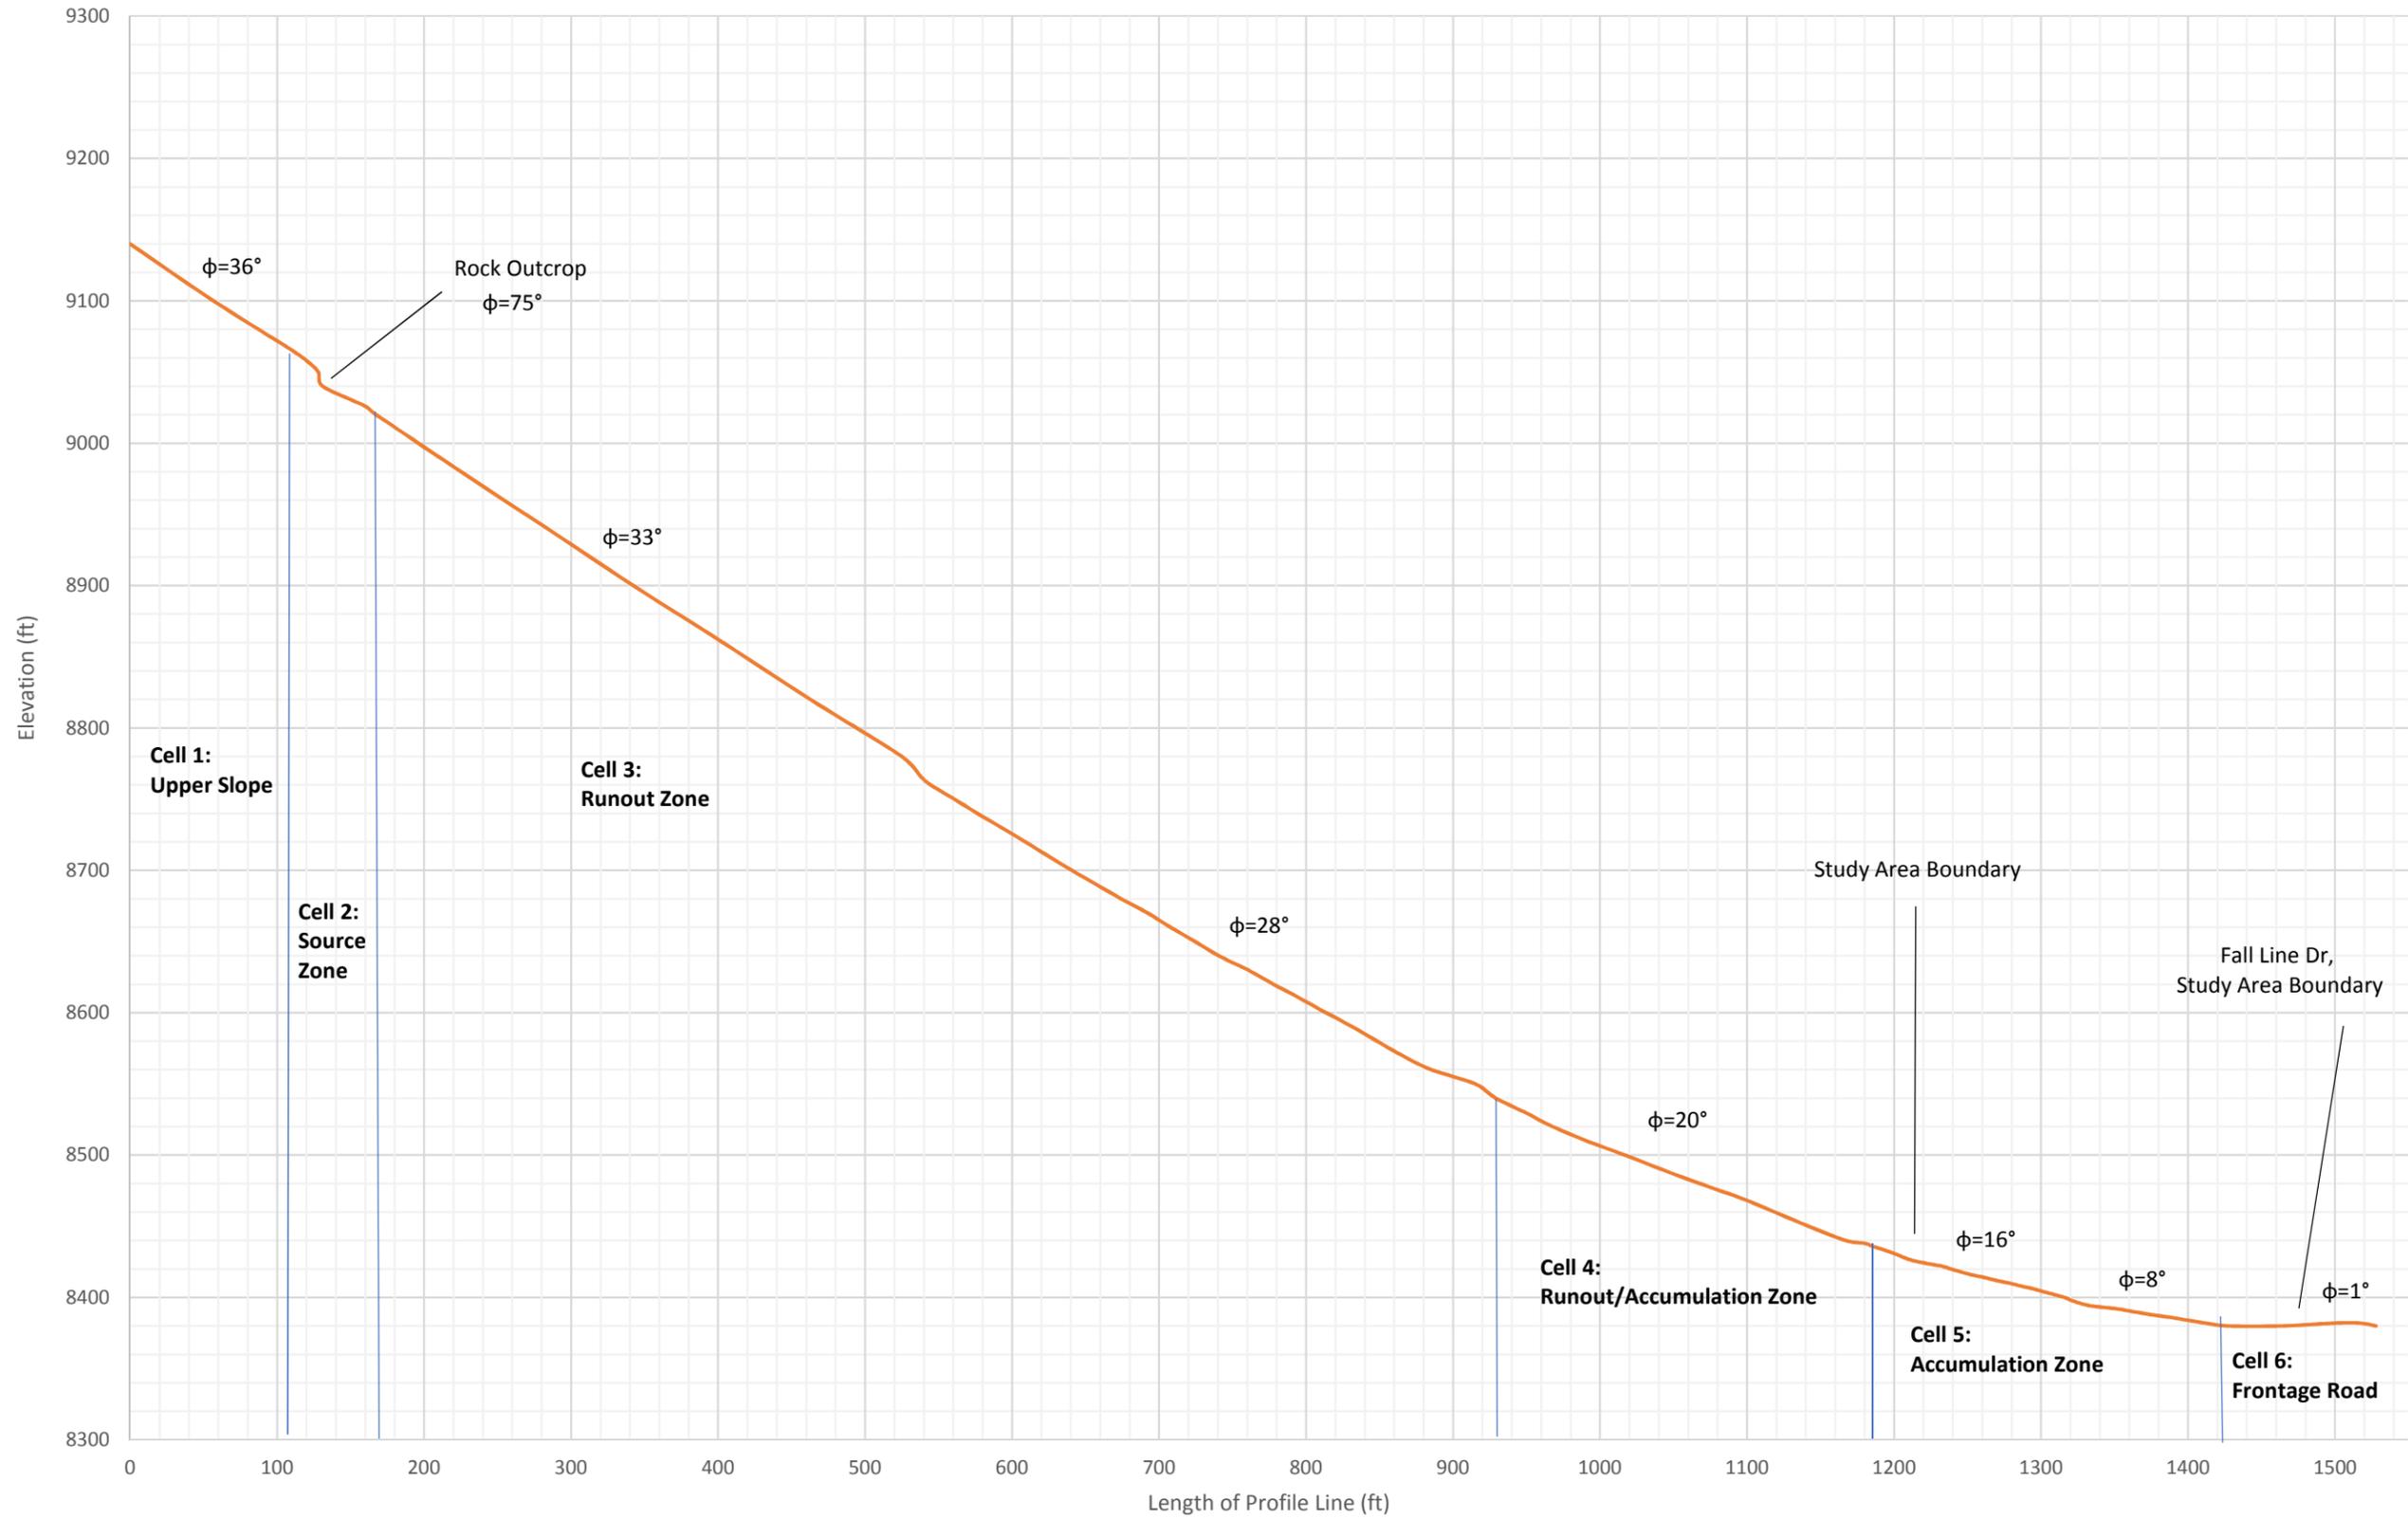
FIGURE 9
Rockfall Study Section

Cesare analyzed one rockfall study section through the west part of the site (Figure 8). The location of this rockfall study section is representative of the slope on the west side and passes through the area of the project site most likely to be developed in the future. The rockfall study section is considered a reasonable representation of the slope in the western part of the site. The section profile was derived from topographic maps available through the USGS, the Town of Vail, and a topographic map for a portion of the western part of the site provided by the client. The rockfall study section is depicted on Figure 9 and shown in Photographs 14 and 15.

Rocks deposited along the rockfall study section slope are primarily blocky to slab shaped, and comprised of gray limestone interbedded with thin layers of sandstone, siltstone, and shale. Boulders comprised of sandstone were also observed. The rockfall study section appears to be an area of more recent rockfall events, compared to other areas of the site. A number of rocks in the rockfall study section area display a comparatively “fresh” appearance, relative lack of lichen or vegetative overgrowth, and some with minimal soil embedment. For other parts of the slope, a majority of the boulders are more deeply embedded in the soil and overgrown with lichen and vegetation (indicating much older rockfall events). Refer to Photographs 19 through 23 for examples of boulders observed on the ground surface in the area of the rockfall study section.

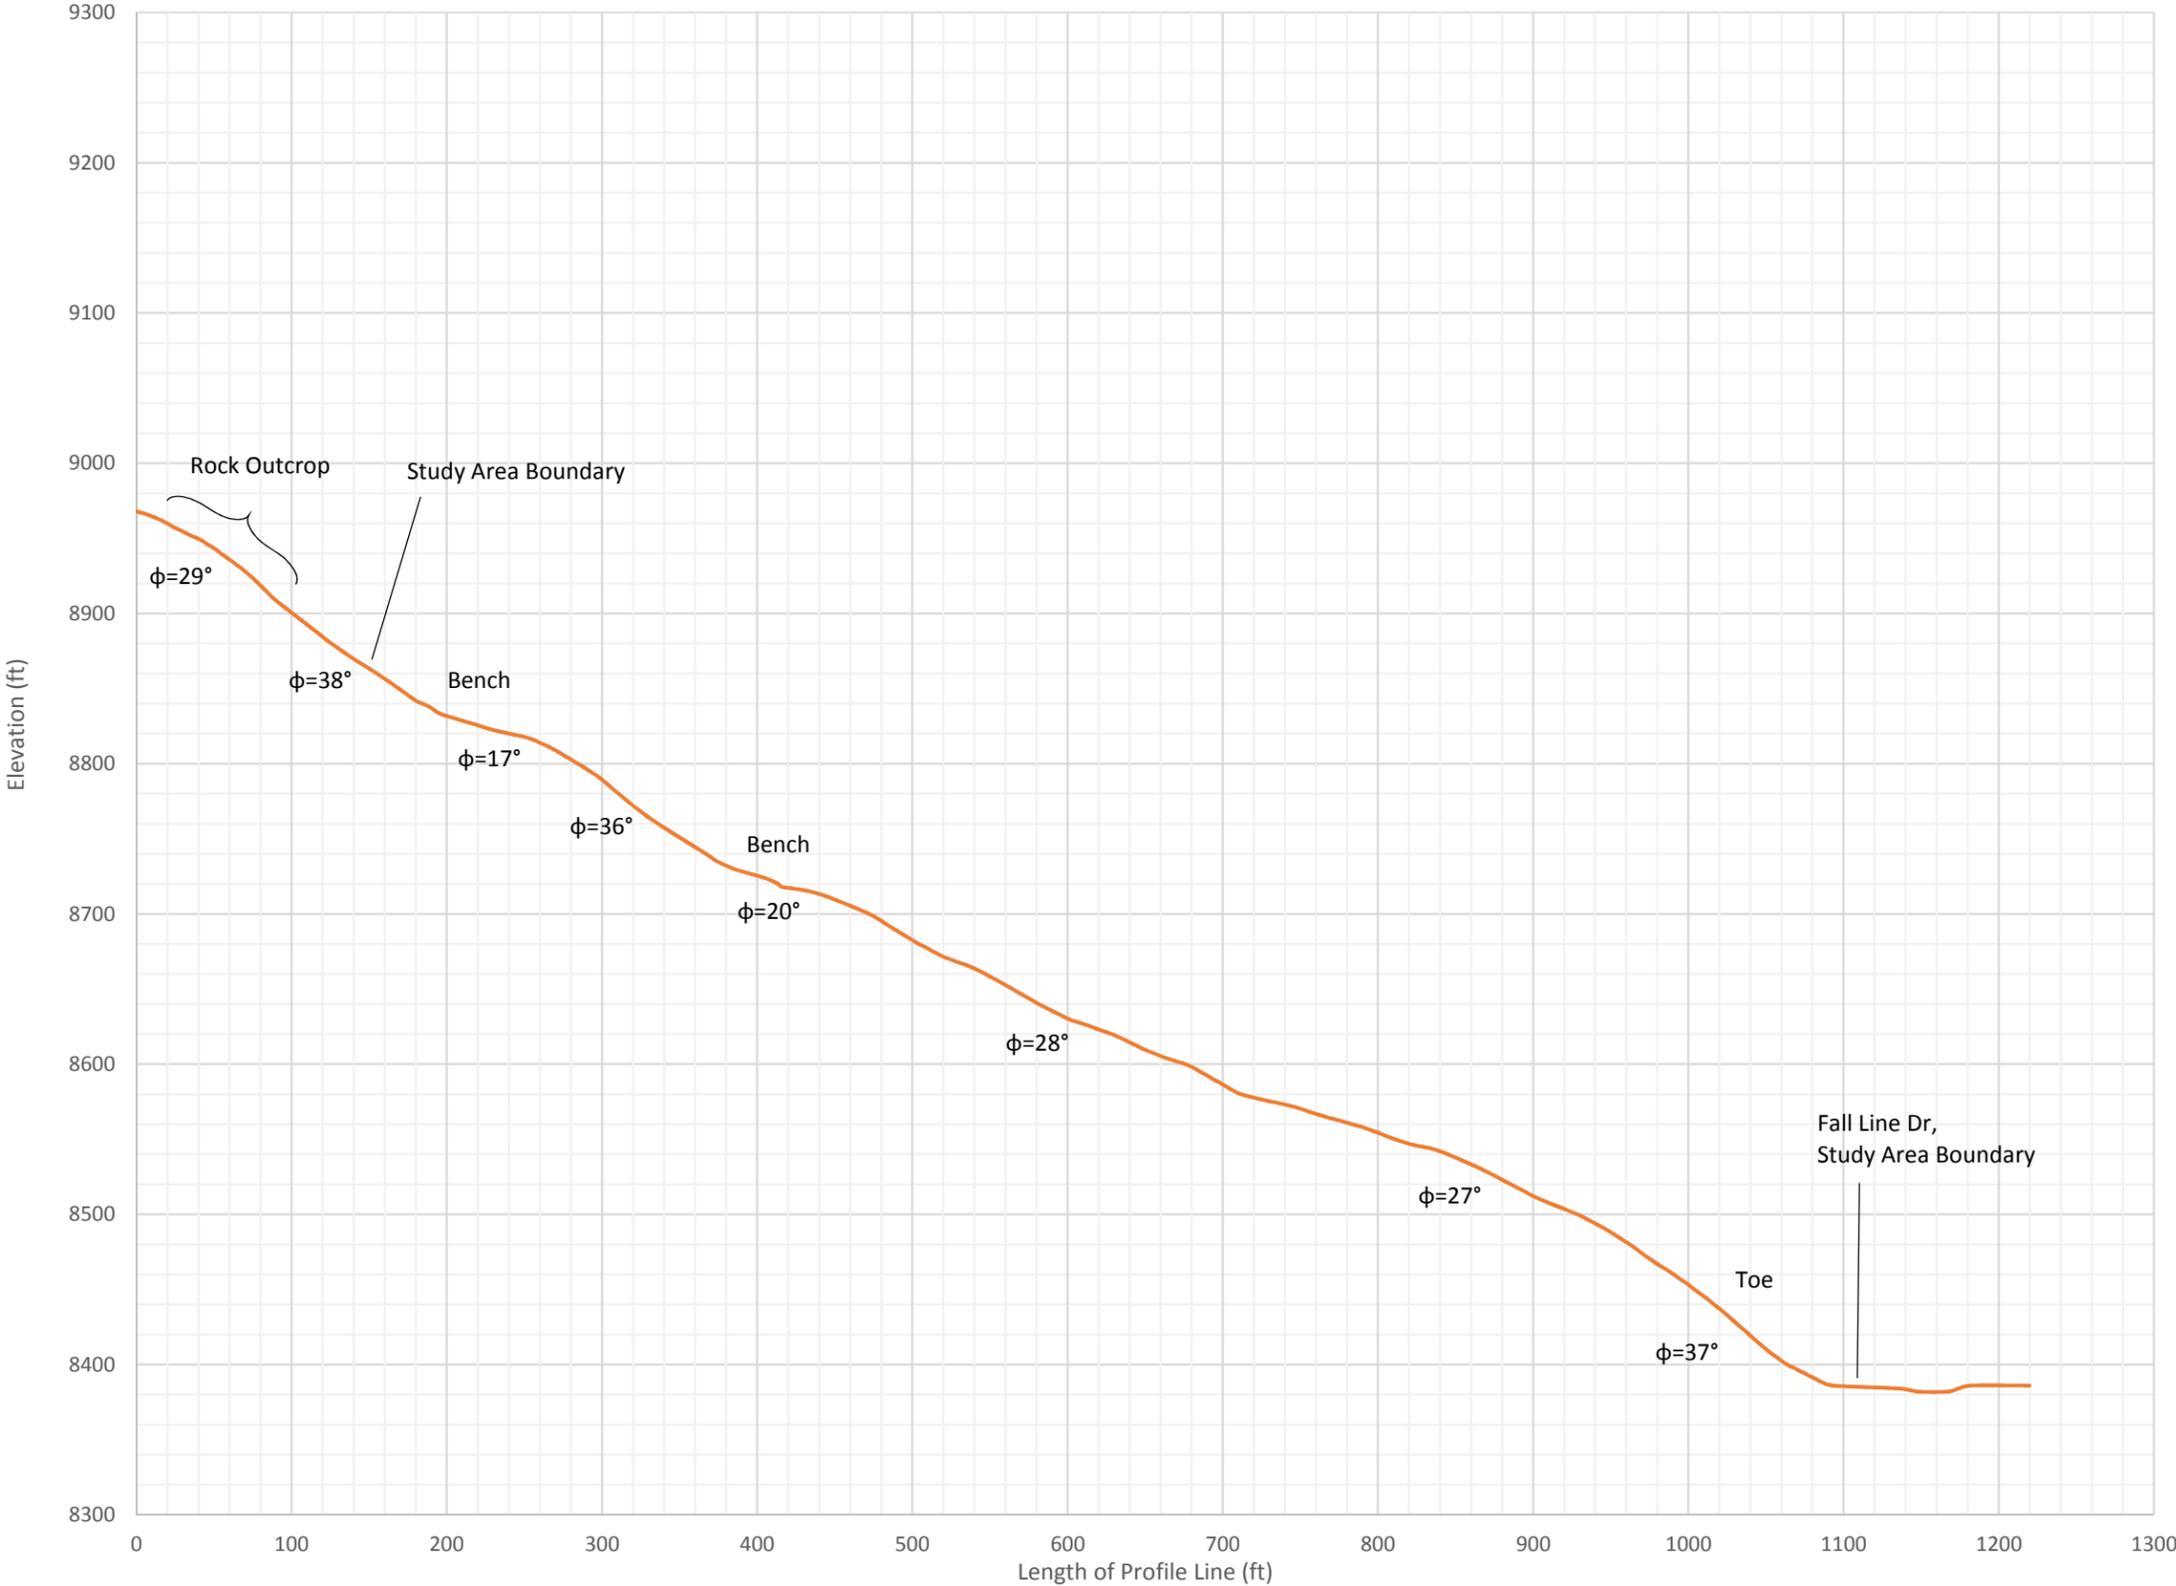
FIGURE 10
Landslide Study Section

The LiDAR bare earth surface and the landslide study section both display a benched and hummocky pattern characteristic of landslide terrain. The flatter parts of the benched areas range from about 15 to 20 degrees, while the toe areas of the benches range from about 30 to 40 degrees. A slope map is shown on Figure 11 and depicts the range of slope angles across the site and surrounding area.

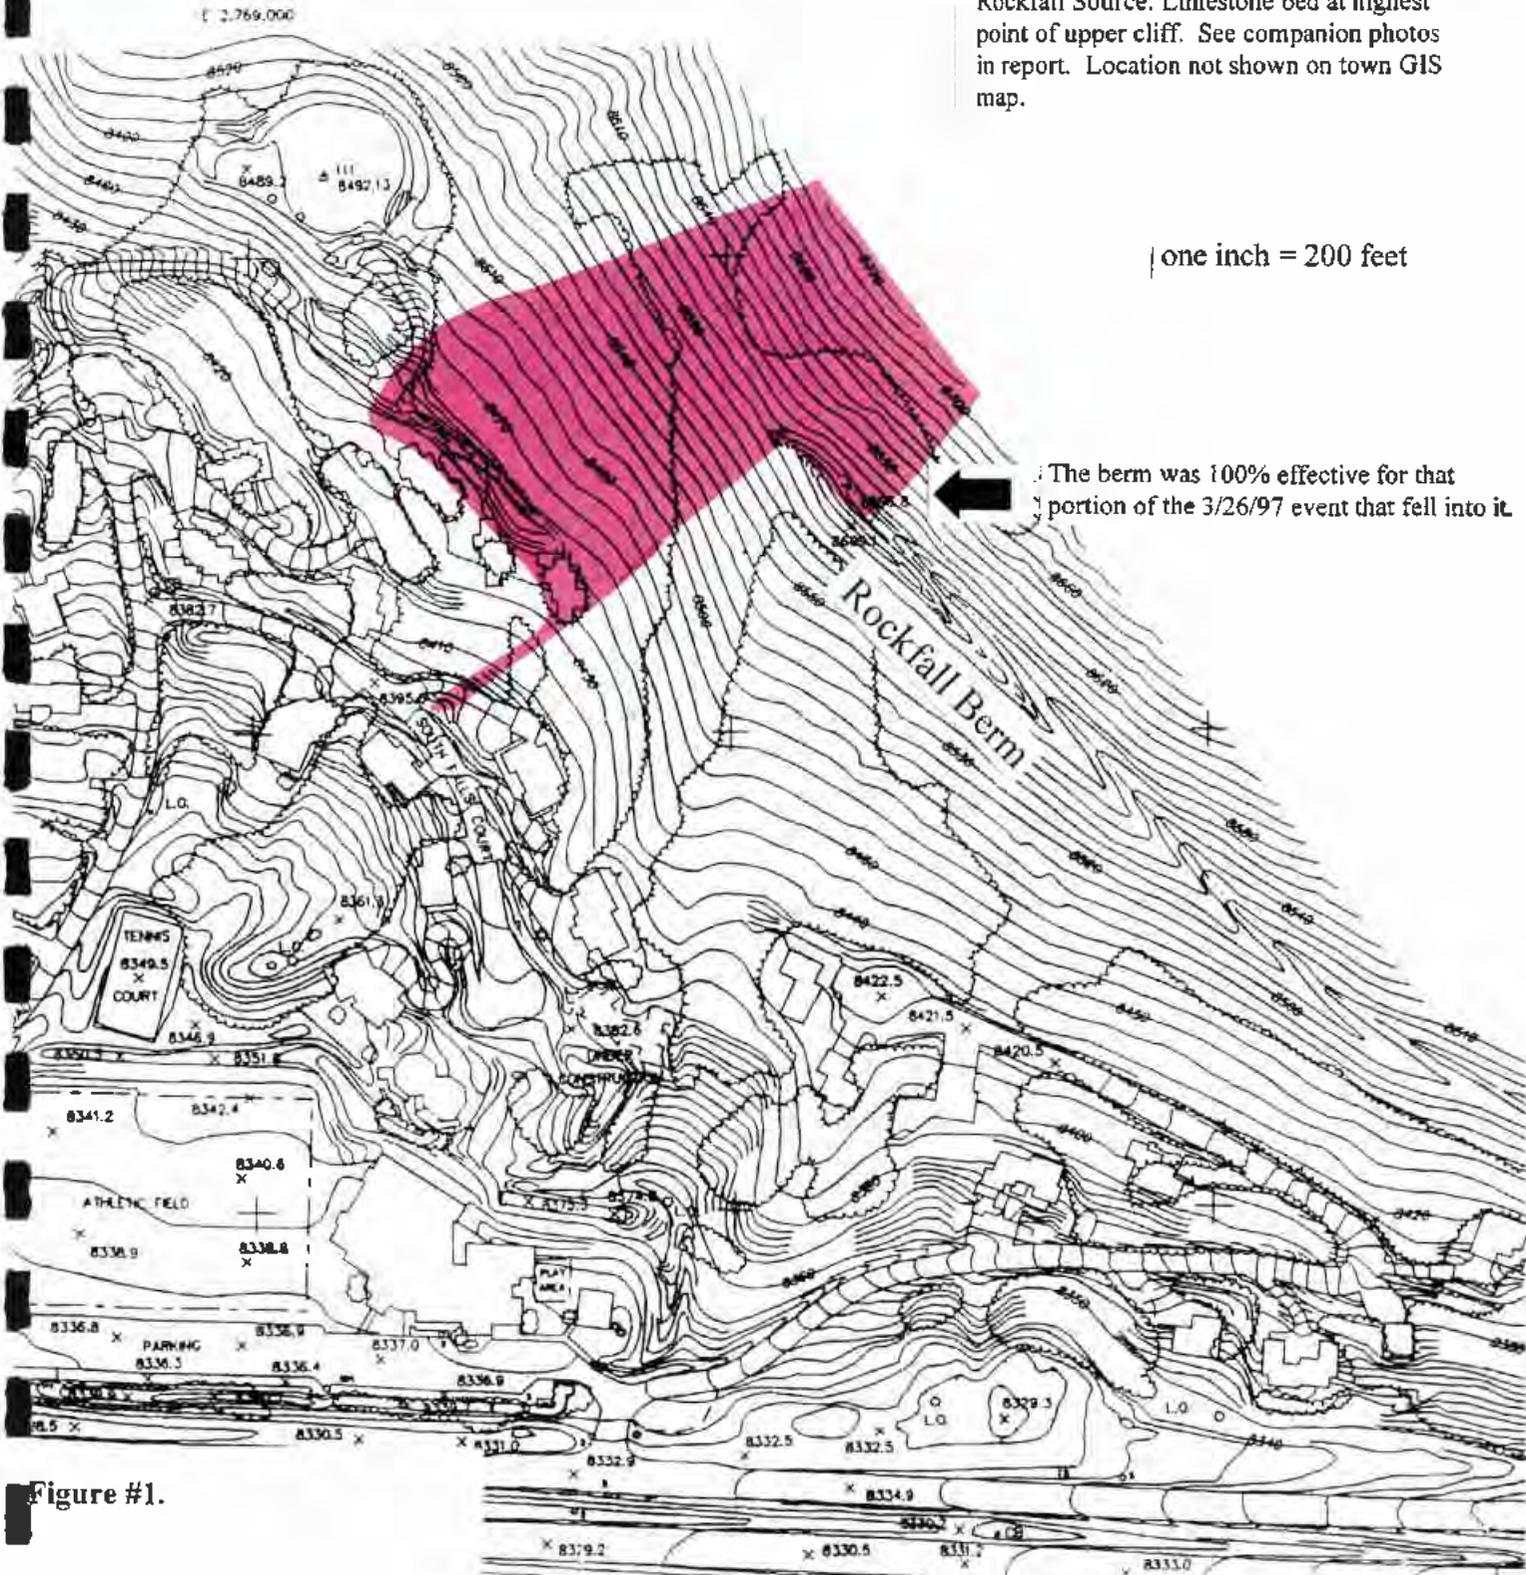
Figure #1.

Rockfall Source: Limestone bed at highest point of upper cliff. See companion photos in report. Location not shown on town GIS map.

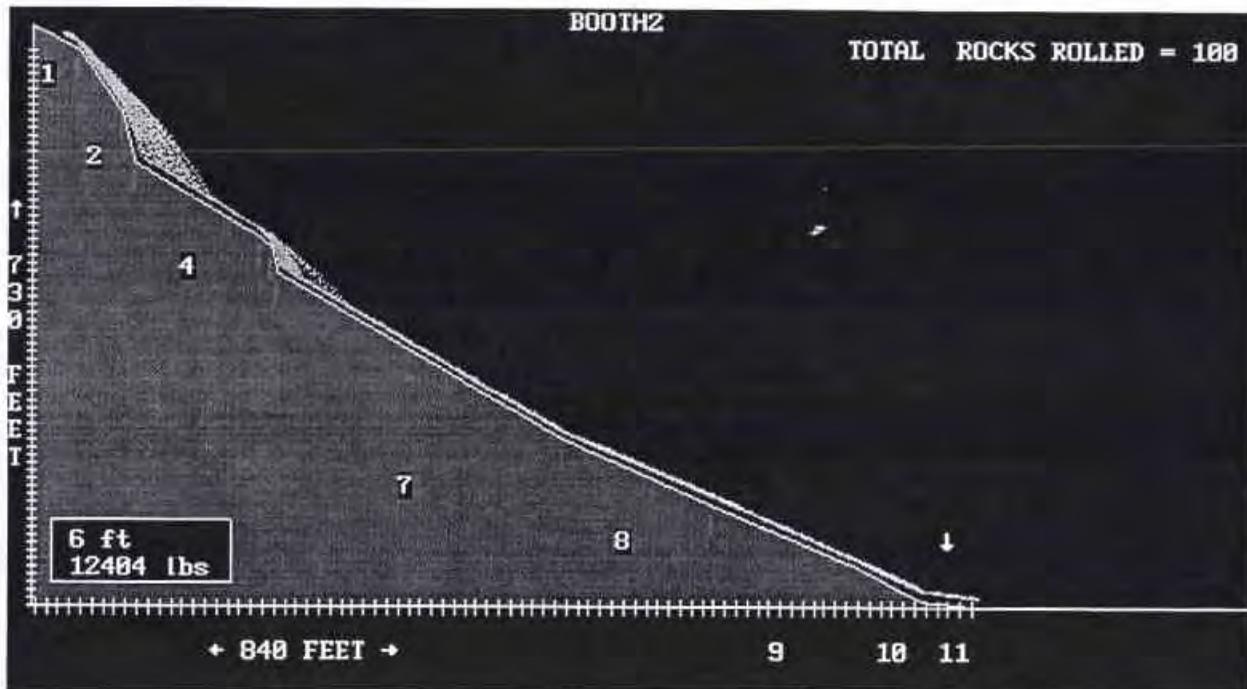
Rock Size	Rock Weight	Bounce ft.	K.E.(max.) ft.-lbs.	K.E.(avg.) ft.-lbs	Vel.(max.) ft/sec	Vel.(avg.) ft/sec
4' sphere	5058	3.0	1,000,000	800,000	98	83
5' sphere	9878	2.1	1,900,000	1,400,000	95	81
6' sphere	17069	2.0	3,000,000	2,300,000	96	78
7' sphere	27106	1.7	4,600,000	3,300,000	89	74
4'x7' cyl.	13272	1.7	2,500,000	1,700,000	93	74
5'x6' cyl.	17775	1.9	3,600,000	2,400,000	94	76
6'x6' cyl.	25600	1.9	4,900,000	3,500,000	89	74
6'x7' cyl.	30000	1.8	5,700,000	3,700,000	90	72

Figure 2. Screen dump of CRSP program of Booth Creek-west side. Analysis point arrow is 30 feet above condominiums. Horizontal and vertical are not at the same scale.

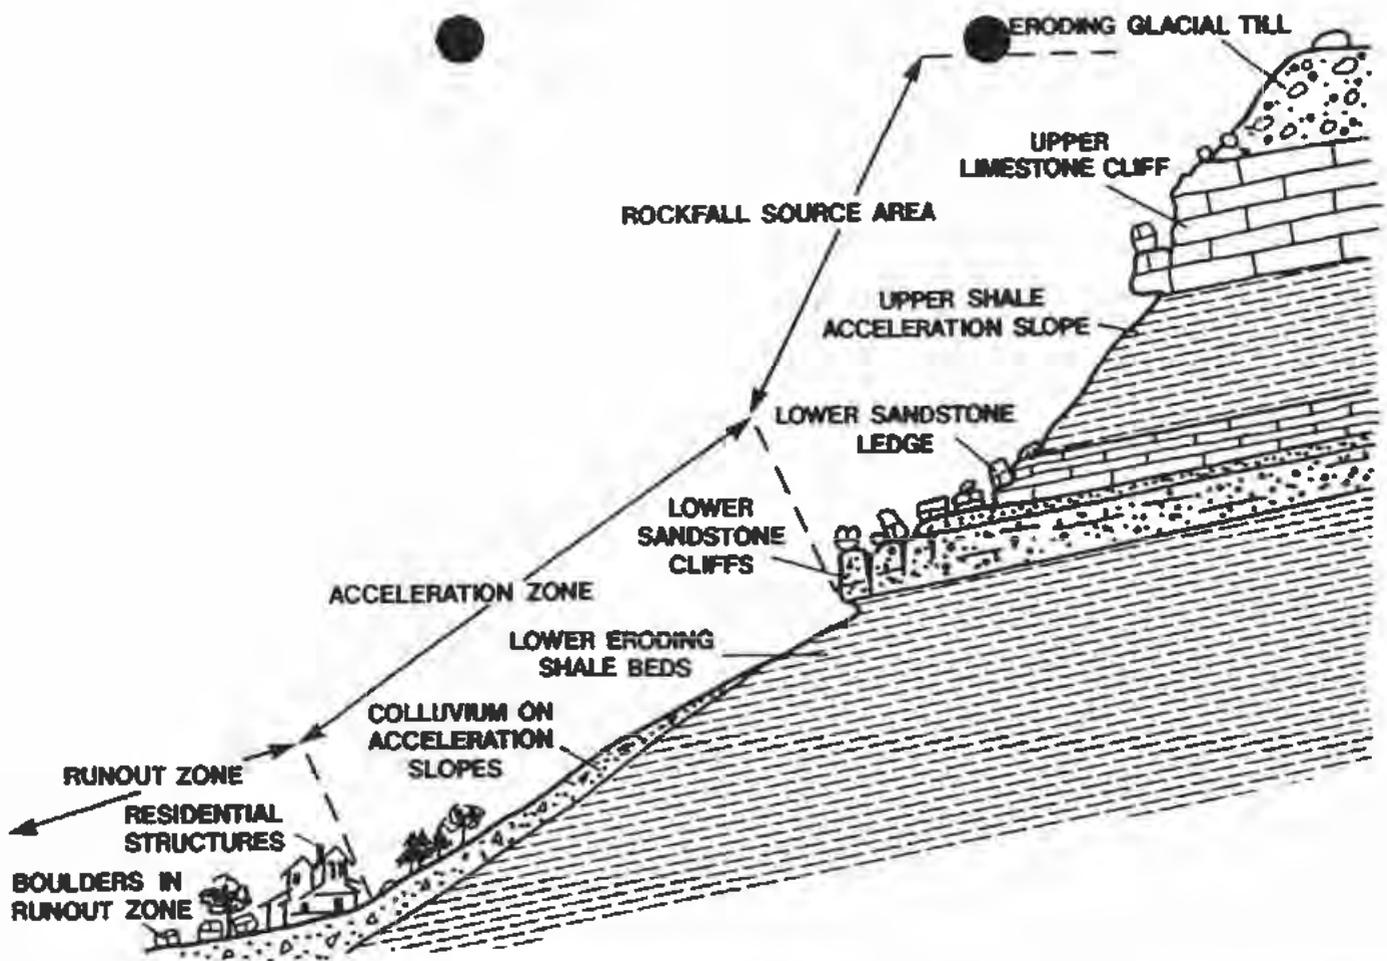
Figure 2. Geologic diagram of compound rock-fall slopes in study area. Drawn to scale with no vertical exaggeration. Note dip of strata toward valley.

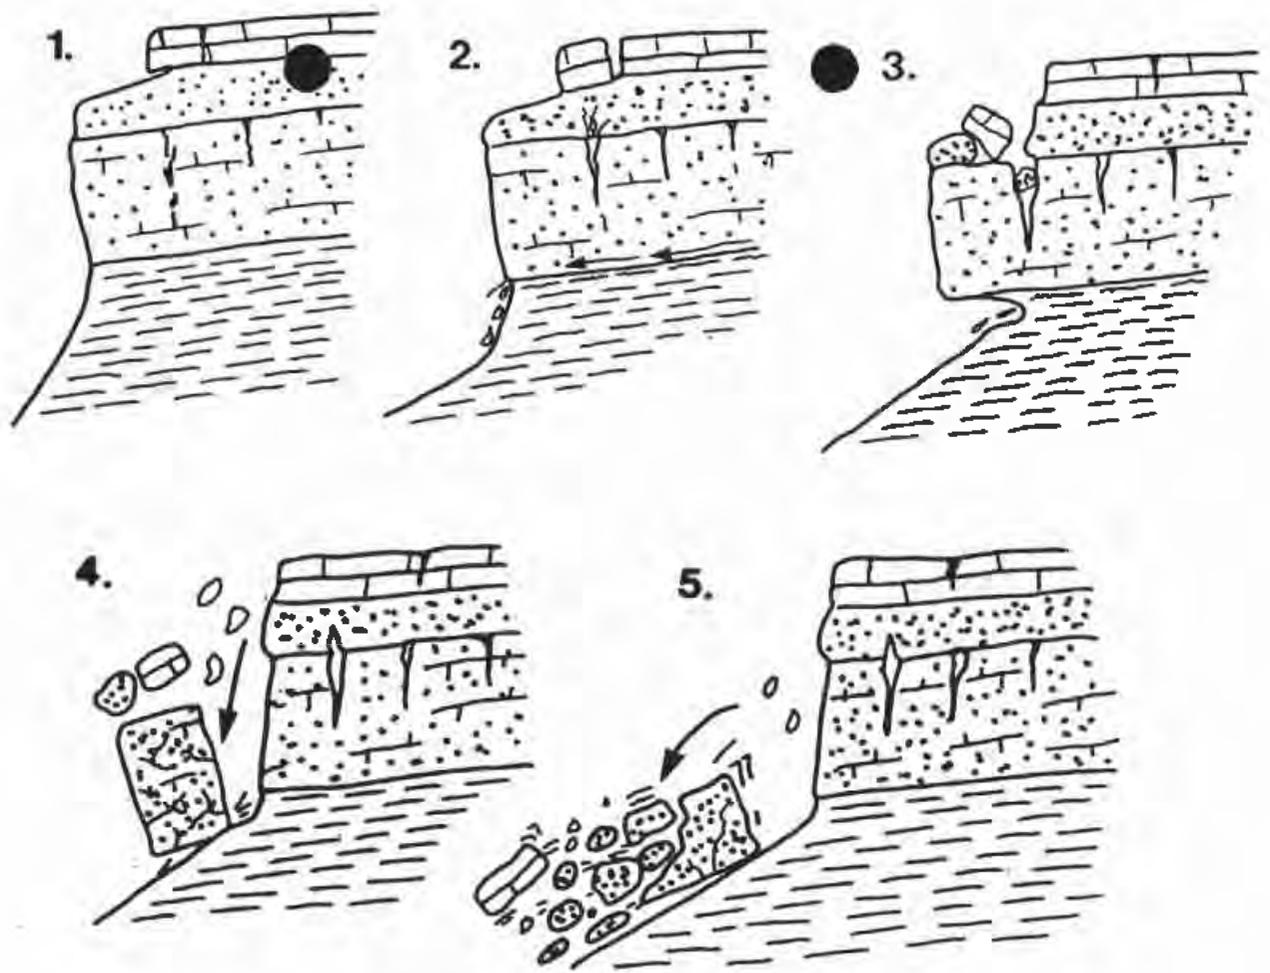
Figure 3. Toppling Slab-failure Sequence. 1. Initial cliff configuration. 2. Differential weathering of soft shale begins to undercut massive cliff forming slab. Joints open and widen due to slope creep and frost wedging. Springs issue from contact beneath cliff. 3. Undercutting continues. Joints widen and are wedged open by smaller rocks, causing slab to tilt outwards. 4. Slab falls from cliff face onto acceleration slopes, bringing down overlying rocks. 5. Slab topples and shatters, showering runout zone below with boulders, and exposing new cliff face to erosion.
