ROCKFALL HAZARD STUDY

East Vail Parcel
Vail, Colorado

Project No. 17.5029
June 19, 2017

**Julia M. Frazier, P.G.
Senior Geologist**

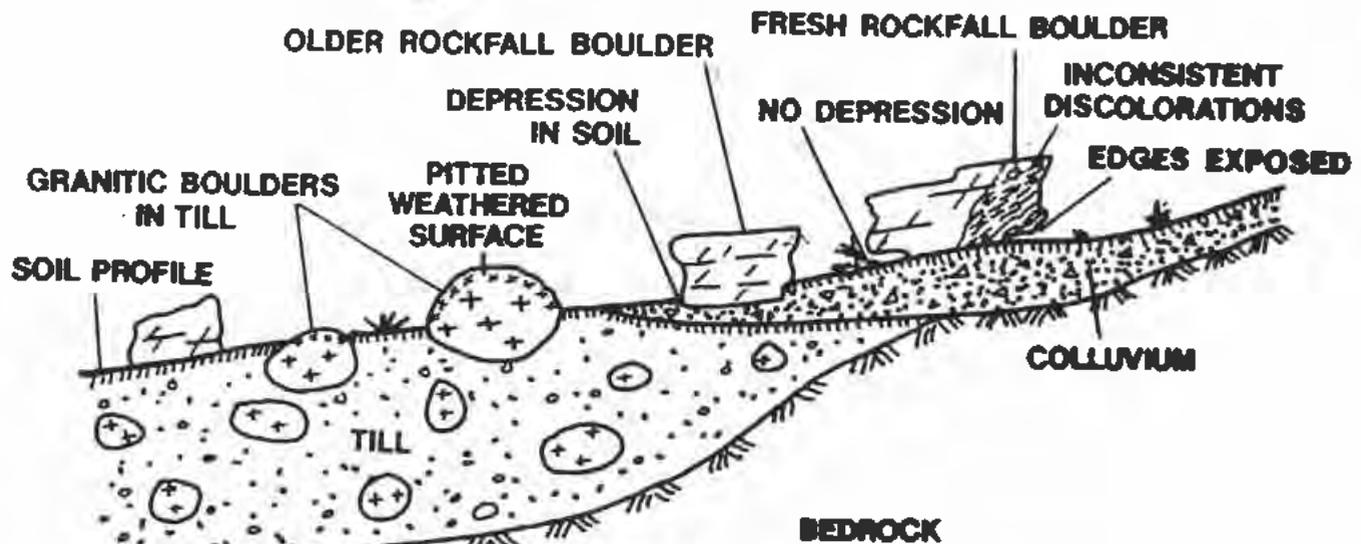
Figure 6. Physical differences between rockfall and glacially deposited boulders in runout zone. Rockfall boulders are all limestone or sandstone, while glacial boulders are mostly rounded granite or metamorphic lithologies. Note that soil exists below rockfall boulders, while it is absent beneath glacial boulders.
