PROJECT NO:	17.5029		
PROJECT NAME:	Rockfall Hazard Study, East Vail Parcel		
DRAWN BY:	RAB	CHECKED BY:	JMF
DWG DATE:	06.16.17	REV. DATE:	--

**ROCKFALL HAZARD ASSESSMENT AT BOOTH FALLS
CONDOMINIUMS
AND PROPOSED MITIGATION**

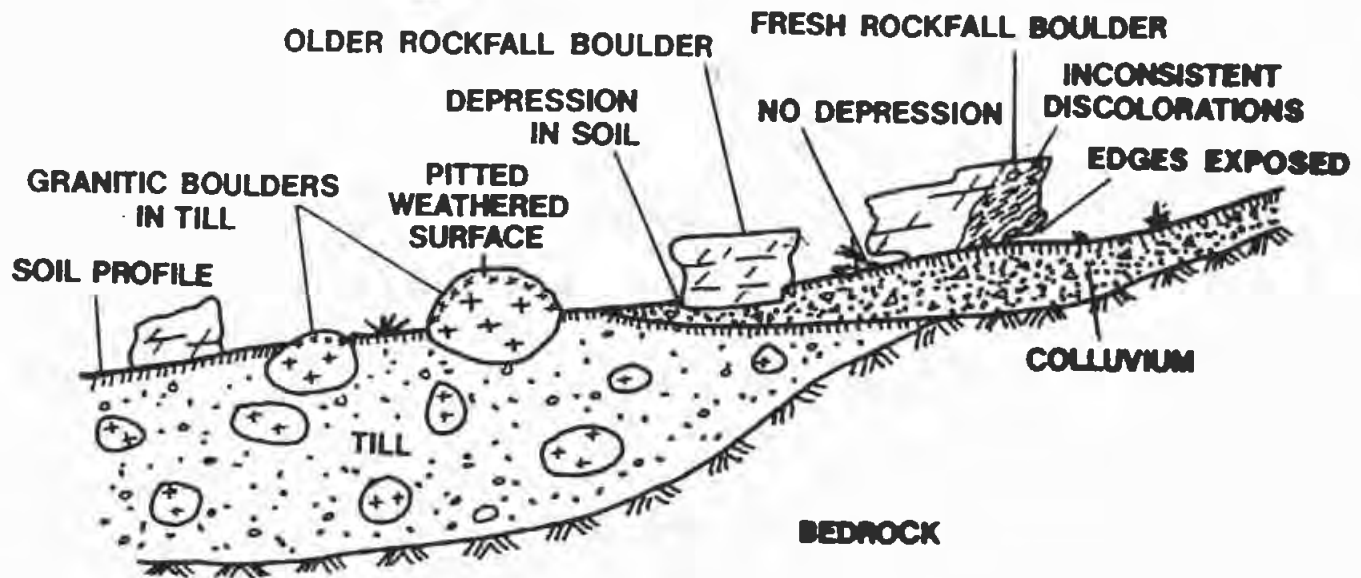
Figure 6. Physical differences between rockfall and glacially deposited boulders in runout zone. Rockfall boulders are all limestone or sandstone, while glacial boulders are mostly rounded granite or metamorphic lithologies. Note that soil exists below rockfall boulders, while it is absent beneath glacial boulders.
